STEEL CORE ENGINEERING

109 East 9th St. New York, NY 10003

Re: Additional Probing of Upper Floors structure

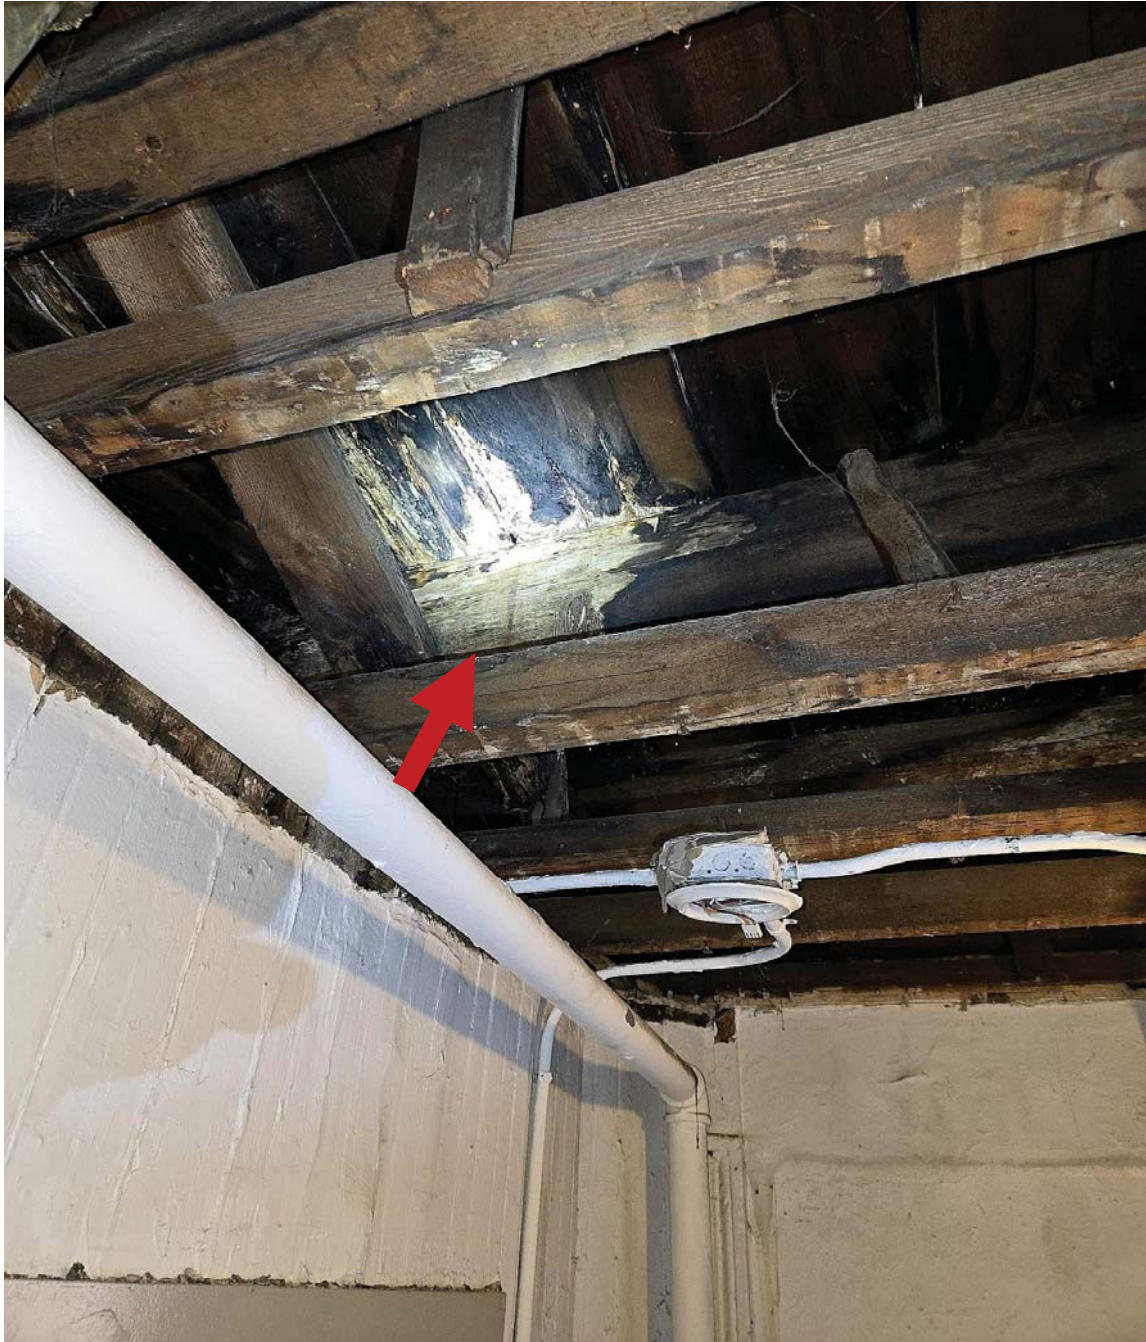
PHOTO #1

- **Photo #1 & #2** show roof rafters and chimney trimmer beam having extensive water deterioration. All of the roof rafters in unit 4A have water stains and have decay due to water exposure.

Roof rafter and chimney trimmer beams show extreme water deterioration

- **Water-Damaged Framing:** Throughout the building where the roof rafters and floor framing have substantial water damage and deterioration at the beam pockets and along their spans, the framing should be either sistered with new reinforcement, which is plumb, dry and stiff enough to span the length of the existing beam at minimum. However, the proper solution would be to replace the deteriorated framing with a new dry framing structure which will not be in contact with existing wet and deteriorated joists.

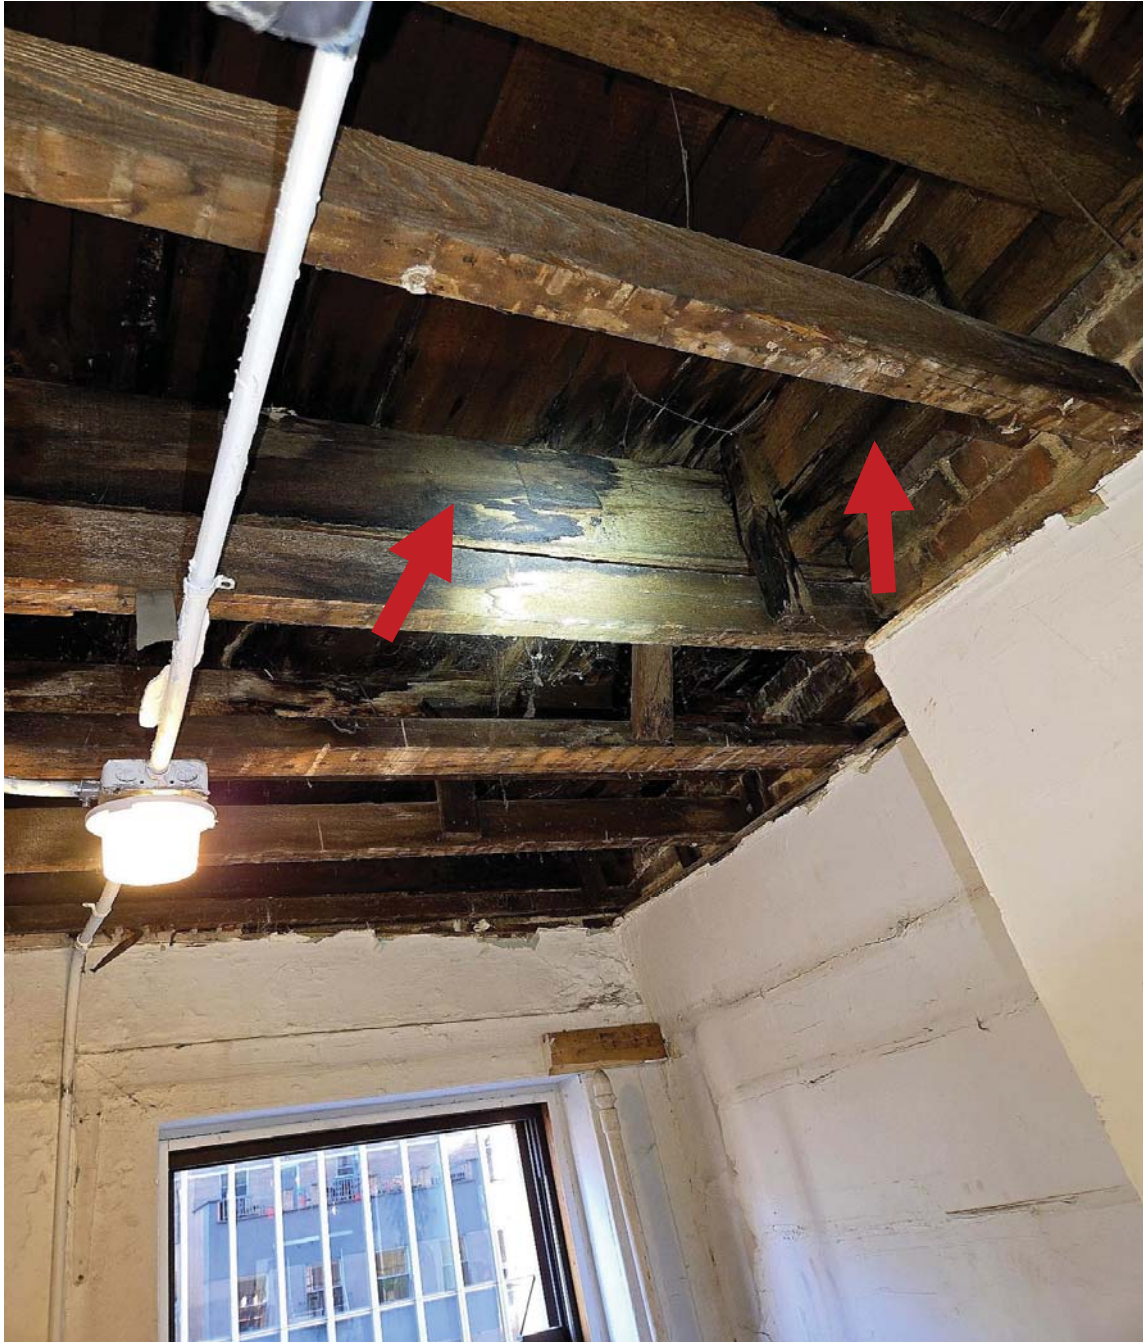
PHOTO #2

Roof rafter and chimney trimmer beams show extreme water deterioration

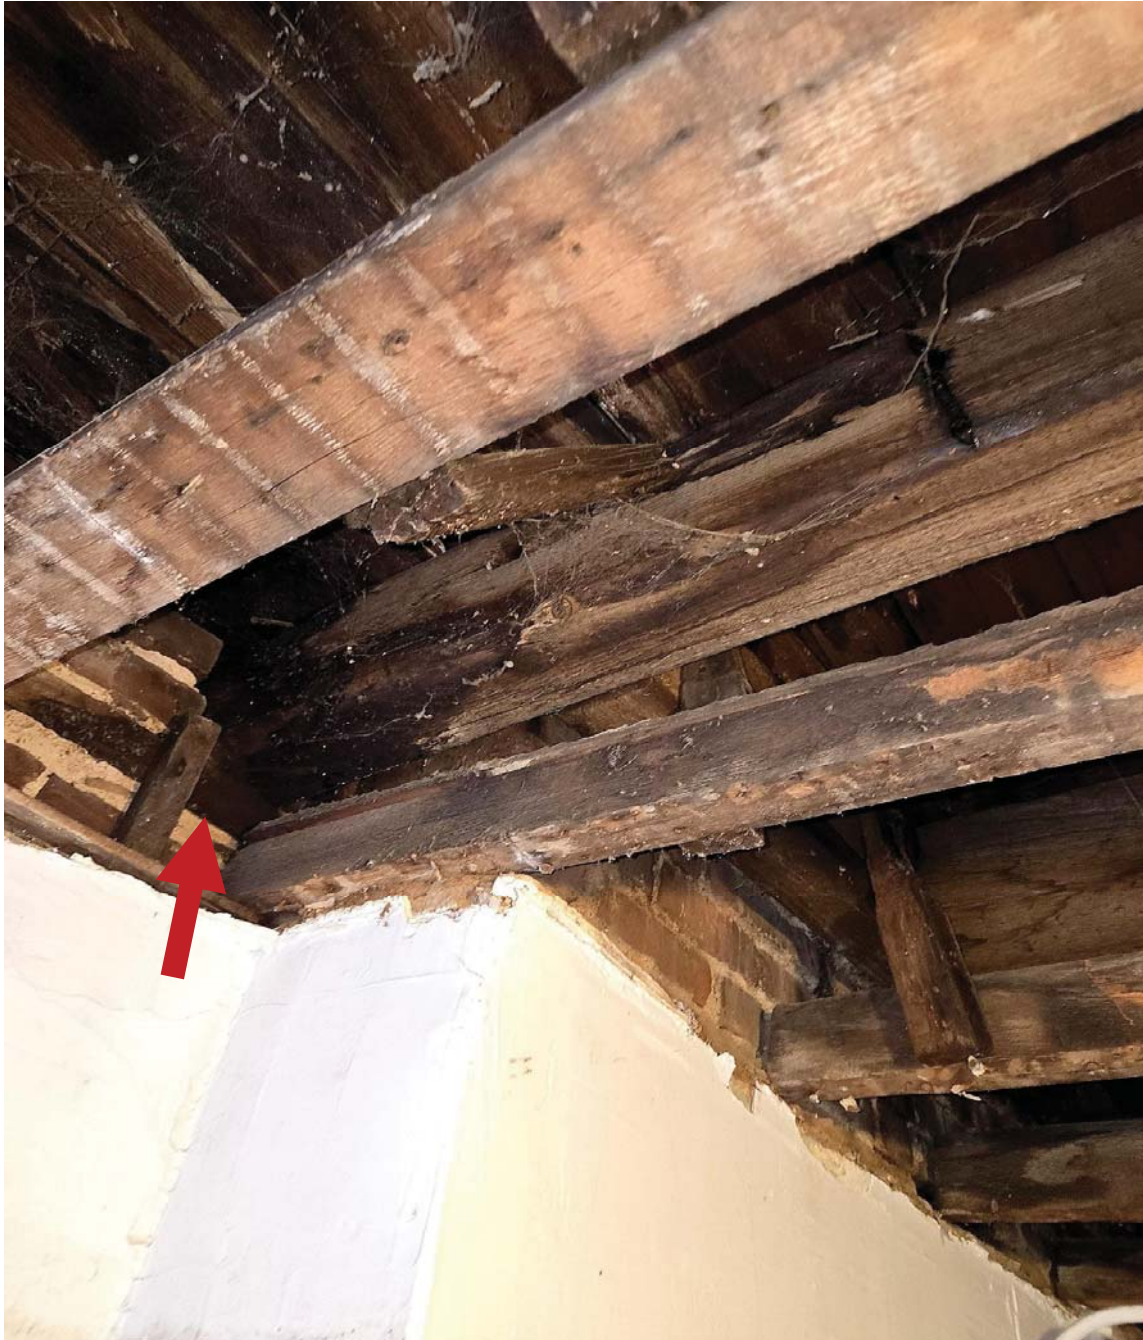
PHOTO #3

- **Photo #3** shows how the chimney trimmer beam is deteriorated at the beam pocket due to water exposure and this is an unsafe condition as the beam is weakened where it has to resist the maximum shear and bearing stresses.

Chimney trimmer beam is deteriorated at the beam pocket due to water exposure and this is an unsafe condition as the beam is weakened where it has to resist the maximum shear and bearing stresses

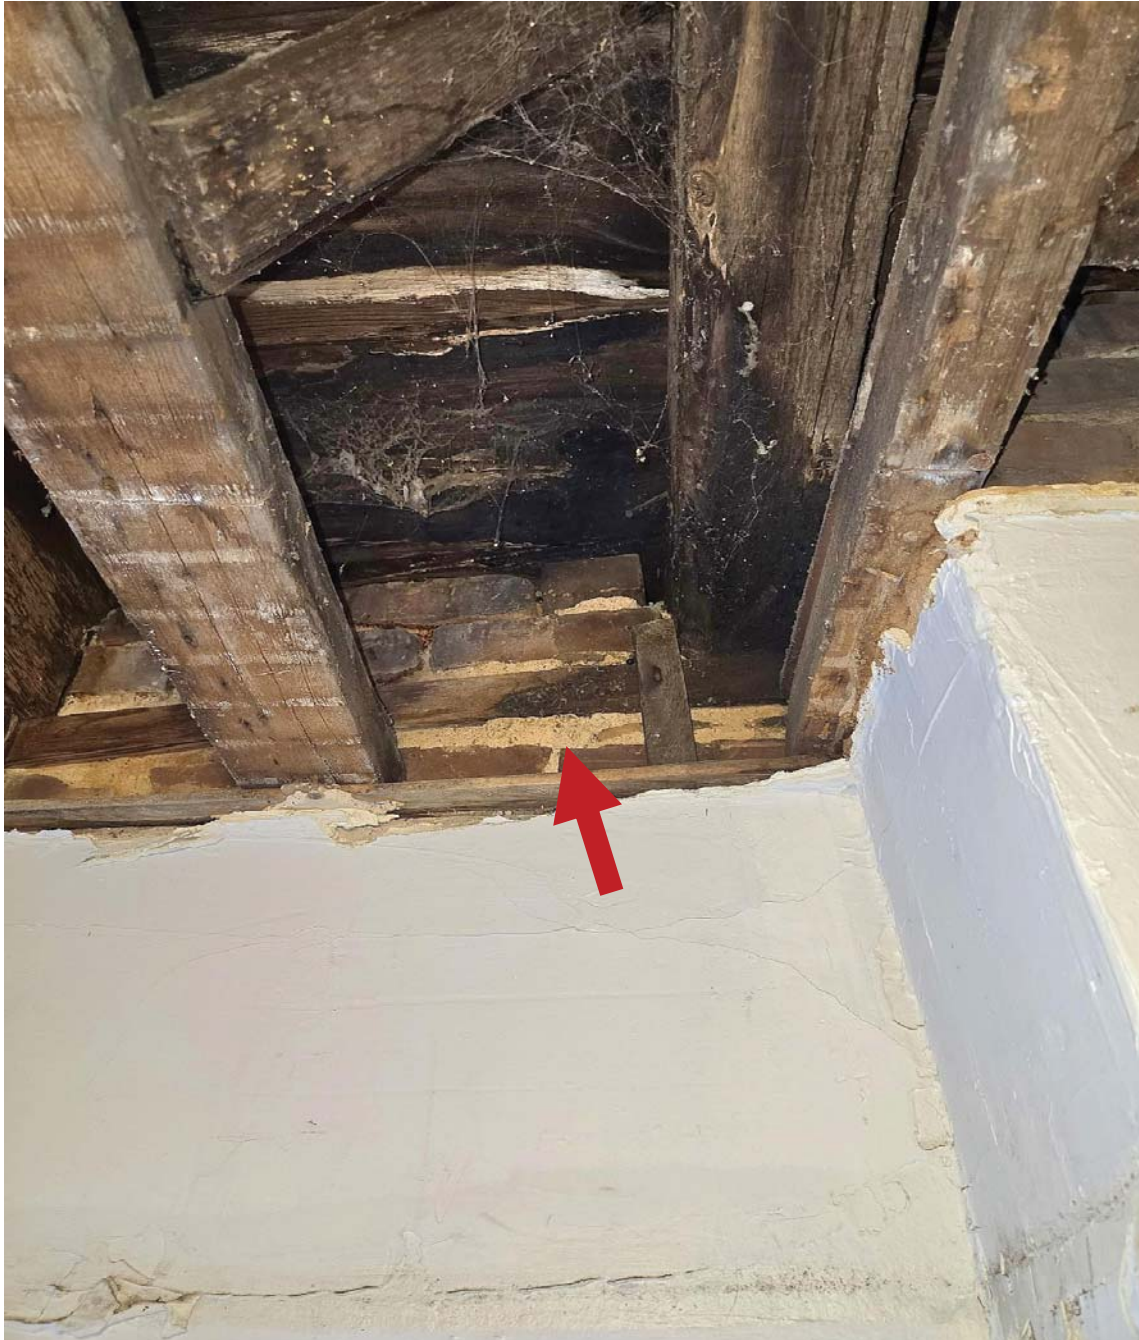
PHOTO #4

- **Photo #4** shows the brick and mortar condition where the roof framing ties into the wall. The brick has extensive water marks throughout and the mortar between the bricks is just sand. There is no adhesive properties in the mortar as it is dry and crumbles when touched. Such a mortar condition does not provide the wall with any tensile strength from out of plane bending and impacts the way the wall transfers the load down the building.

The brick has extensive water marks throughout and the mortar between the bricks is just sand. There is no adhesive properties in the mortar as it is dry and crumbles when touched. Such a mortar condition does not provide the wall with any tensile strength from out of plane bending and impacts the way the wall transfers the load down the building

- **Masonry Walls:** At the bearing masonry walls, removal and replacement of the deteriorated brick as well as deep repointing. Masonry stitching at the interior corners of the building, as required.

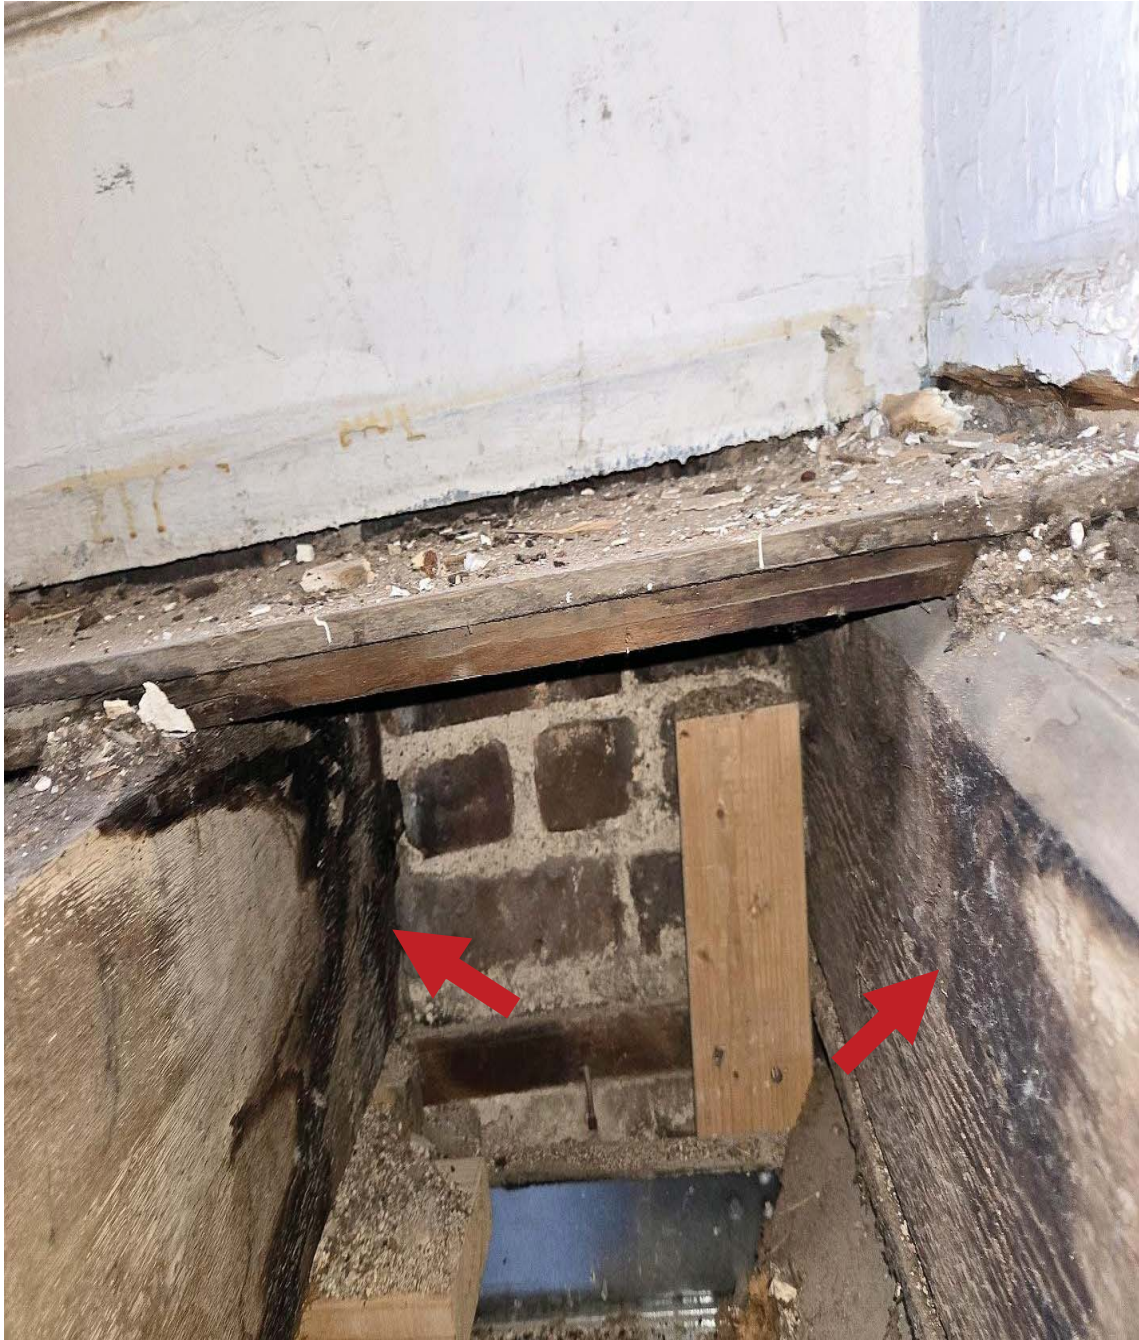
PHOTO #5

- **Photo #5** also shows dried mortar conditions at the 5th floor and extensive water deterioration in the floor joists where the 5th floor joists pocket into the wall and where the shear and bearing stresses are the highest in the floor joists.

Dried mortar conditions at the 5th floor and extensive water deterioration in the floor joists where the 5th floor joists pocket into the wall and where the shear and bearing stresses are the highest in the floor joists.

- **Floor Joists at Beam Pockets:** At the deteriorated and unsupported floor joists at the beam pockets, the remediation work would be to sister the floor joists and pocket the sister member into the wall and/or replace the floor joists with a new wood joist or LVL member which would bear at least four inches into the wall.

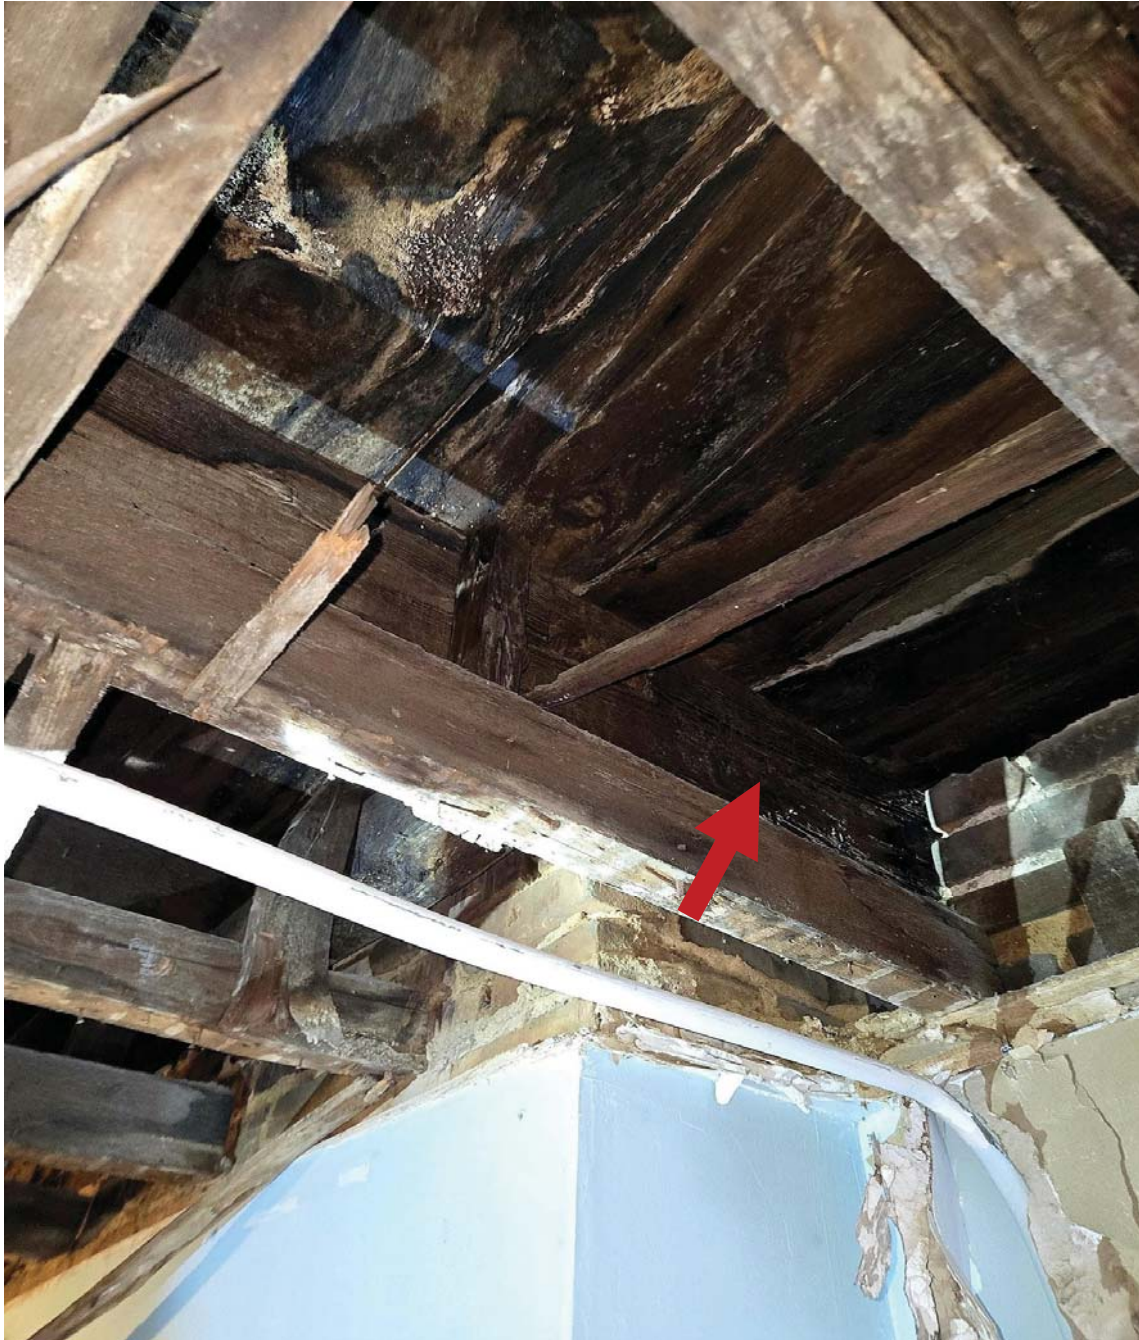
PHOTO #6

- **Photo #6** show that in unit 4C, the roof rafters were exposed and the chimney header along with the trimmer beams have water stains throughout and excessive decay at the beam pockets.

The roof rafters where exposed and the chimney header and trimmer beams have water stains throughout and excessive decay at the beam pockets

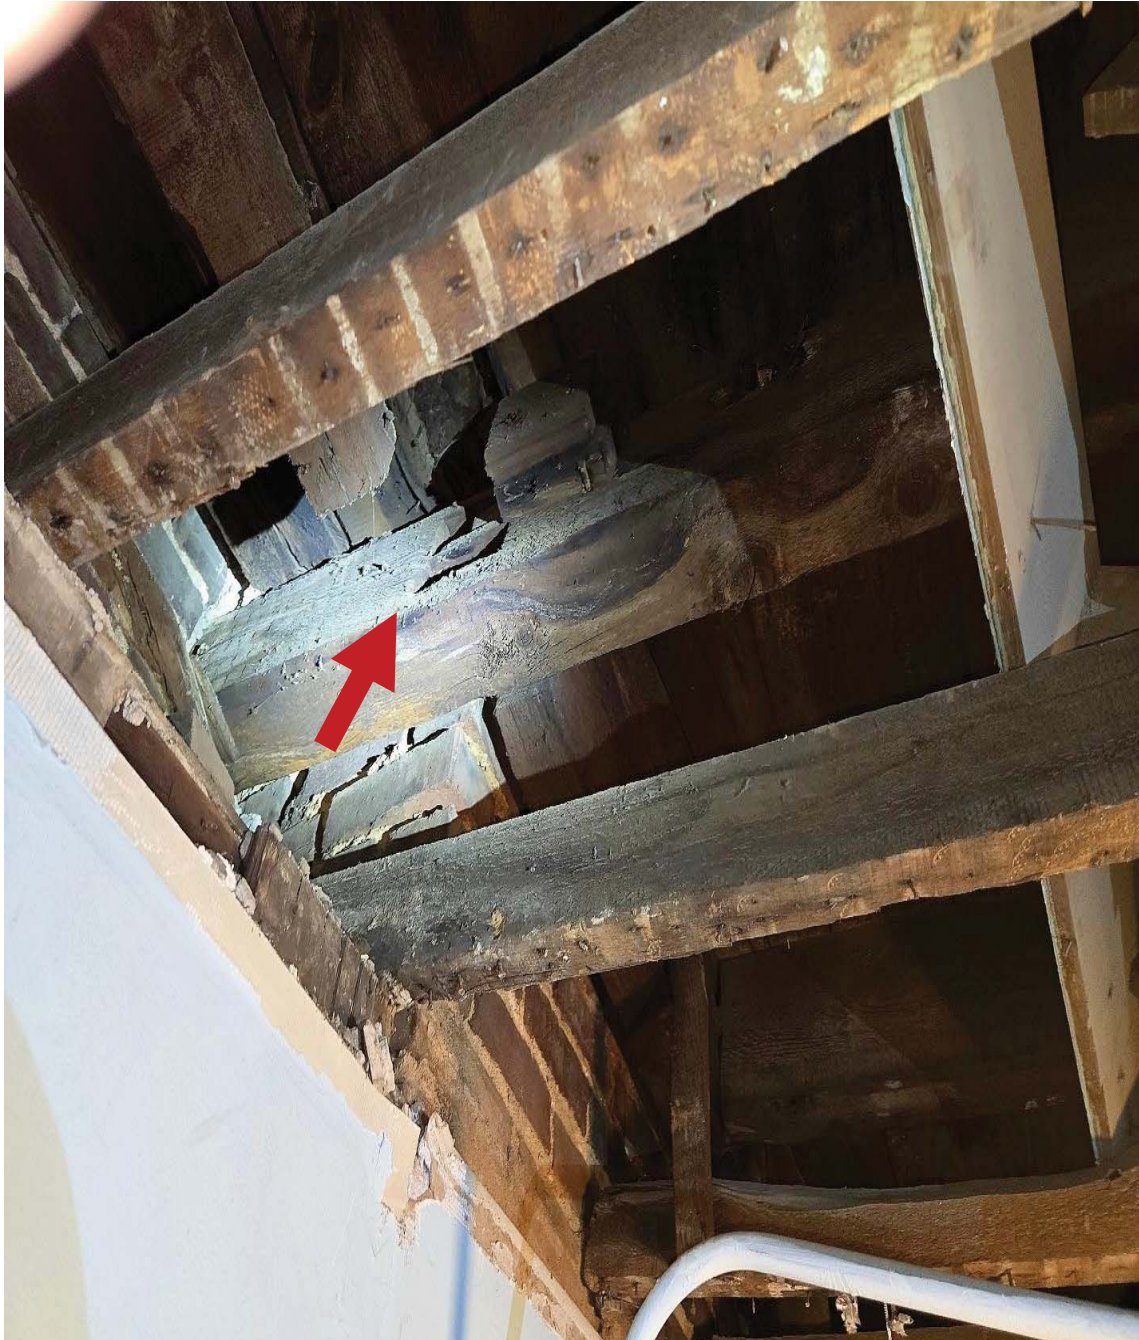
PHOTO #7

- **Photo #7** shows multiple mortise holes made into the trimmer beam which take away bending moment capacity in the trimmer where it has the largest bending moment due to the point load acting on it from the chimney header beam.

Multiple mortise holes made into the trimmer beam which take away bending moment capacity in the trimmer where it has the largest bending moment due to the point load acting on it from the chimney header beam.

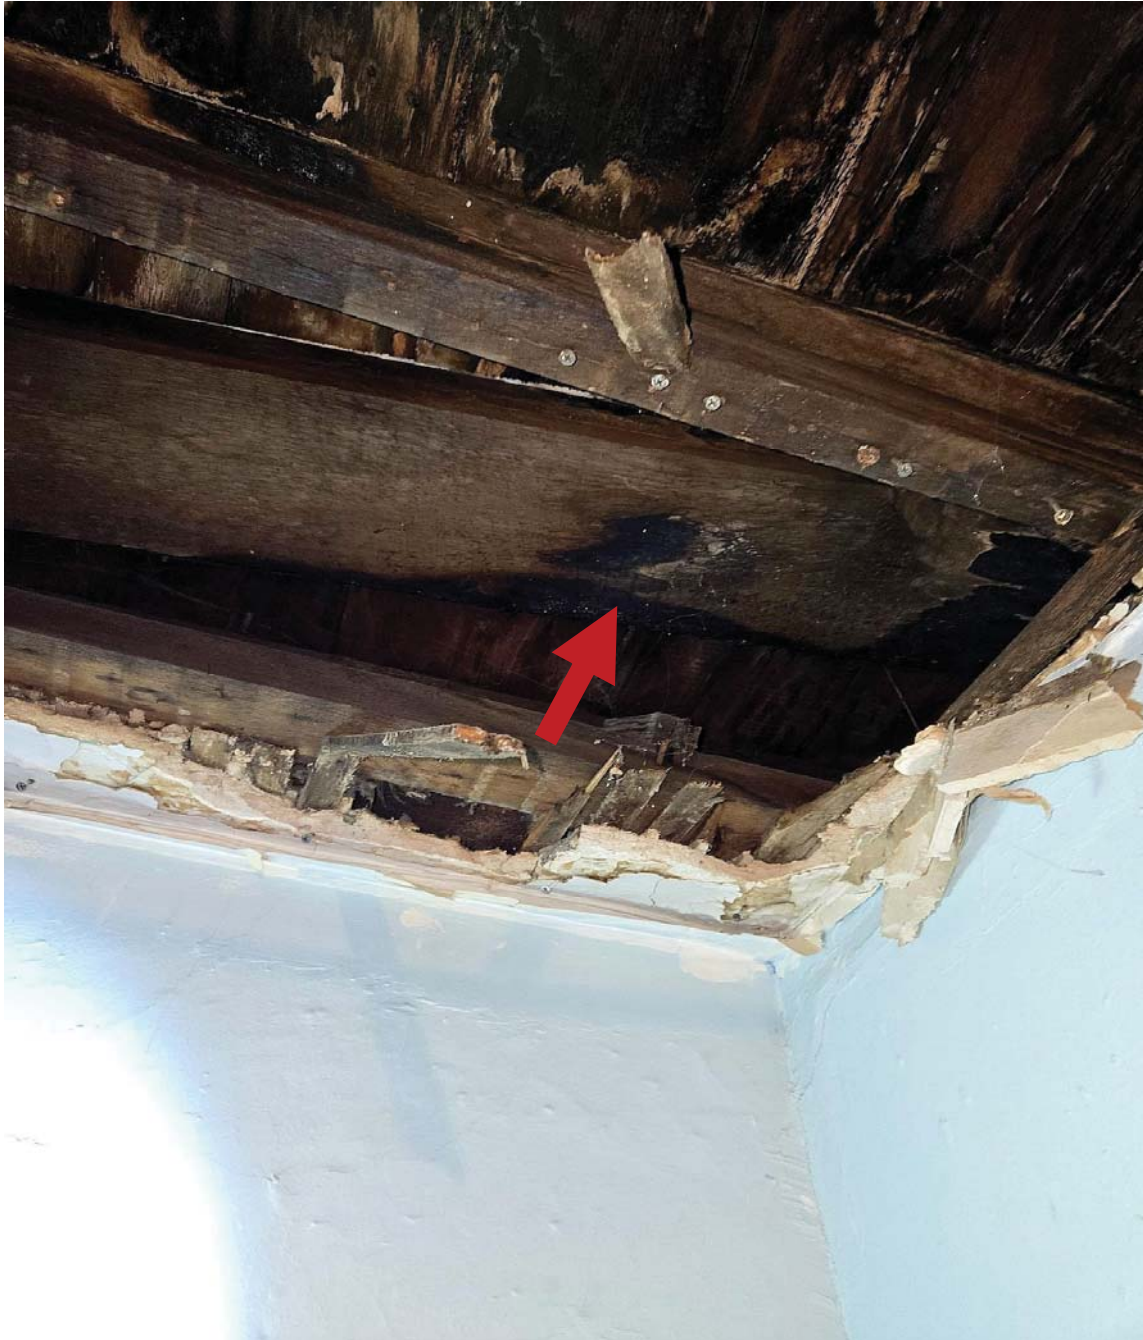
PHOTO #9

- **Photo #9 & #10** show a roof rafter which is oriented to 90 degrees with water damage. Such a rafter is supporting the roof load along its weak axis and does not have the capacity to support the roof loading imposed onto it.

Roof rafter which is oriented to 90 degrees with water damage. Such a rafter is supporting the roof load along its weak axis and does not have the capacity to support the roof loading imposed onto it.

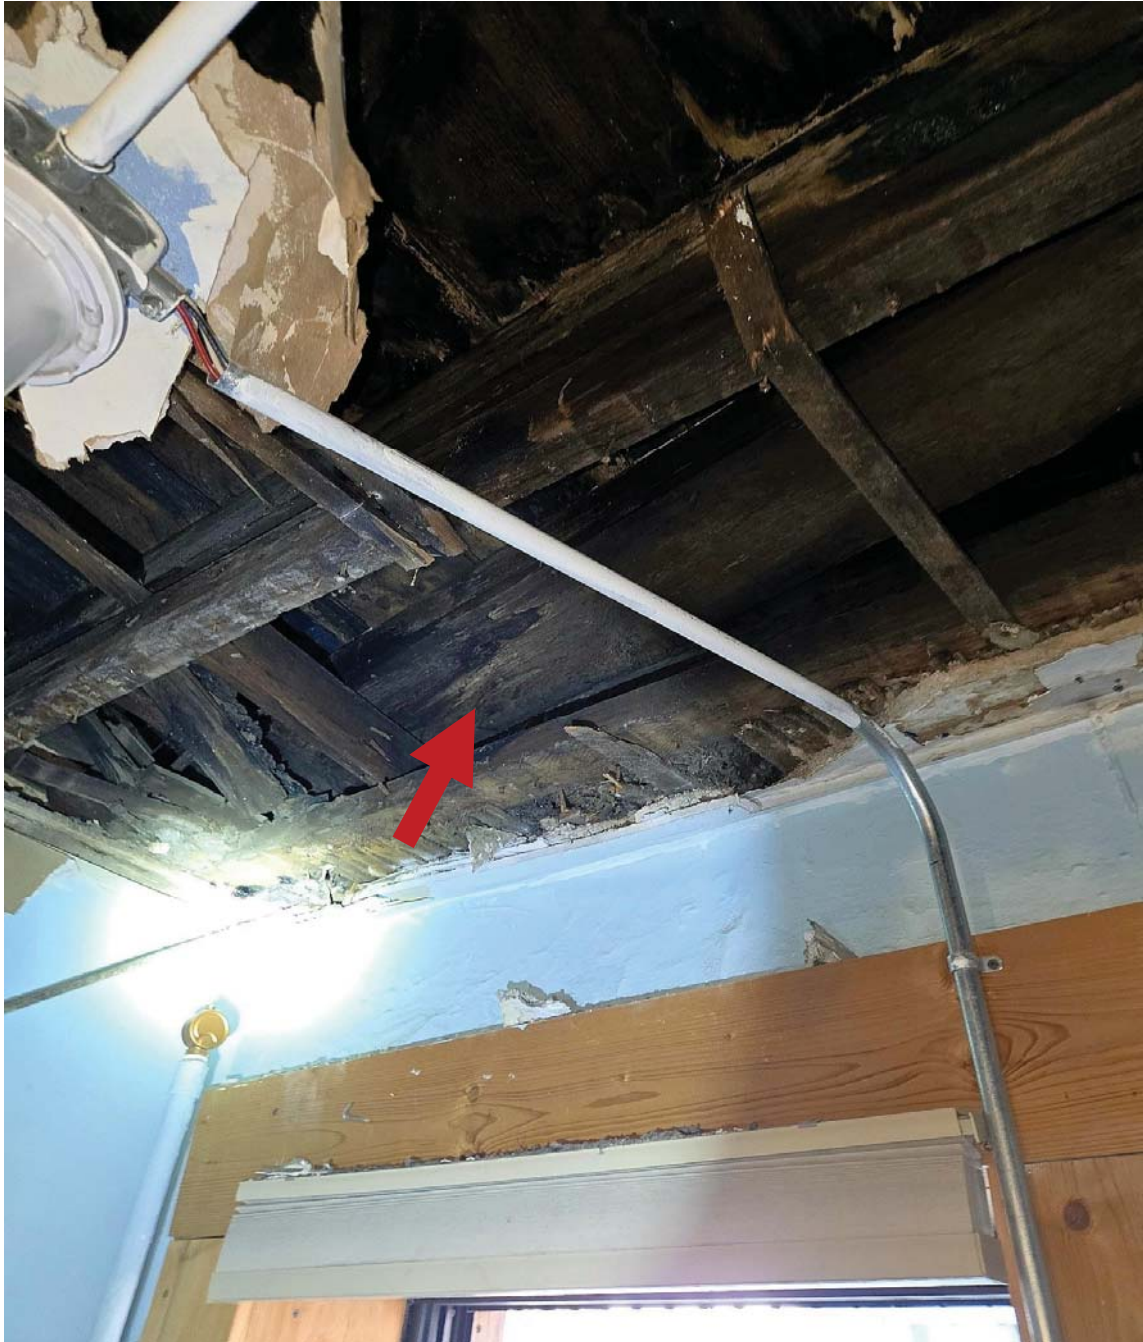
PHOTO #10

Roof rafter which is oriented to 90 degrees with water damage. Such a rafter is supporting the roof load along its weak axis and does not have the capacity to support the roof loading imposed onto it.

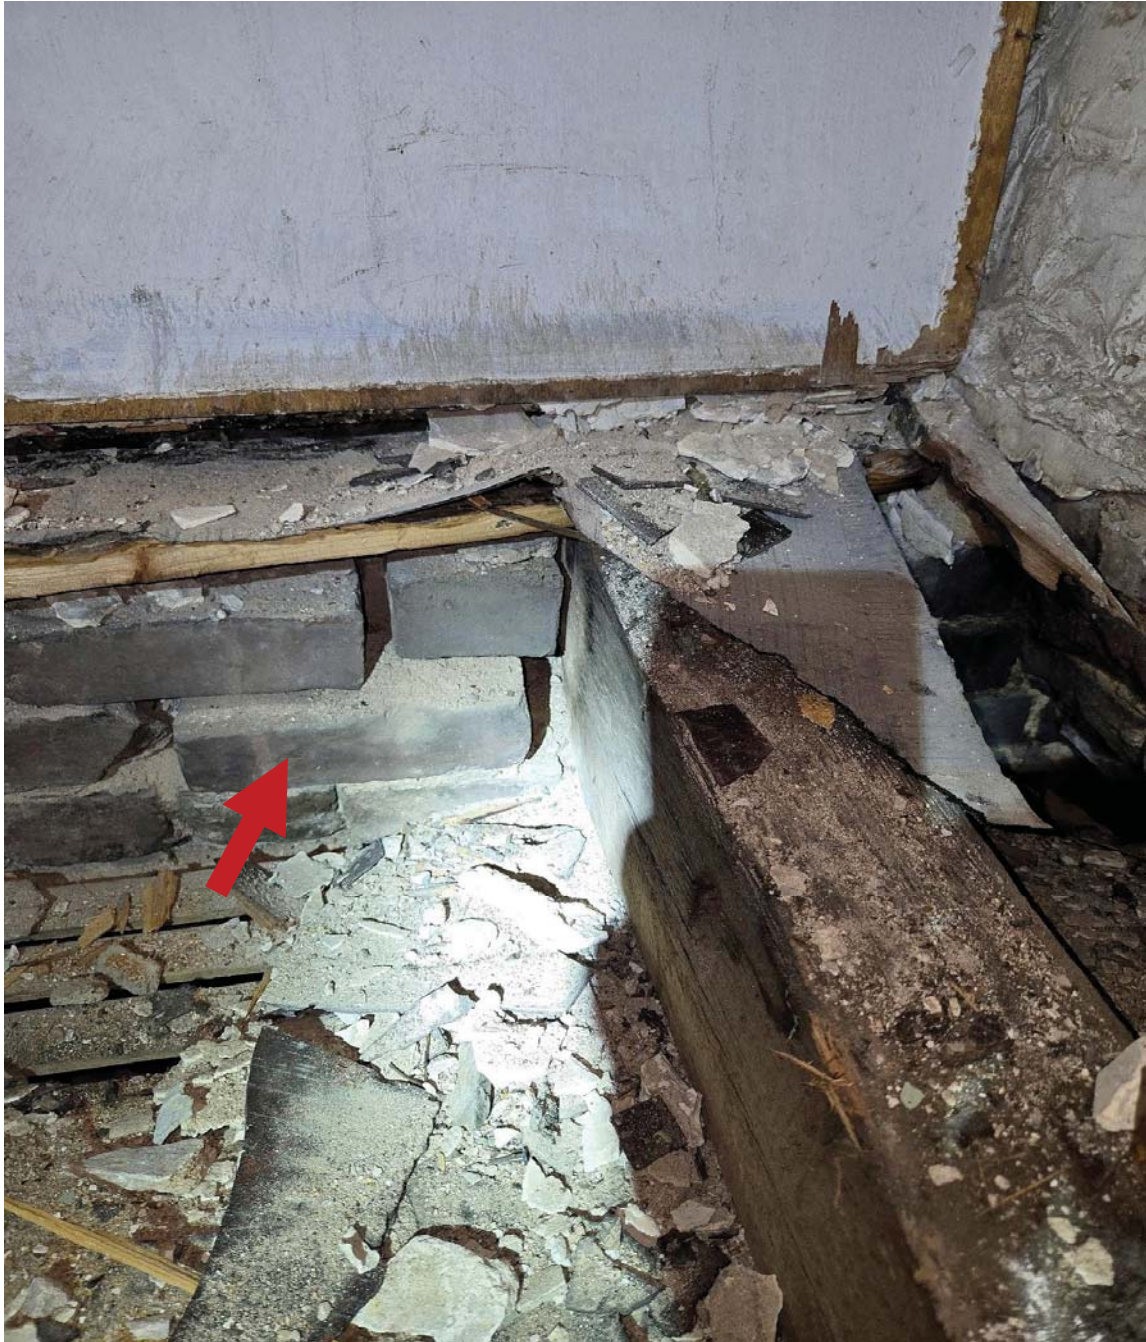
PHOTO #11

- **Photo #11 & #12** show the condition of the masonry wall where the 5th floor framing ties into it. The masonry wall in this location has experienced so much deterioration that the mortar has been completely washed out, leaving large gaps between the bricks. The bricks can be moved by hand and are not bonded to each other and work independently, not like a wall. Such a masonry condition is incredibly dangerous, and this wall has no structural integrity and is in risk of collapse due to there being no bonding between the bricks and large gaps that allow for movement.

Condition of the masonry wall where the 5th floor framing ties into it. Mortar of the masonry wall is deteriorated to the extent that bricks are no longer bonded together and do not function like an incumbent system. There is no structural integrity to this wall

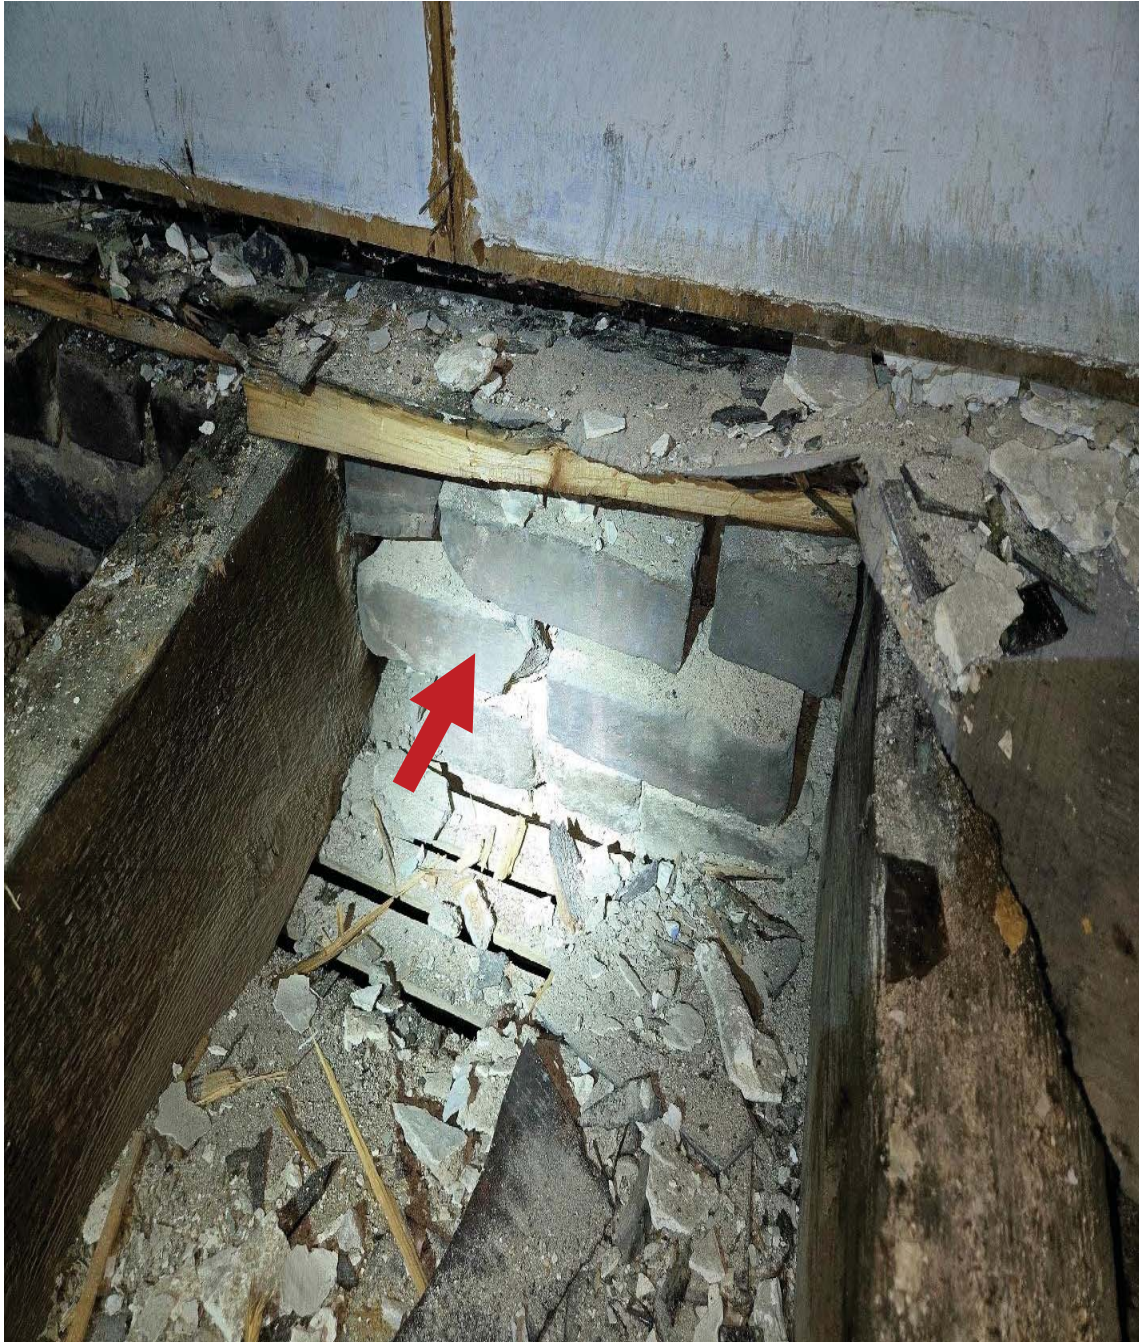
PHOTO #12

Condition of the masonry wall where the 5th floor framing ties into it. Mortar of the masonry wall is deteriorated to the extent that bricks are no longer bonded together and do not function like an incumbent system. There is no structural integrity to this wall

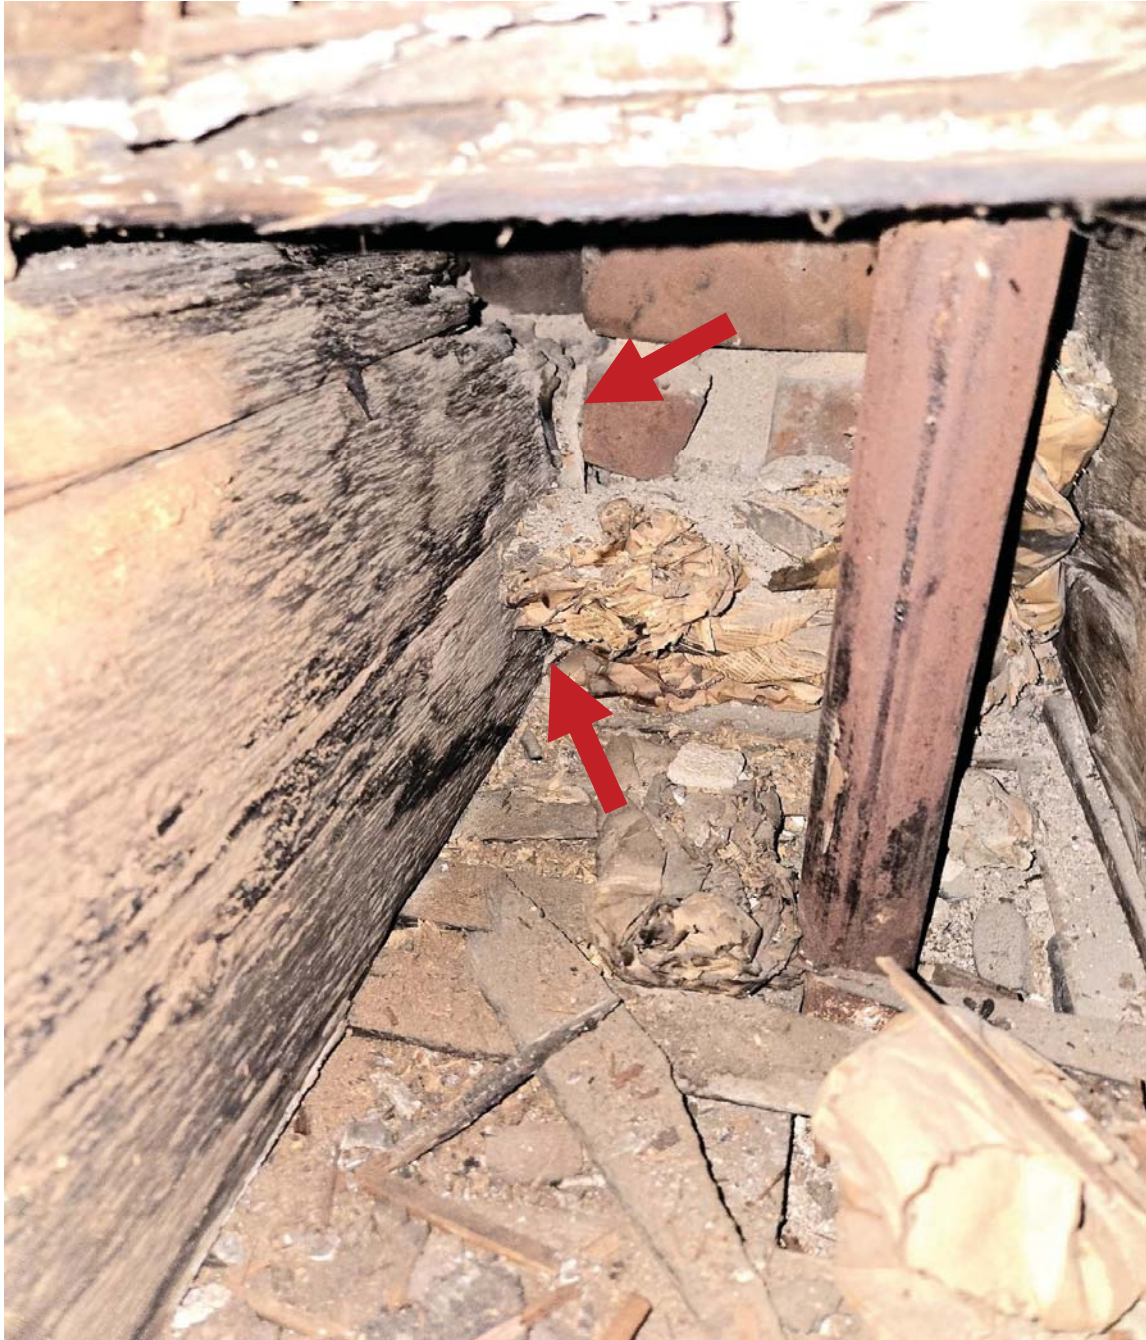
PHOTO #13

- **Photo #13** shows how the floor joist had rotten away at the beam pocket and has absolutely no bearing in the wall, this floor joist is hanging off the subflooring and is relying on the stiffness of the subflooring to support it.

The floor joist has rotted away at the beam pocket and has absolutely no bearing in the wall, this floor joist is hanging off the subflooring and is relying on the stiffness of the subflooring to support it.

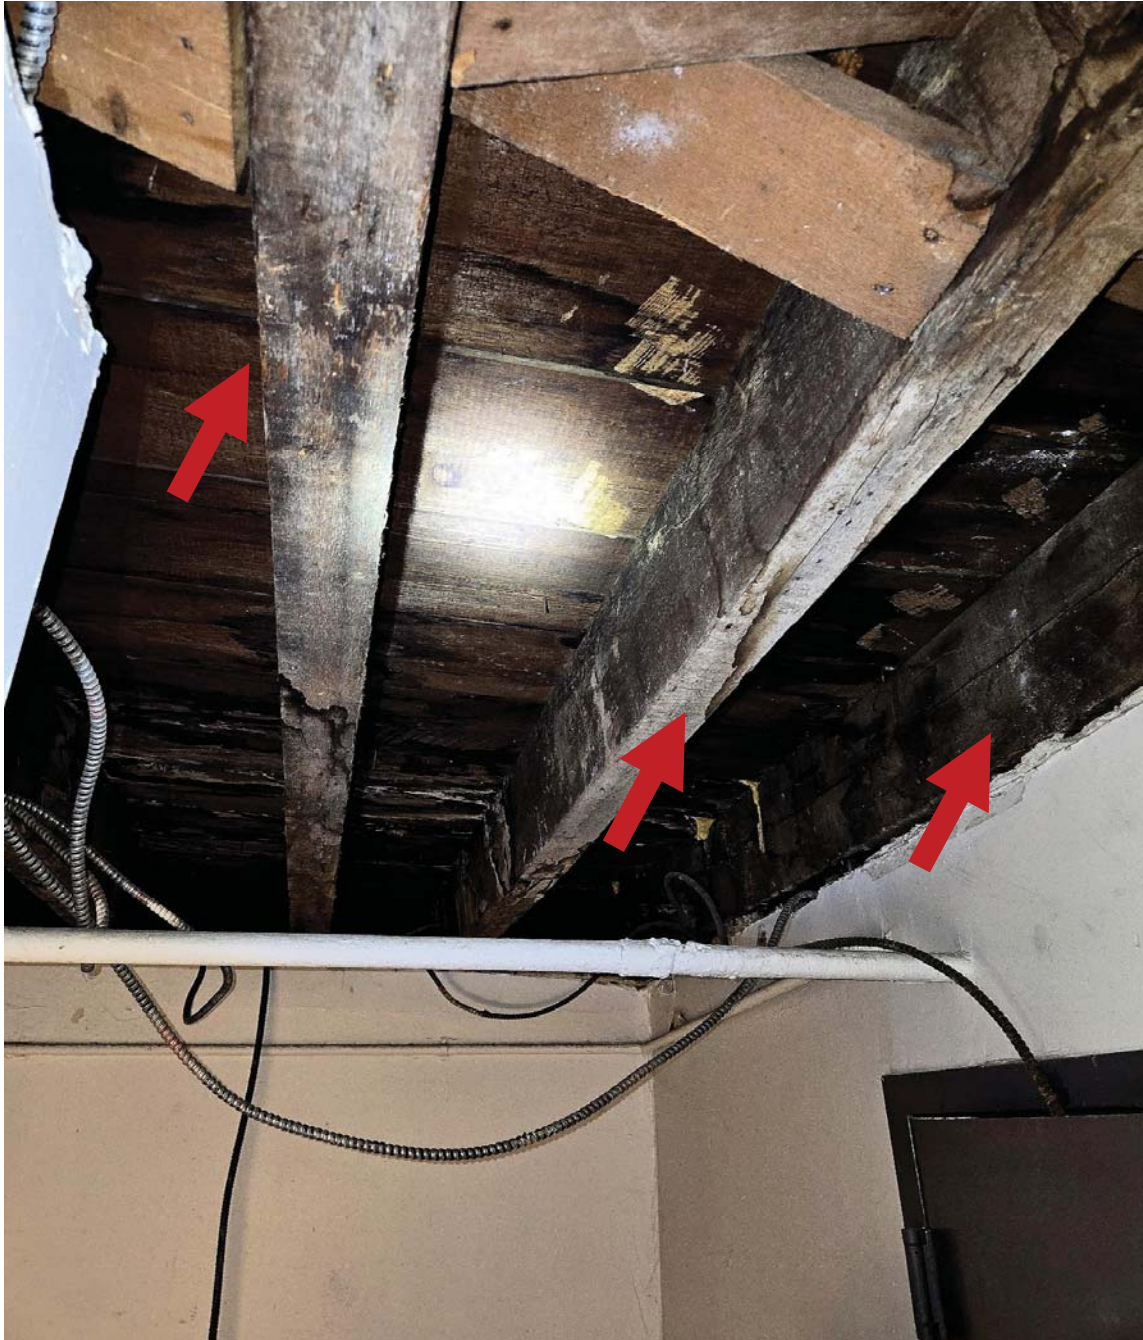
PHOTO #14

- **Photo #14 & #15** show that in unit 3B, all of the ceiling joists were exposed, and we can see warping in the ceiling joists and excessive water damage throughout the joist span.

In unit 3B, all of the ceiling joists were exposed, and we can see warping in the ceiling joists and excessive water damage throughout the joist span
