STEEL CORE ENGINEERING

109 East 9th St. New York, NY 10003

Re: Additional Probing of Upper Floors structure

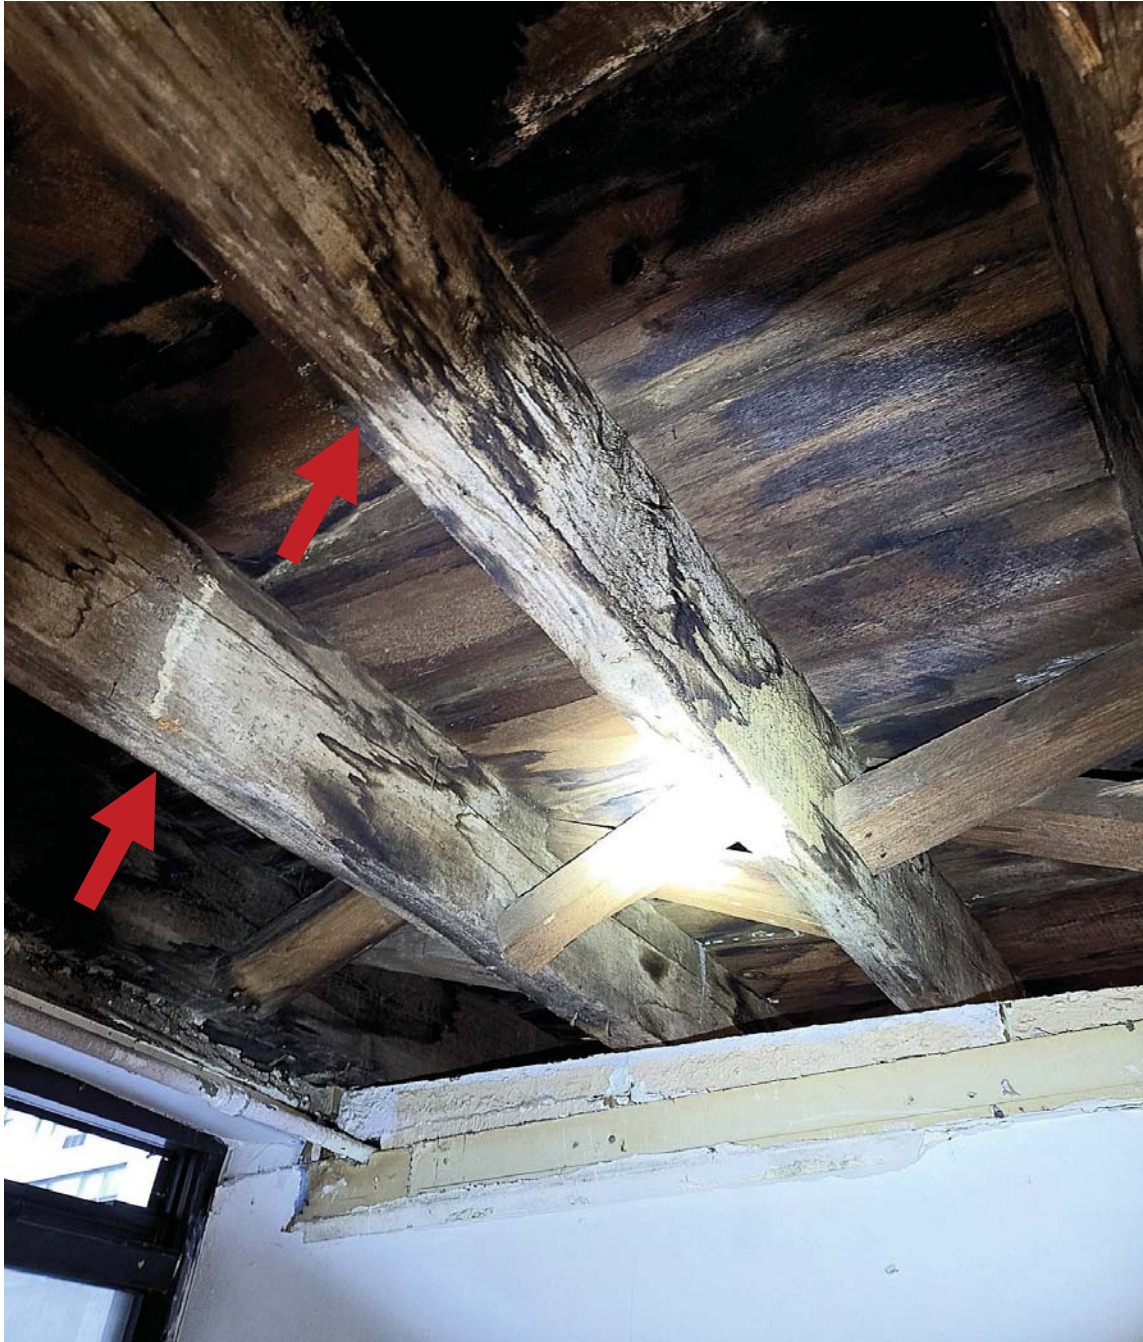
PHOTO #15

- **Photo #14 & #15** show that in unit 3B, all of the ceiling joists were exposed, and we can see warping in the ceiling joists and excessive water damage throughout the joist span.

In unit 3B, all of the ceiling joists were exposed, and we can see warping in the ceiling joists and excessive water damage throughout the joist span

- **Water-Damaged Framing:** Throughout the building where the roof rafters and floor framing have substantial water damage and deterioration at the beam pockets and along their spans, the framing should be either sistered with new reinforcement, which is plumb, dry and stiff enough to span the length of the existing beam at minimum. However, the proper solution would be to replace the deteriorated framing with a new dry framing structure which will not be in contact with existing wet and deteriorated joists.

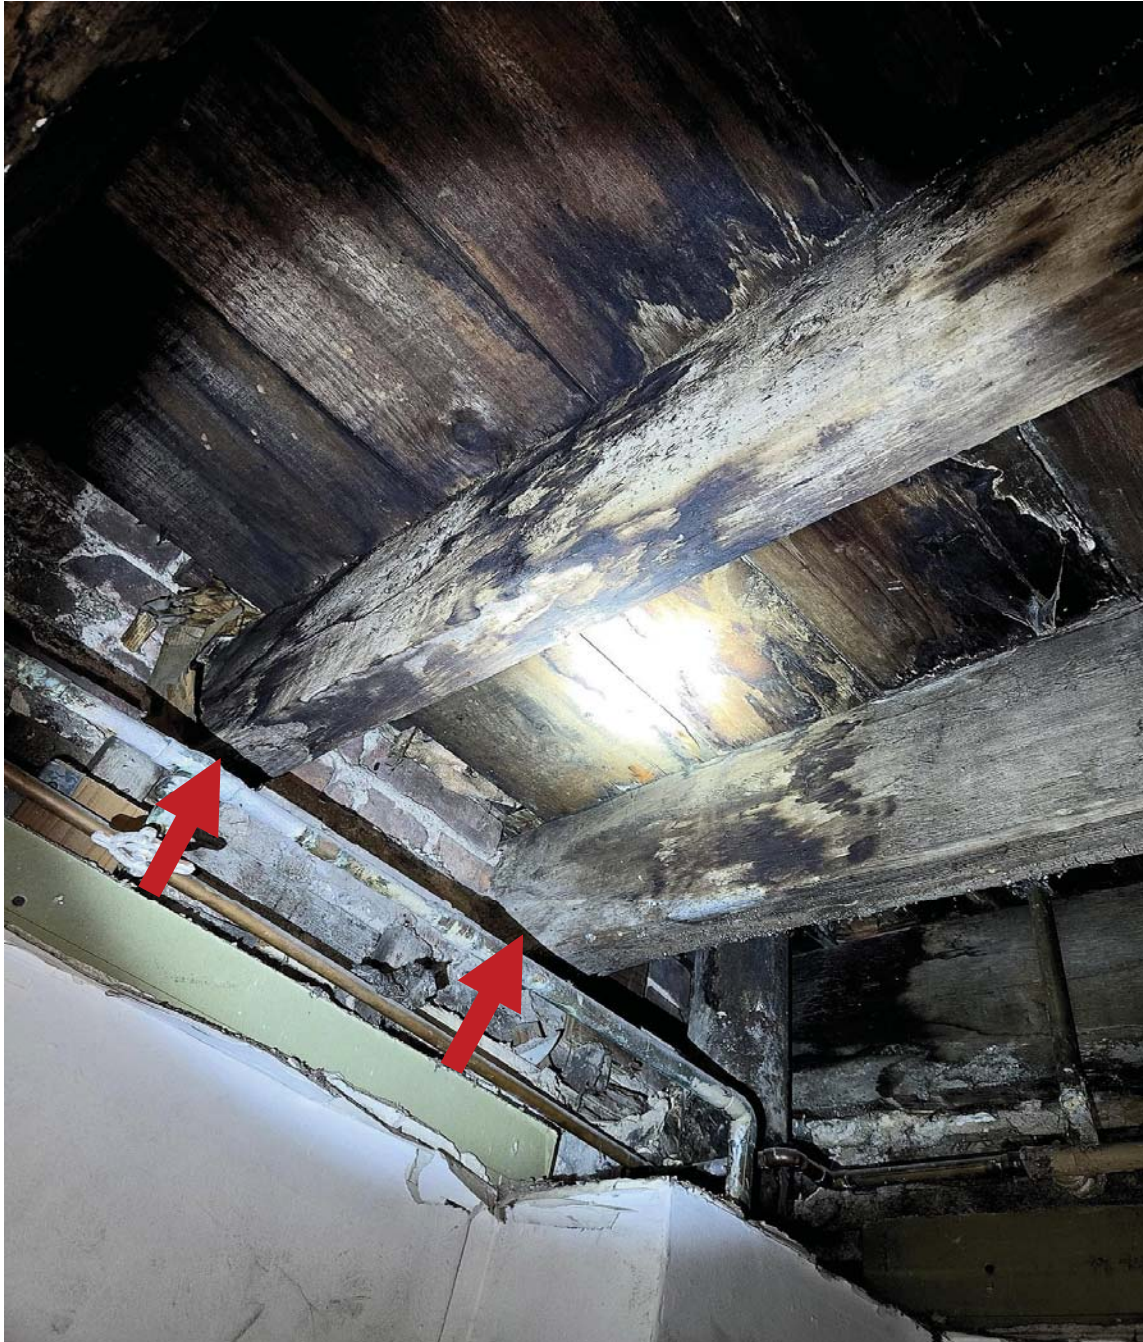
PHOTO #16

- **Photo #16 & #17** show the extensive water damage in the floor joists, especially at the beam pockets where water contact is present due to porous and poor masonry wall conditions which allow rainwater infiltration.

Extensive water damage in the floor joists, especially at the beam pockets where water contact is present due to porous and poor masonry wall conditions which allow rainwater infiltration

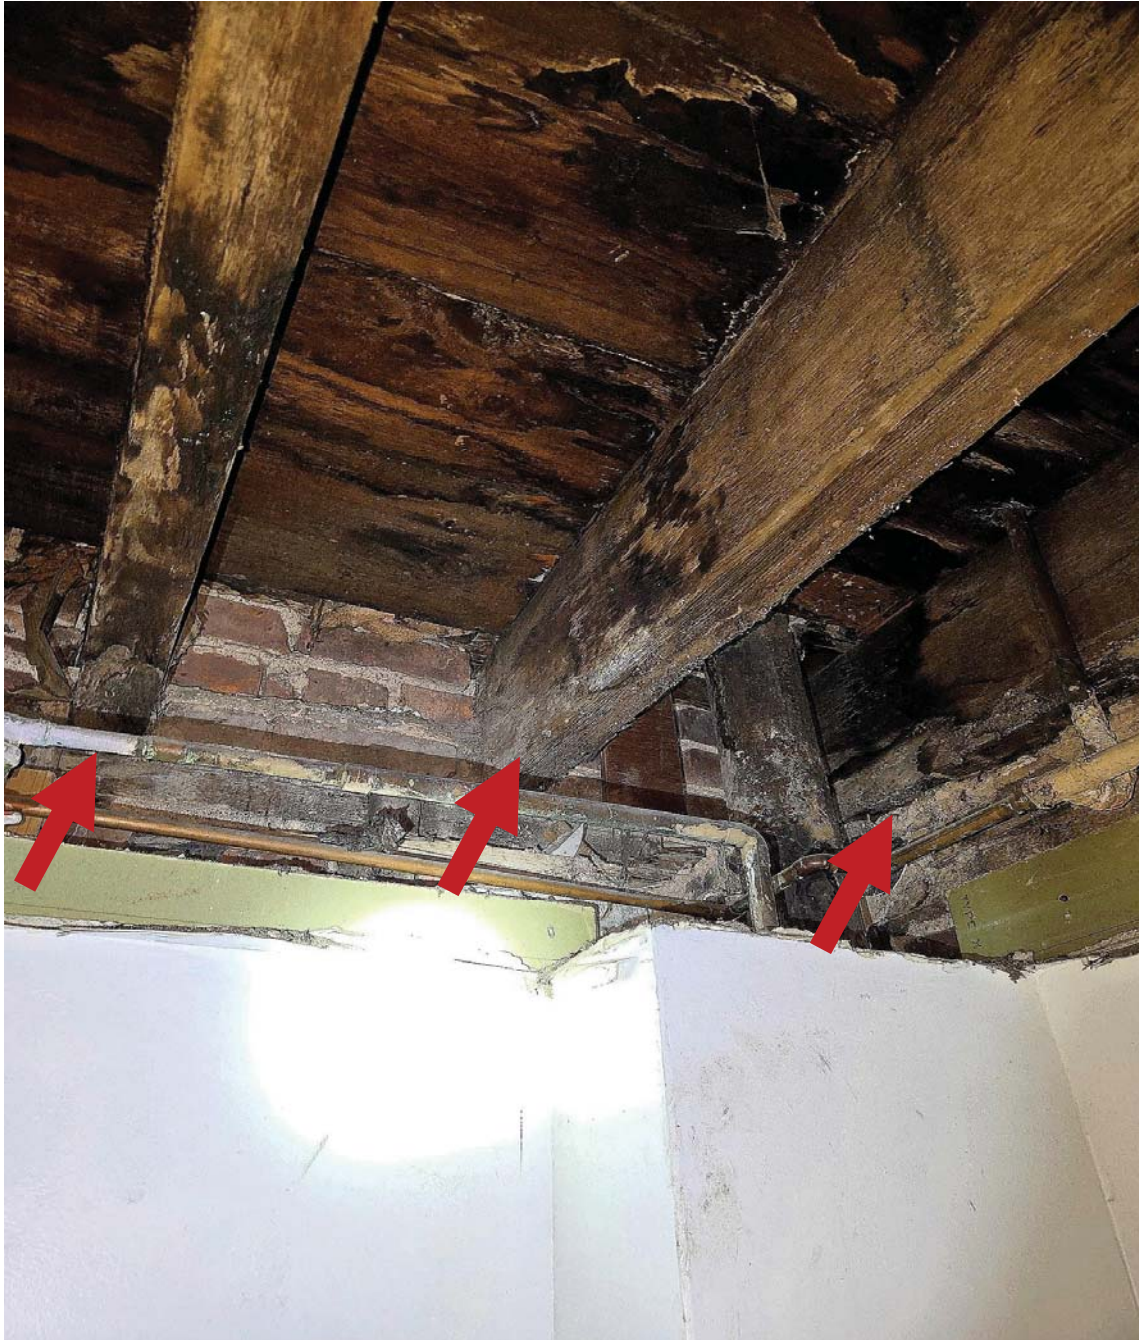
PHOTO #17

Extensive water damage in the floor joists, especially at the beam pockets where water contact is present due to porous and poor masonry wall conditions which allow rainwater infiltration.

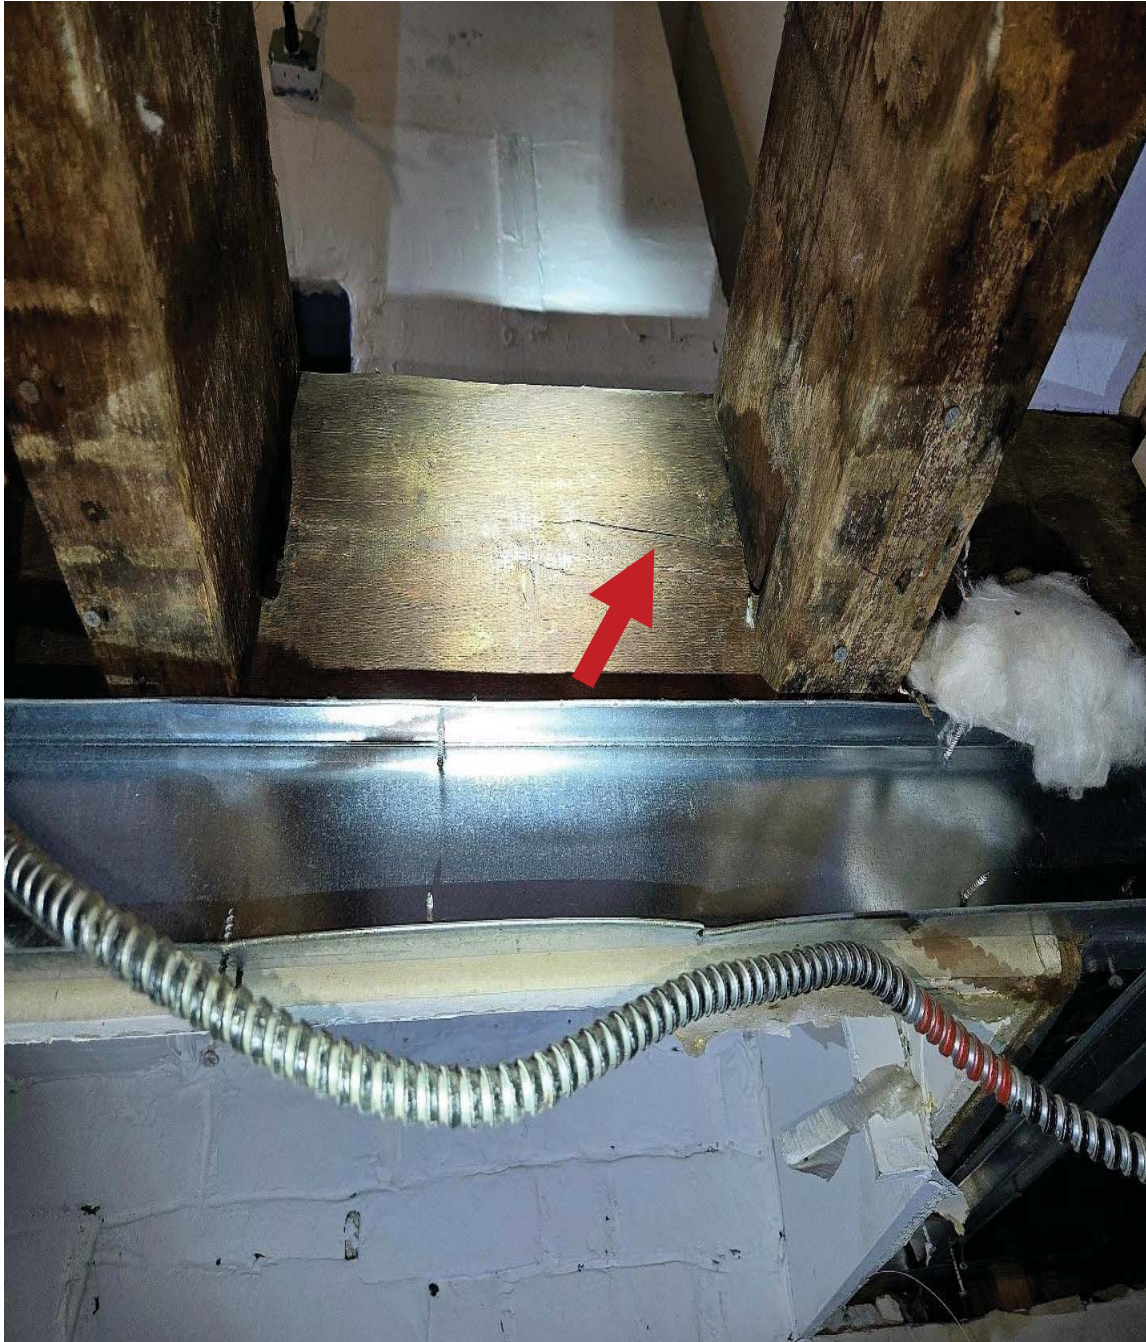
PHOTO #18

- **Photo #18** shows cracking of the chimney header beam which supports multiple floor joists.
- **Photo #19 & #20** shows horizontal cracks for the visible span of the floor beam. Such large cracks compromise the beams' structural integrity and deem it unsafe. Such beams rely on the adjacent beams to support the floor weight as they themselves do not have the structural integrity to do so, such a condition is hazardous and unsafe.

Cracking of the chimney header beam which supports multiple floor joists.

- **Cracked Structural Members:** At the existing headers, trimmers and floor joists throughout the building that have large cracks, and are at imminent risk of failure, such members must be replaced.

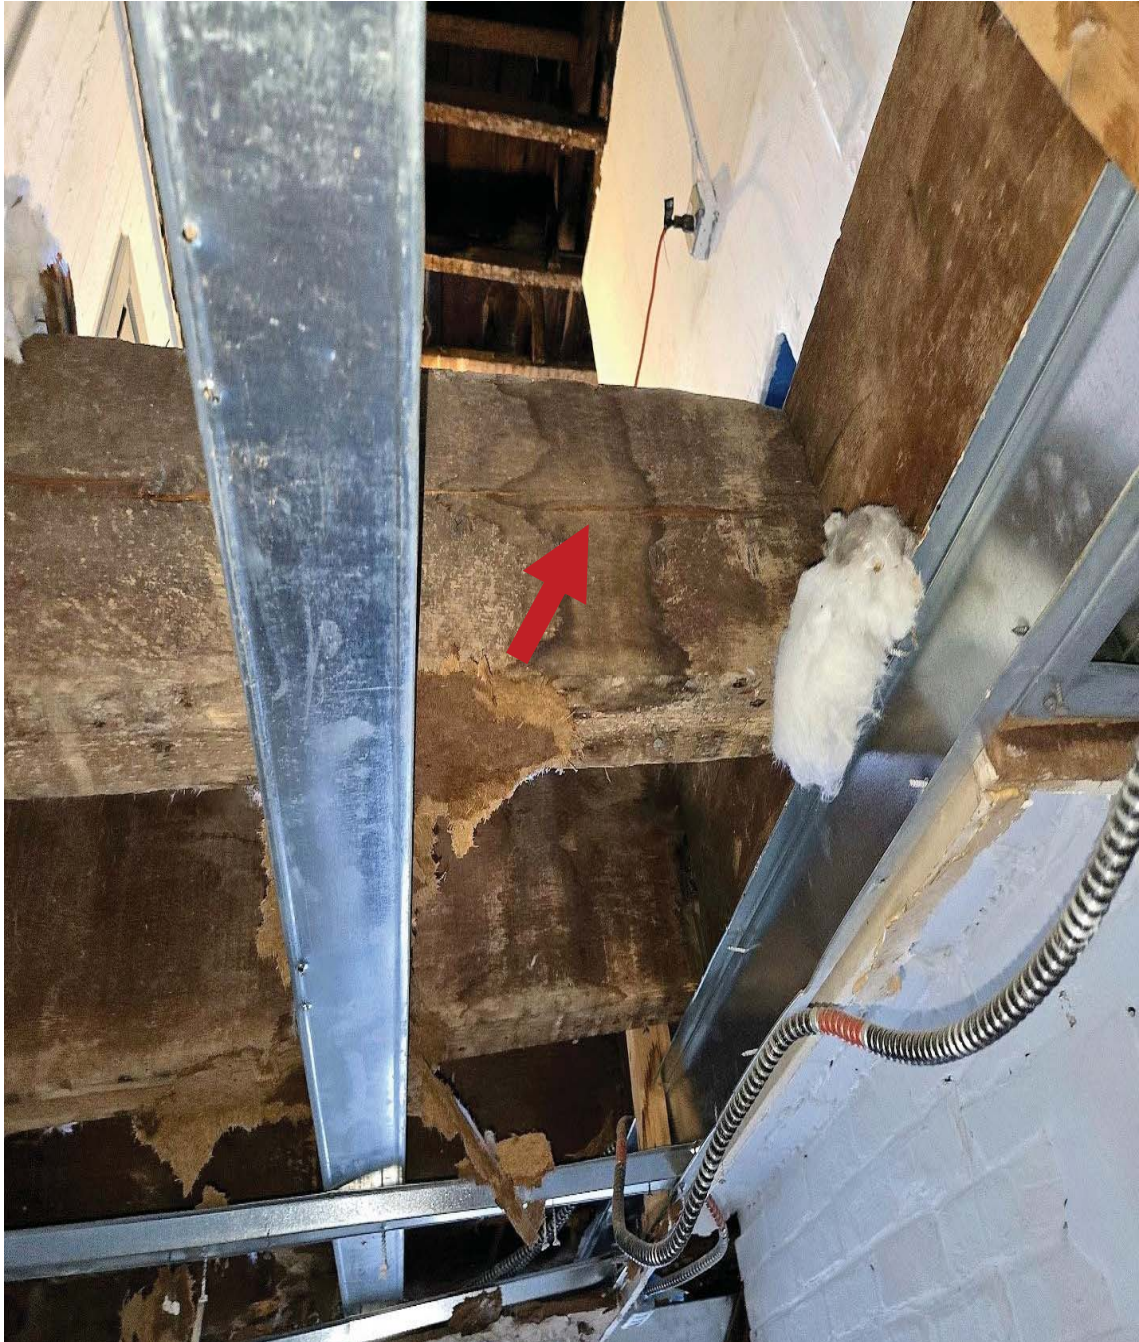
PHOTO #19

Horizontal cracks for the visible span of the floor beam. Such large cracks compromise the beams' structural integrity and deem it unsafe. Such beams rely on the adjacent beams to support the floor weight as they themselves do not have the structural integrity to do so, such a condition is hazardous and unsafe.

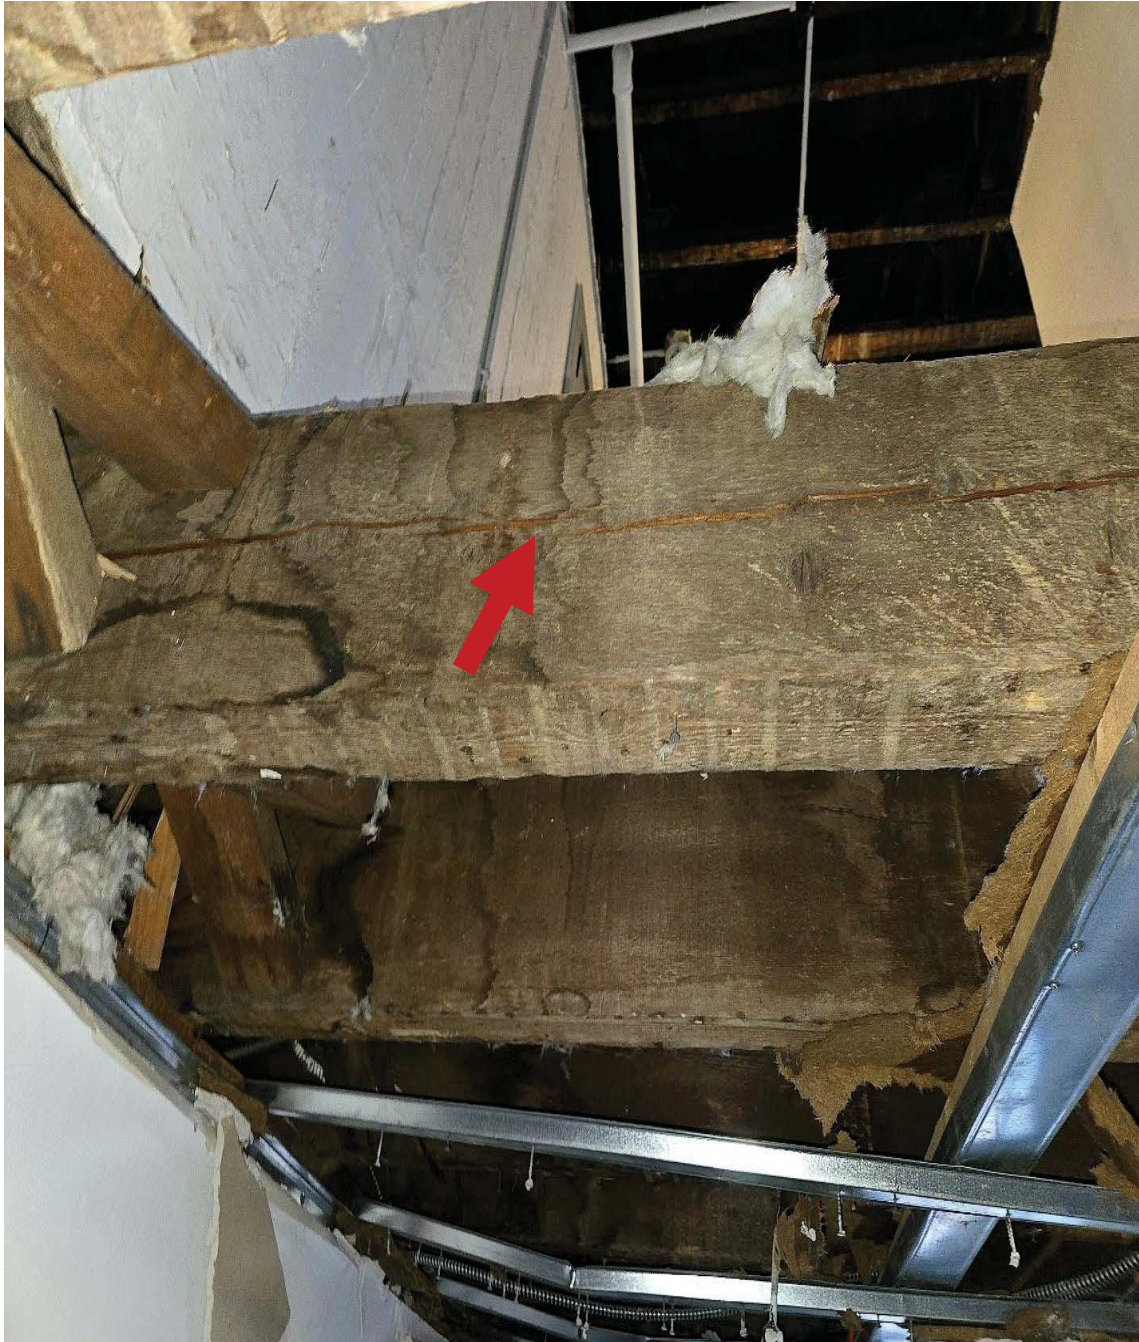
PHOTO #20

Horizontal cracks for the visible span of the floor beam. Such large cracks compromise the beams' structural integrity and deem it unsafe. Such beams rely on the adjacent beams to support the floor weight as they themselves do not have the structural integrity to do so, such a condition is hazardous and unsafe.

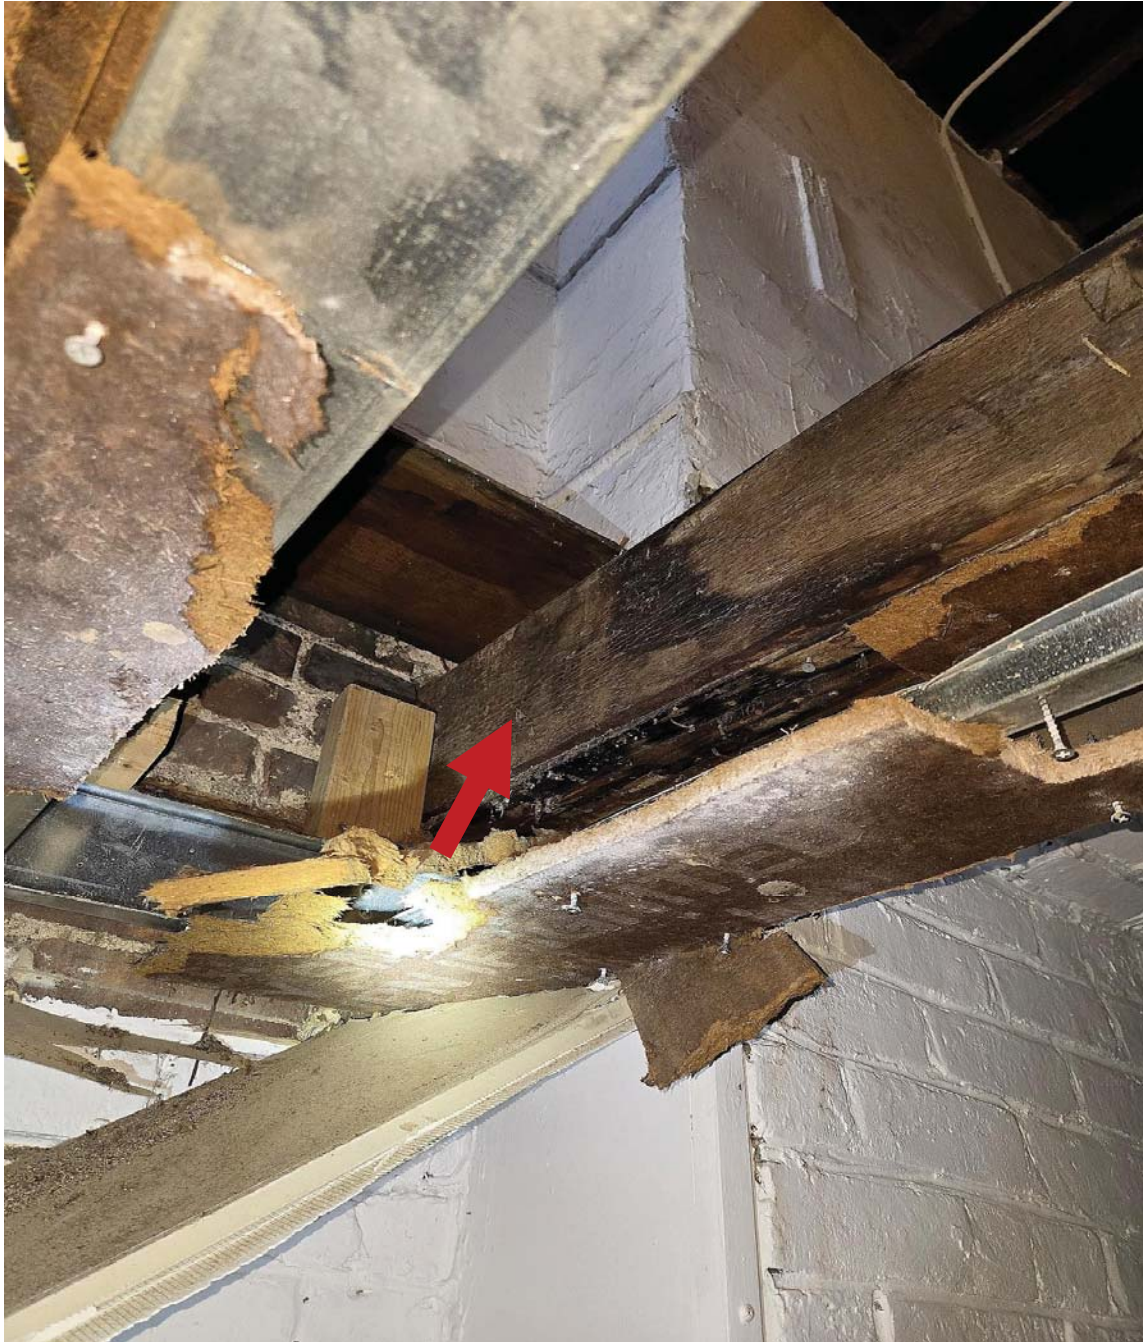
PHOTO #21

- **Photo #21, #22 & #23** show the conditions of the 5th floor joists at the masonry wall and the water damage that these joists have at the beam pockets which weakens their integrity at the beam pockets. The mortar condition is also compromised and can be easily scraped with a nail or chisel.

The conditions of the 5th floor joists at the masonry wall and the water damage that these joists have at the beam pockets which weakens their integrity at the beam pockets. The mortar condition is also compromised and can be easily scraped with a nail or chisel.

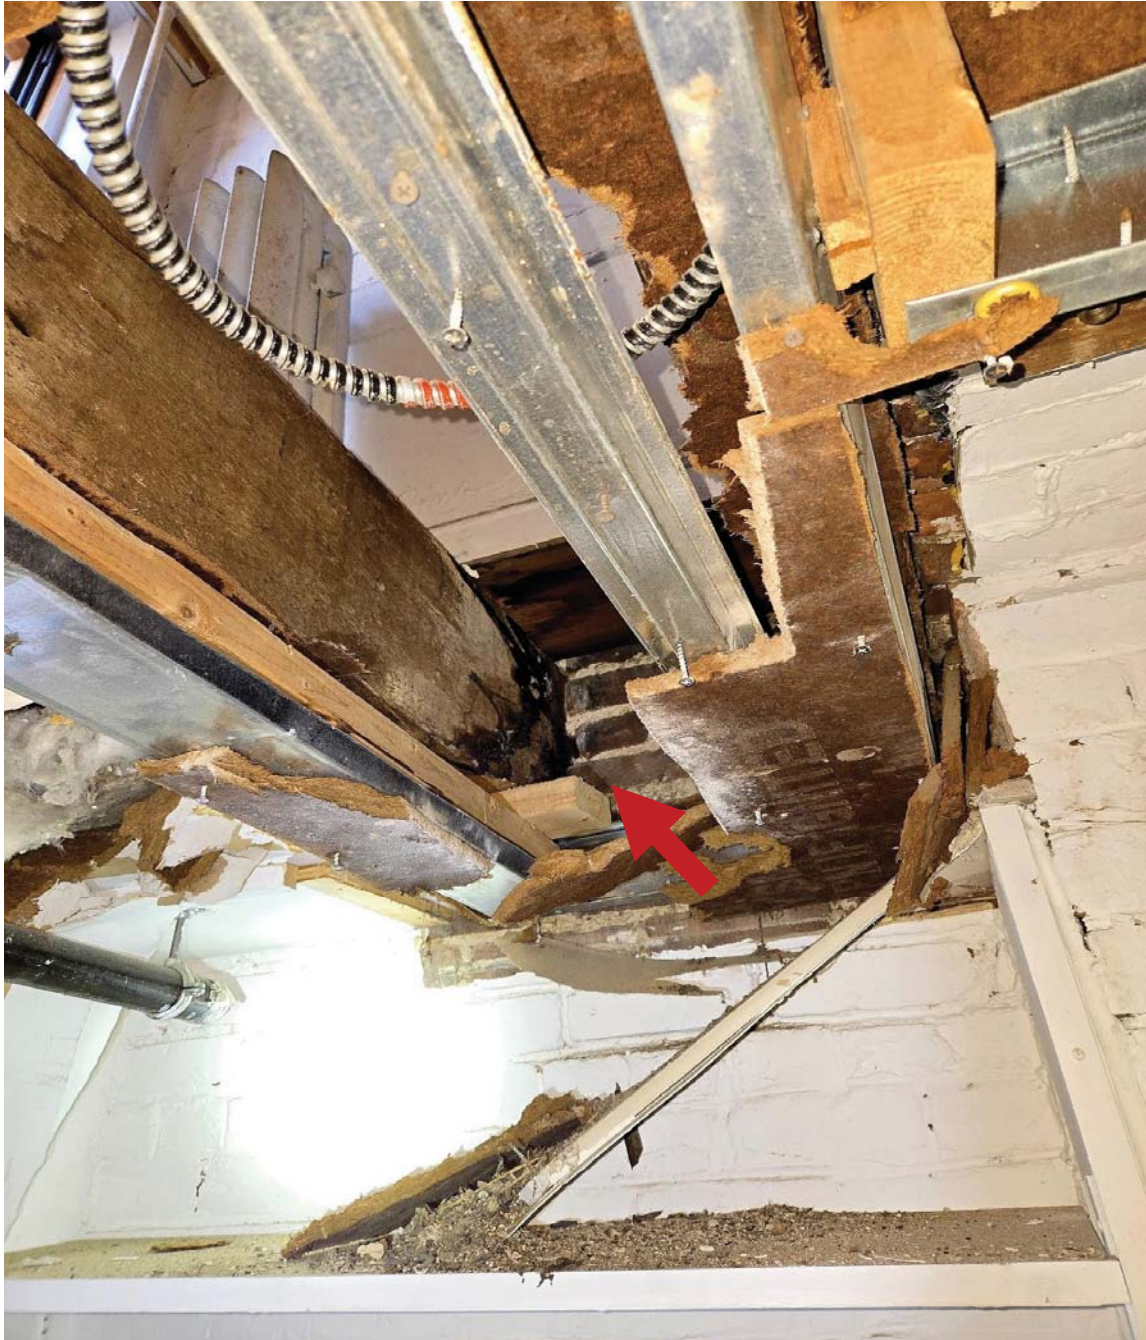
PHOTO #22

The conditions of the 5th floor joists at the masonry wall and the water damage that these joists have at the beam pockets which weakens their integrity at the beam pockets. The mortar condition is also compromised and can be easily scraped with a nail or chisel.

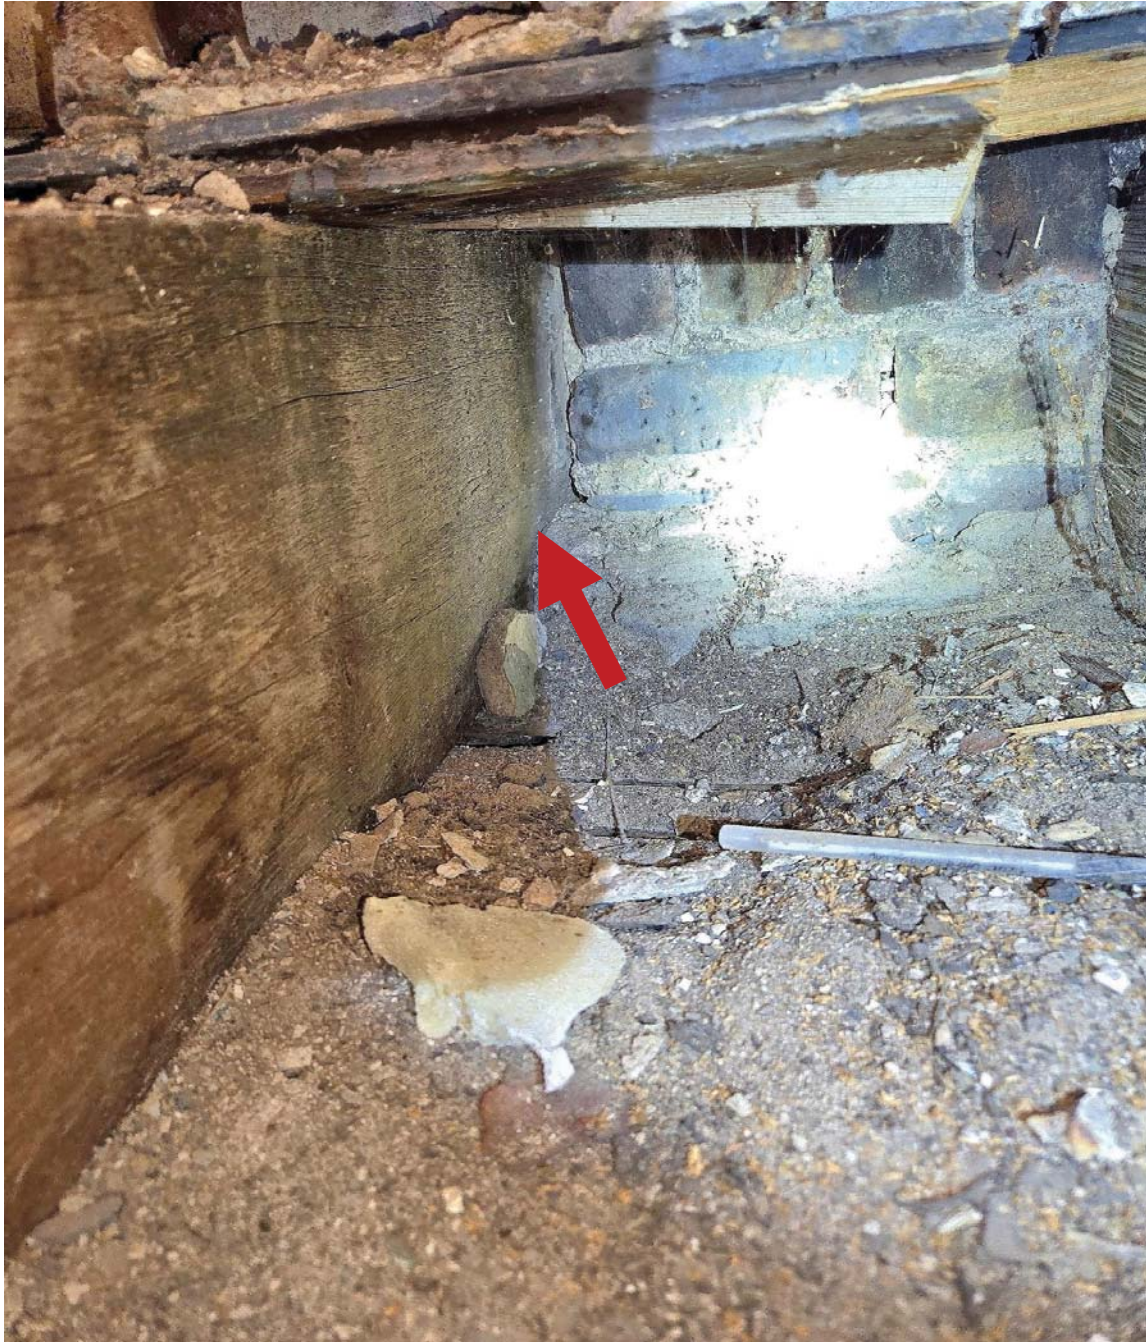
PHOTO #23

The conditions of the 5th floor joists at the masonry wall and the water damage that these joists have at the beam pockets which weakens their integrity at the beam pockets. The mortar condition is also compromised and can be easily scraped with a nail or chisel.

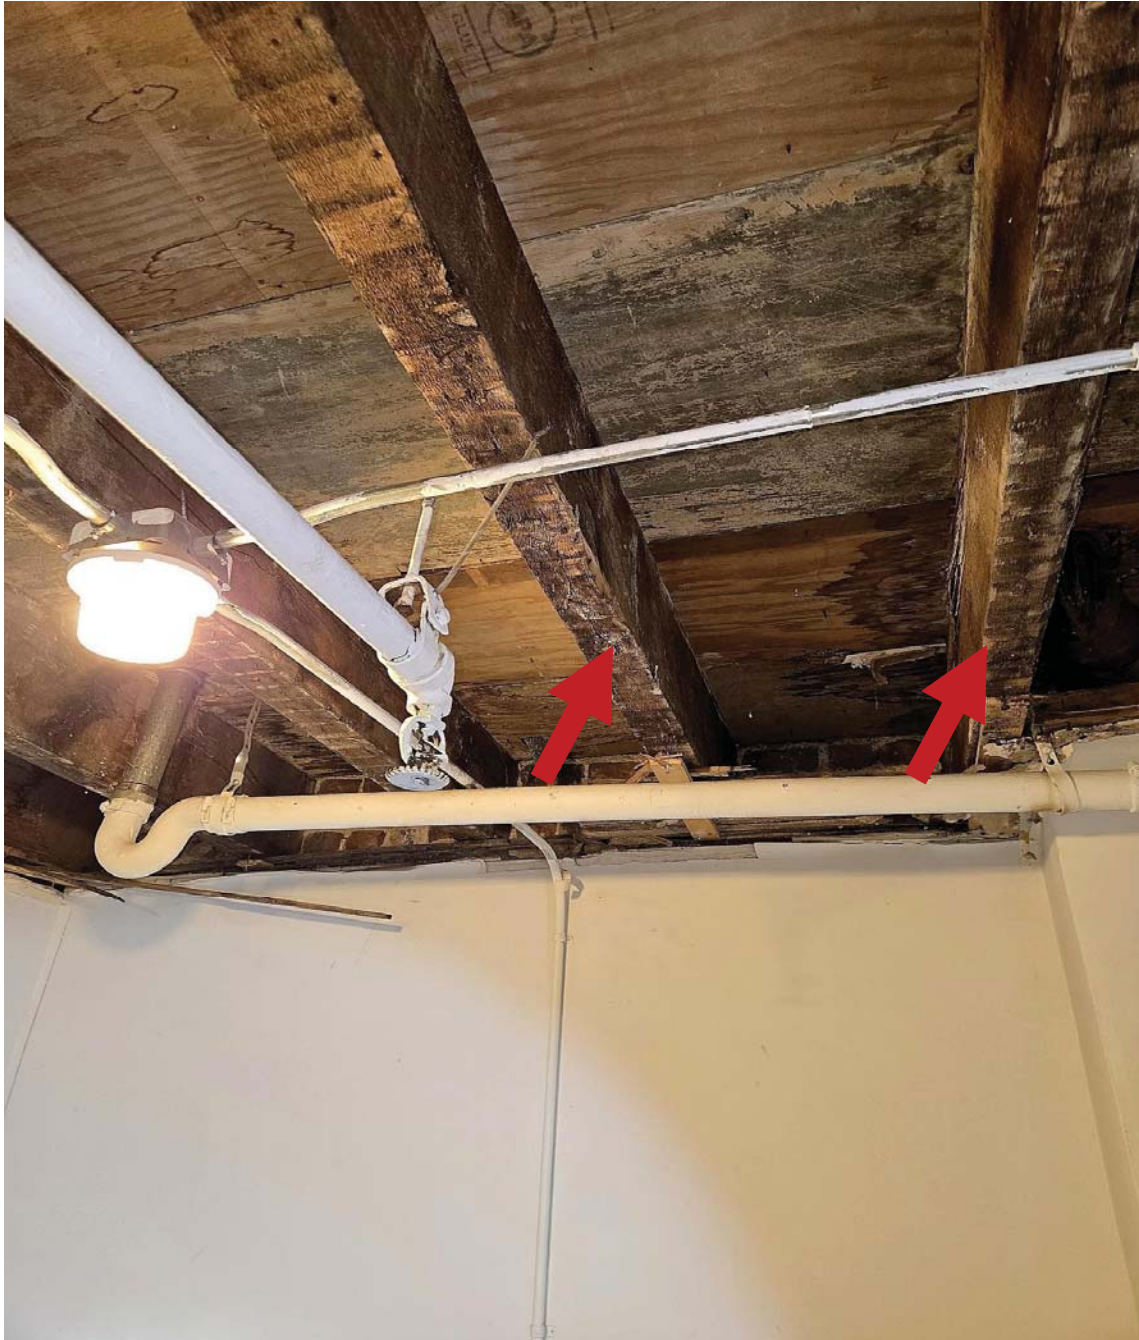
- **Photo #24, #25 & #26** provide multiple views of the 4th floor joist conditions and their deterioration. In unit 2B, all of the exposed 4th floor joists (ceiling joists) have water stains and deterioration from water damage. The 4th floor joists are sloping down towards the center of the building at a minimum of 2 degrees and lack bridging in some bays. deterioration.

<p>EXISTING FOURTH FLOOR PLAN</p>	<p>PHOTO #24</p> <p>In unit 2B, all of the exposed 4th floor joists (ceiling joists) have water stains and deterioration from water damage. The 4th floor joists are sloping down towards the center of the building at a minimum of 2 degrees and lack bridging in some bays. Photos #24, #25 and #26 provide multiple views of the 4th floor joist conditions and their deterioration.</p>
---	---

- **Sloping Floors:** At the severely sloping floors, the framing can be leveled by sistering/reinforcing the floor joists and/or replacing the floor joist with new framing.

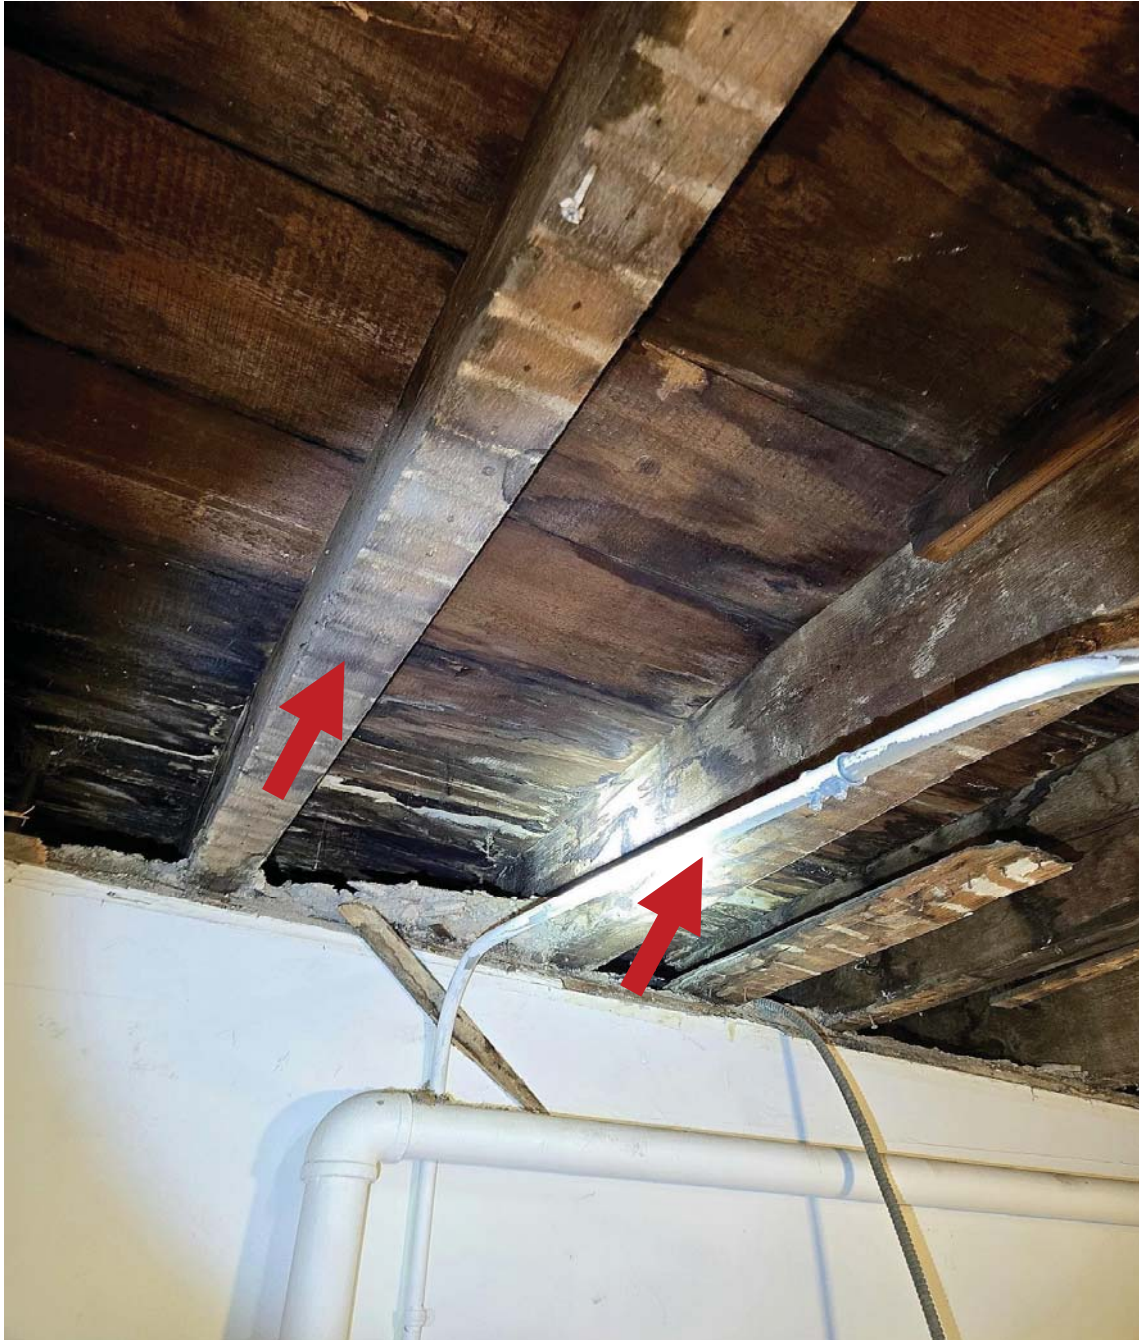
<p>EXISTING FOURTH FLOOR PLAN</p>	<p>PHOTO #25</p> <p>In unit 2B, all of the exposed 4th floor joists (ceiling joists) have water stains and deterioration from water damage. The 4th floor joists are sloping down towards the center of the building at a minimum of 2 degrees and lack bridging in some bays. Photos #24, #25 and #26 provide multiple views of the 4th floor joist conditions and their deterioration.</p>
---	---

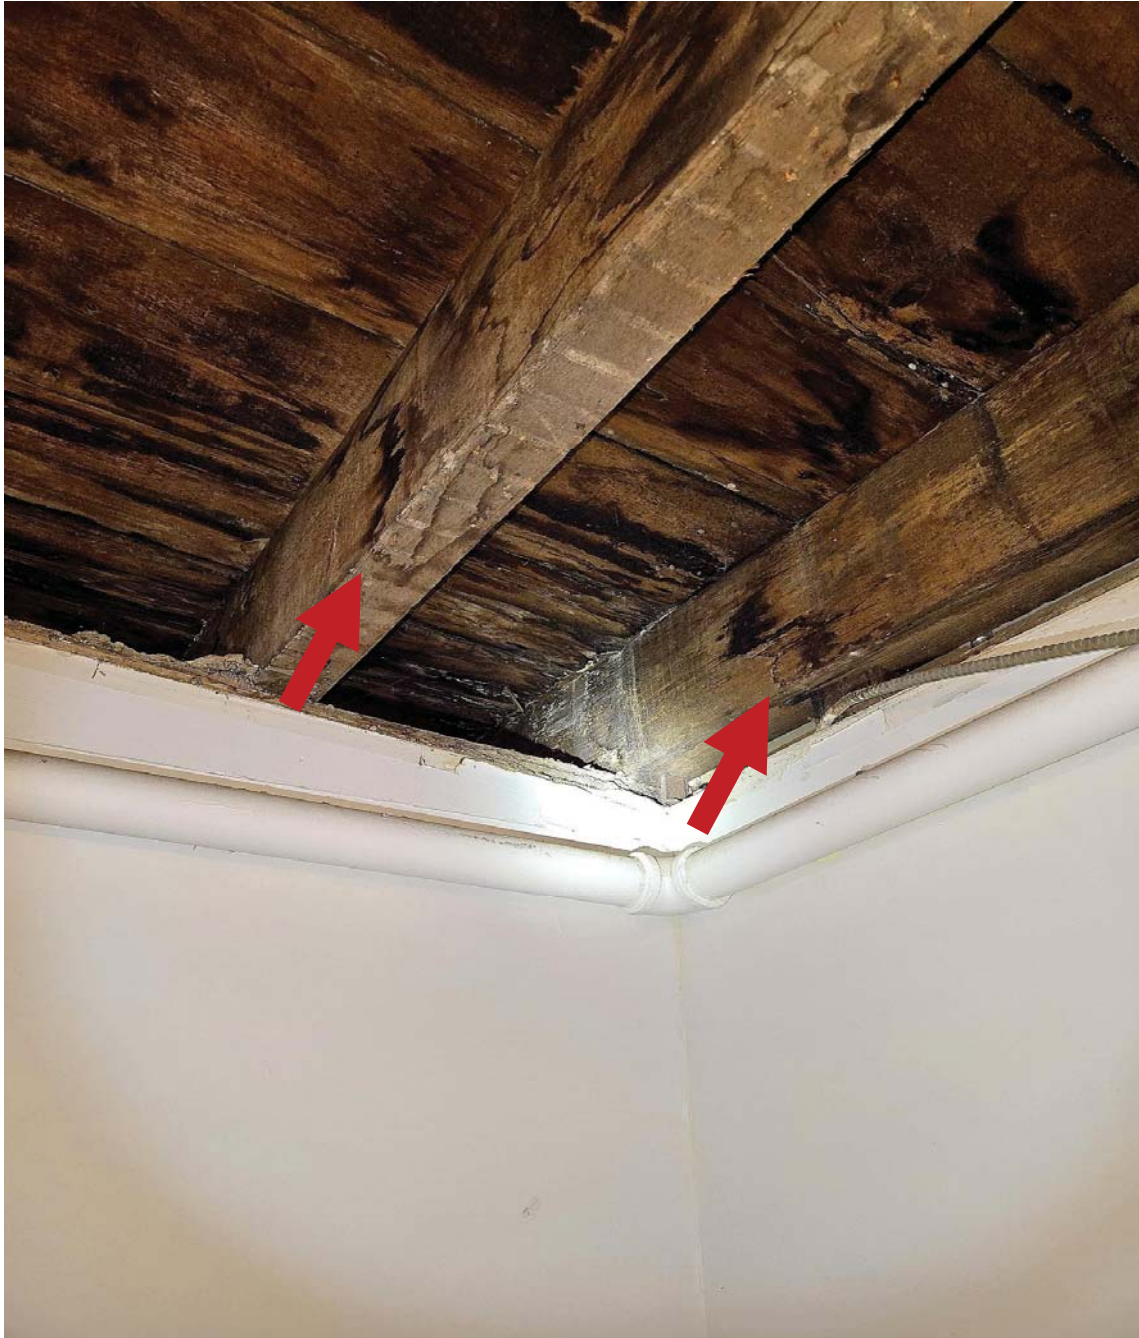
PHOTO #26

In unit 2B, all of the exposed 4th floor joists (ceiling joists) have water stains and deterioration from water damage. The 4th floor joists are sloping down towards the center of the building at a minimum of 2 degrees and lack bridging in some bays. Photos #24, 25 and #26 provide multiple views of the 4th floor joist conditions and their deterioration.

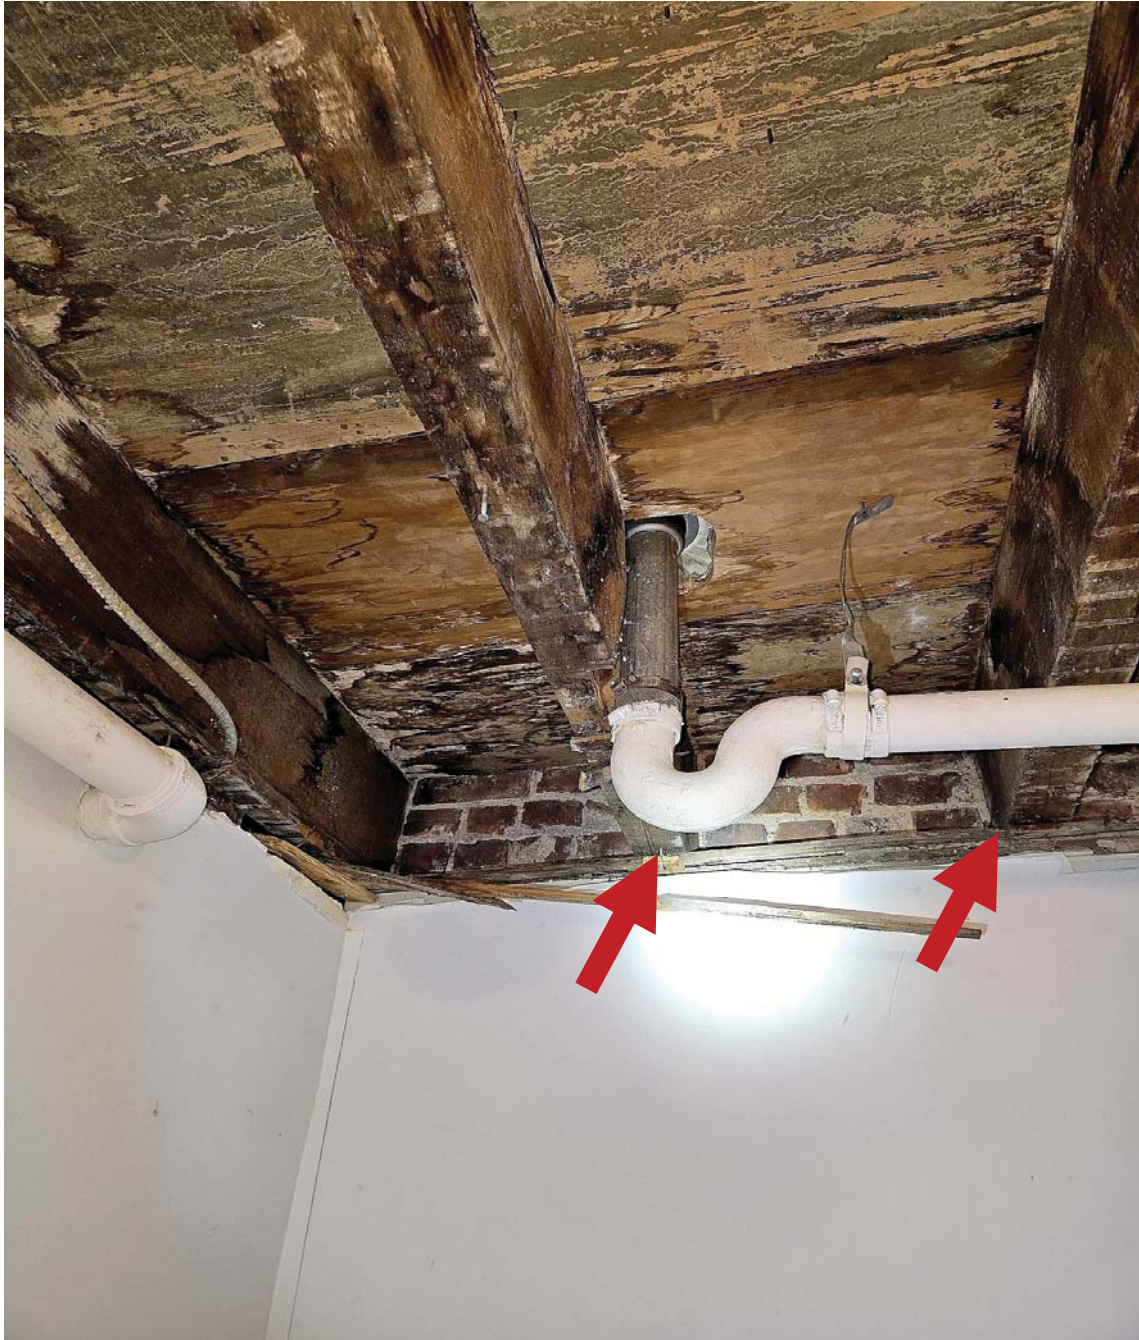
PHOTO #27

- **Photo #27 & #28** show the water damage of the 4th floor joists at the beam pockets and the dried-up mortar joints in the bearing masonry wall.
- **Photo #29** shows lack of bridging in a bay between two floor joists.

Water damage of the 4th floor joists at the beam pockets and the dried-up mortar joints in the bearing masonry wall.

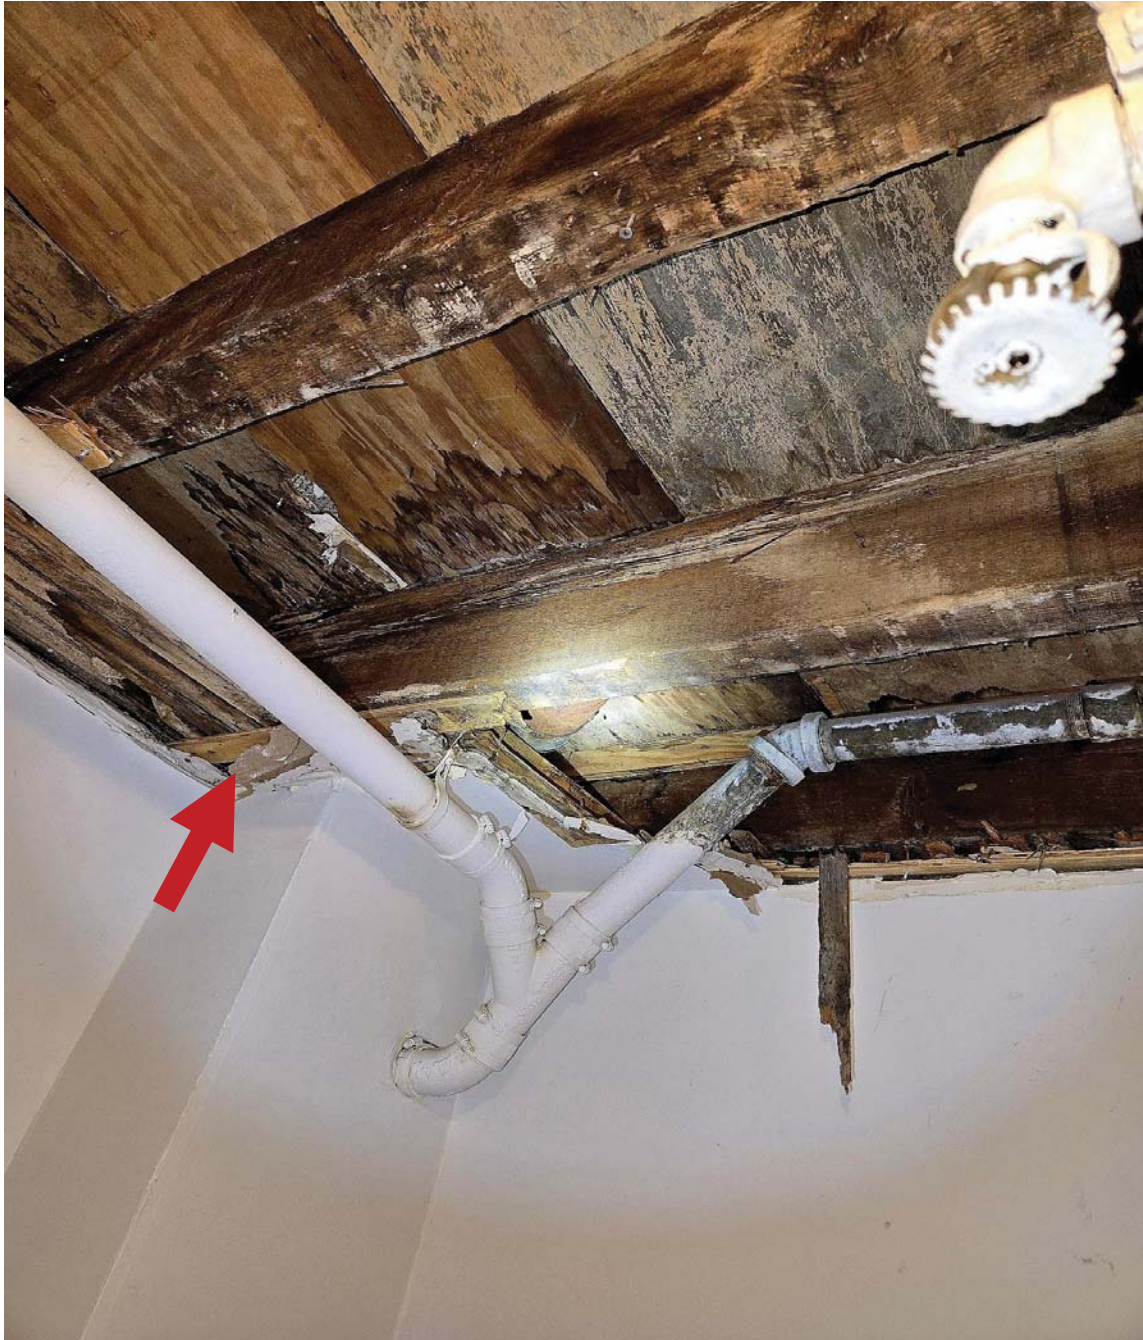
PHOTO #28

Water damage of the 4th floor joists at the beam pockets and the dried-up mortar joints in the bearing masonry wall.
