STEEL CORE ENGINEERING

109 East 9th St. New York, NY 10003

Re: Additional Probing of Upper Floors structure

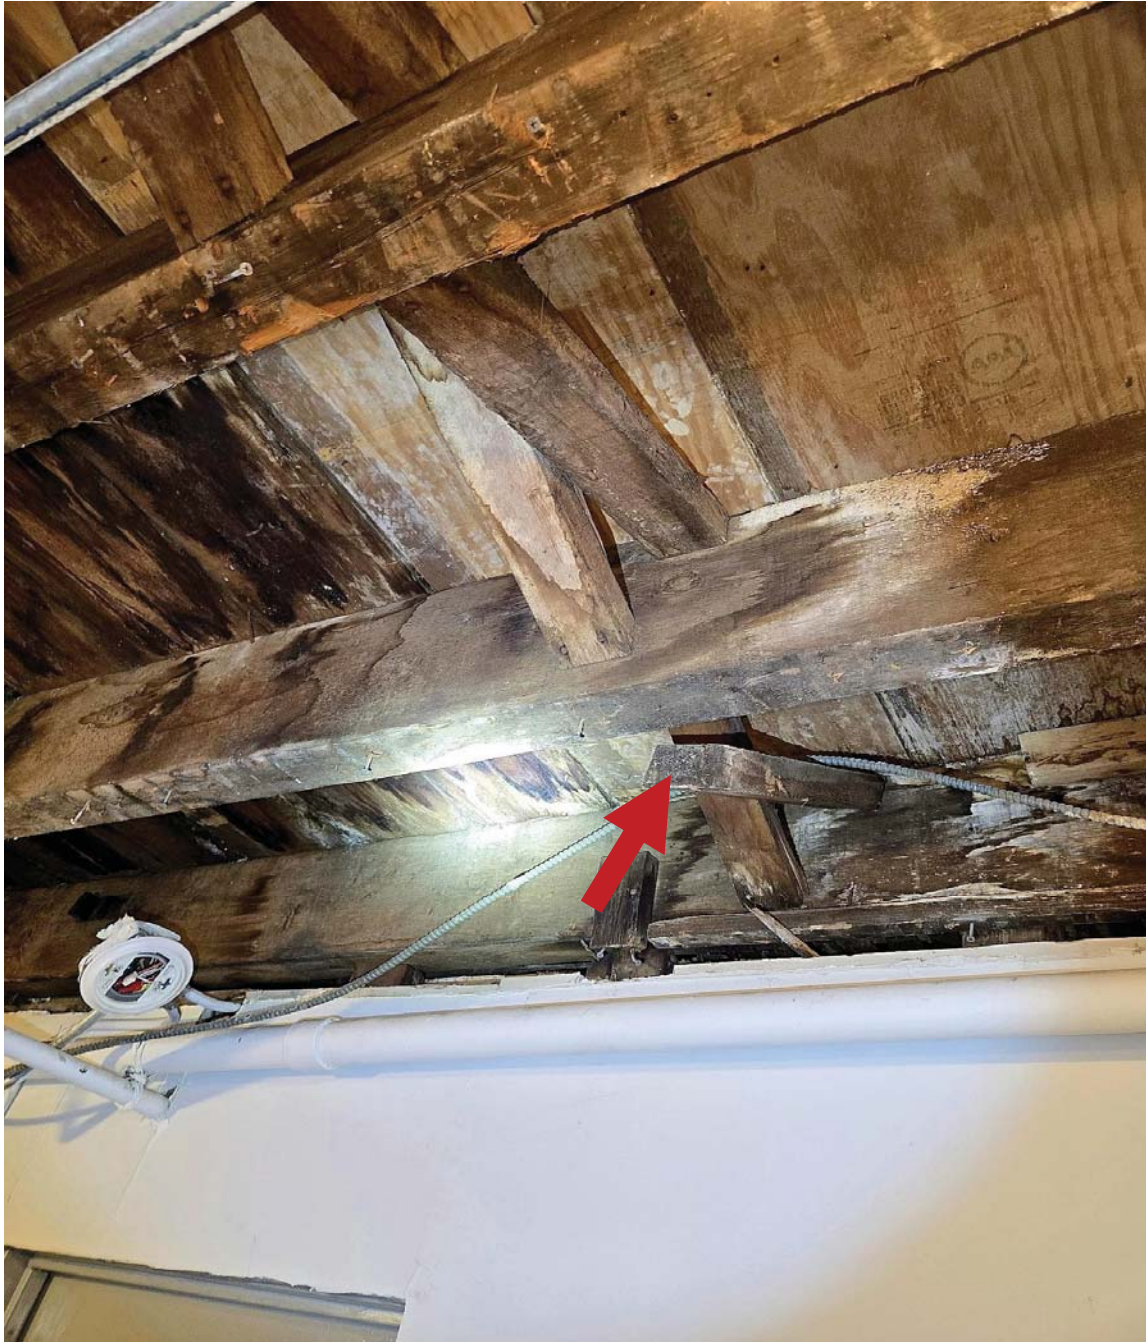
- **Photo #27 & #28** show the water damage of the 4th floor joists at the beam pockets and the dried-up mortar joints in the bearing masonry wall.
- **Photo #29** shows lack of bridging in a bay between two floor joists.

<p>EXISTING FOURTH FLOOR PLAN</p>	<p>PHOTO #29</p> <p>Lack of bridging in a bay between two floor joists.</p>
---	--

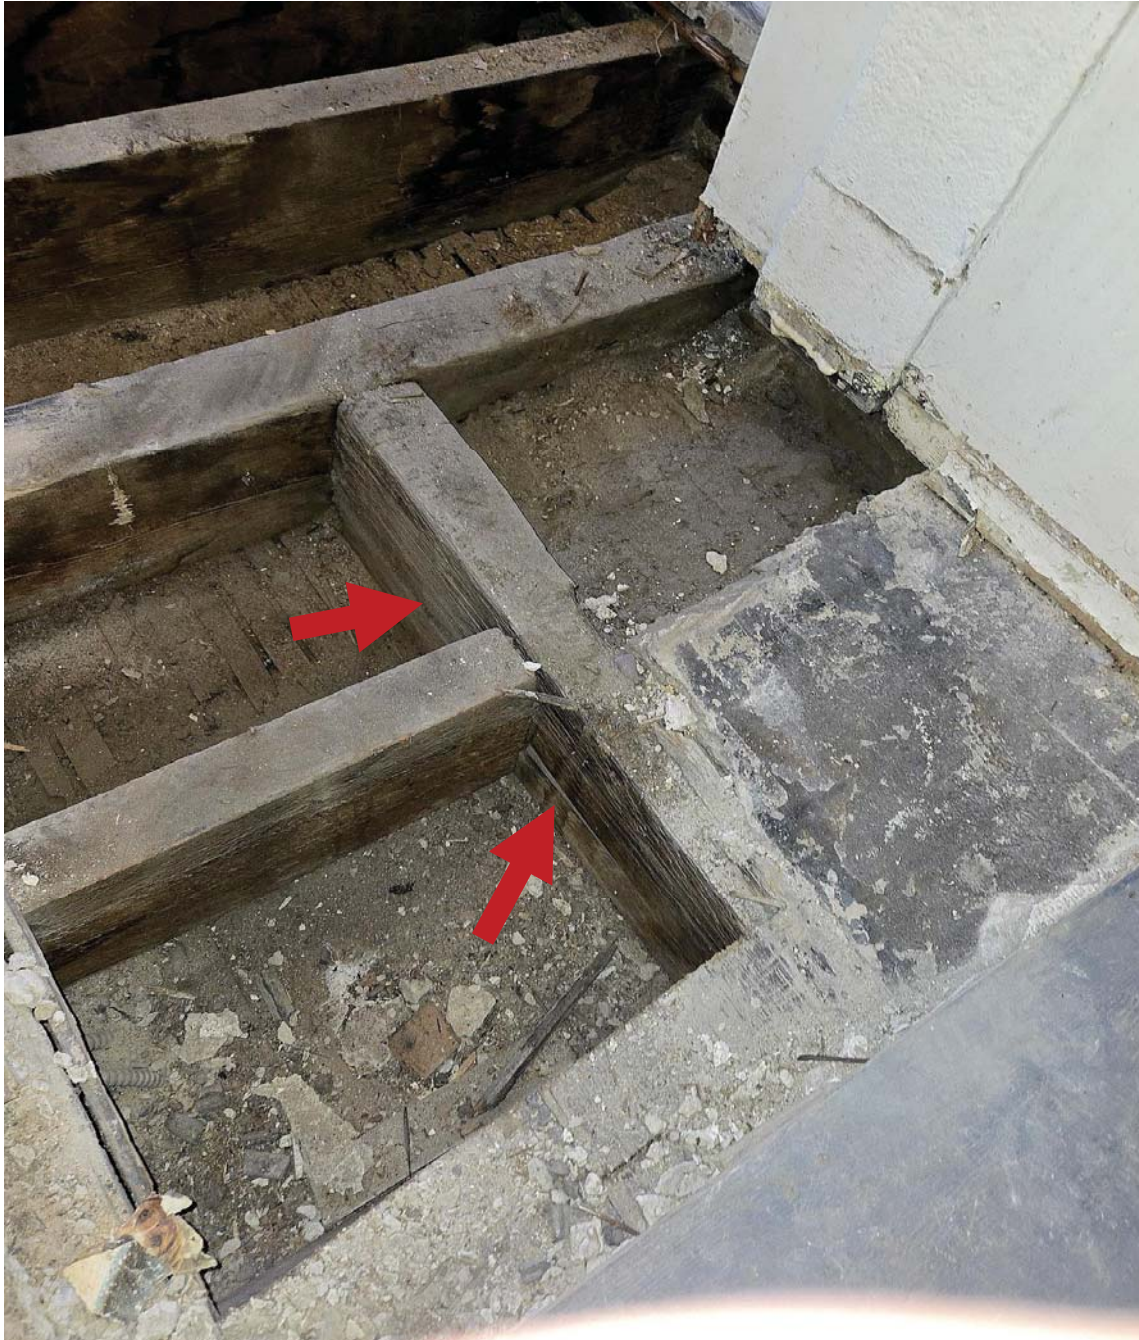
PHOTO #30

- In unit 2A, some of the 3rd floor joists were exposed and large cracks, water damage and joist sloping were observed.
- **Photo #30 & #31** show the chimney header beam having a very large horizontal check/crack which represents beam failure. This beam supports multiple floor joists and the joists are sloping towards the middle of the building which also pull on this cracked chimney header in its weak axis. Such a framing condition is not safe and hazardous.

Chimney header beam having a very large horizontal check/crack which represents beam failure. This beam supports multiple floor joists and the joists are sloping towards the middle of the building which also pull on this cracked chimney header in its weak axis. Such a framing condition is not safe and hazardous.

- **Cracked Structural Members:** At the existing headers, trimmers and floor joists throughout the building that have large cracks, and are at imminent risk of failure, such members must be replaced.

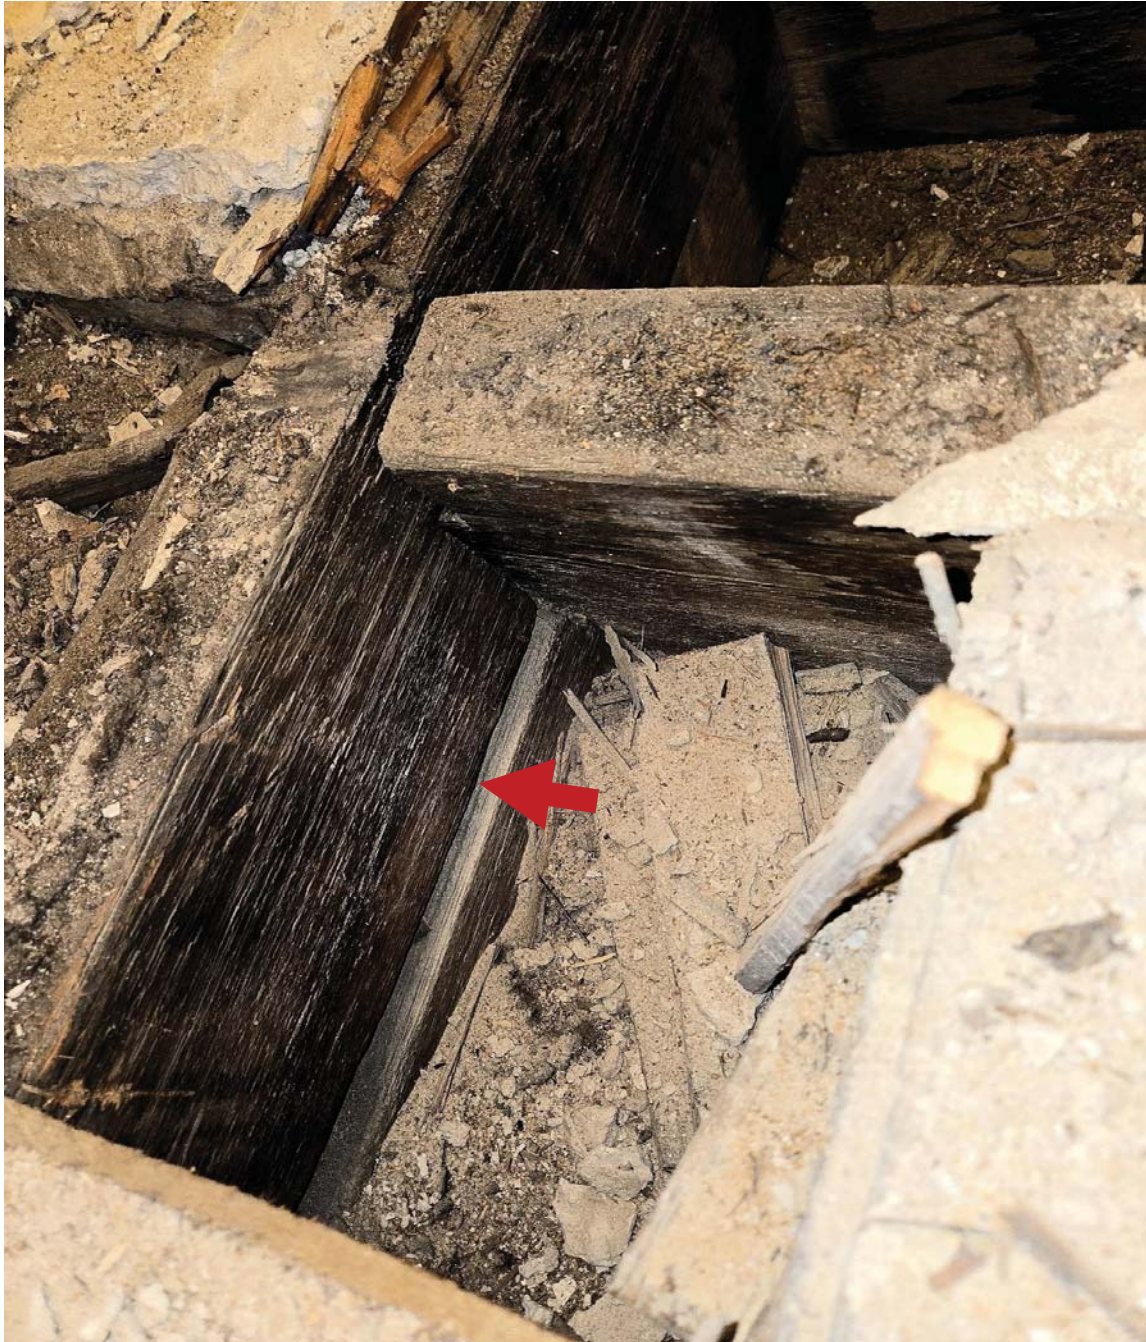
PHOTO #31

Chimney header beam having a very large horizontal check/crack which represents beam failure. This beam supports multiple floor joists and the joists are sloping towards the middle of the building which also pull on this cracked chimney header in its weak axis. Such a framing condition is not safe and hazardous.

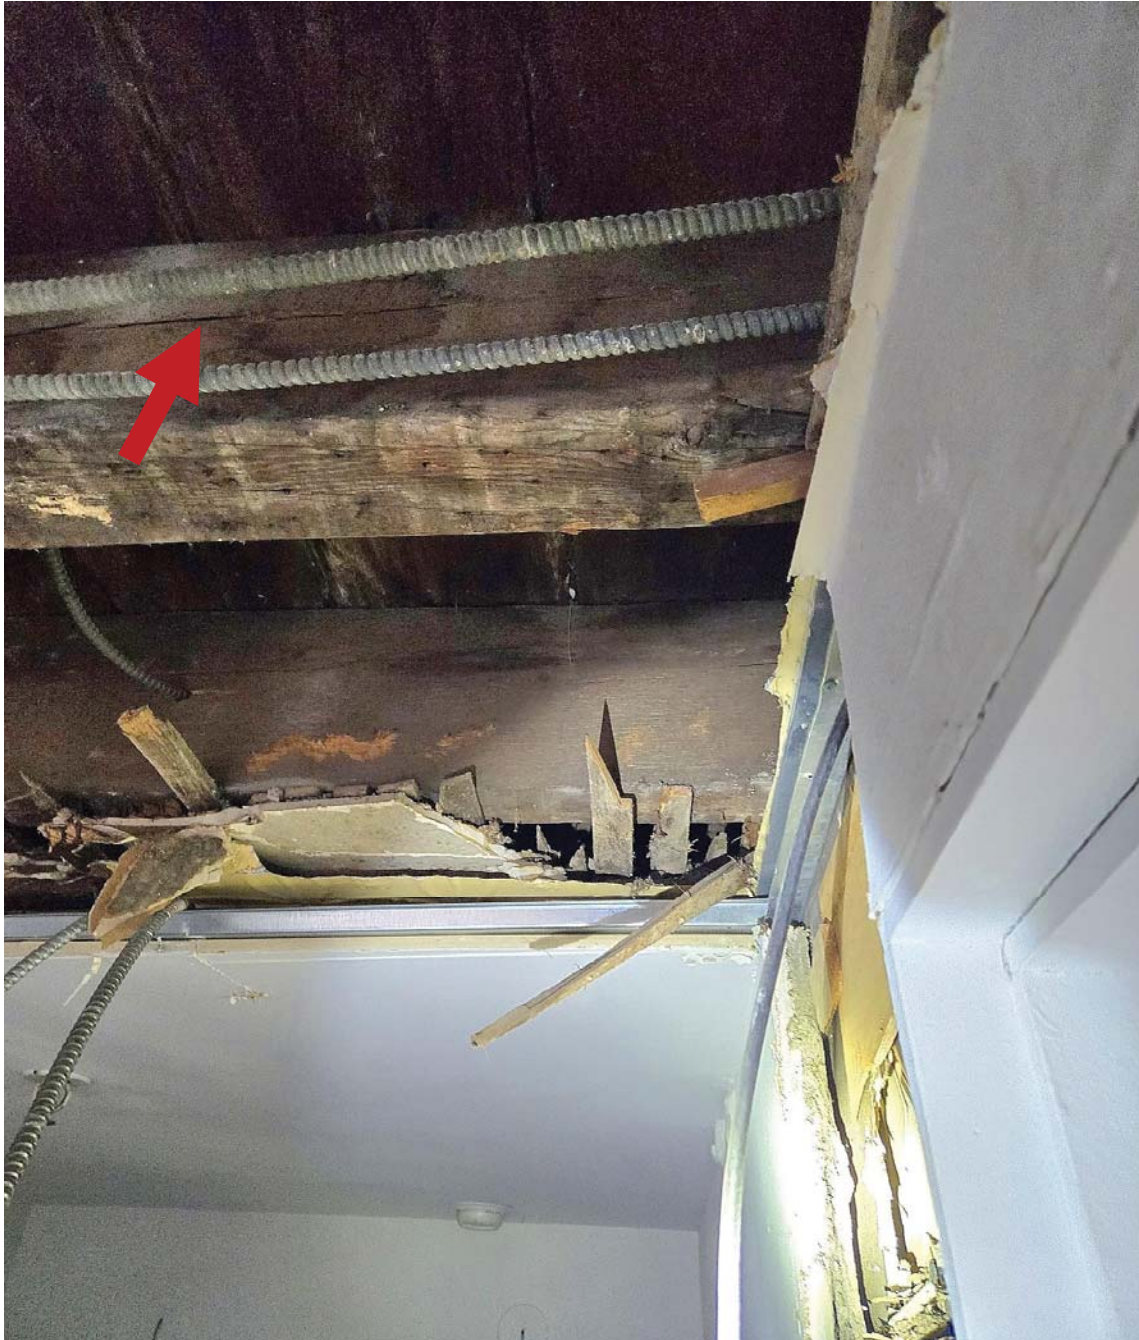
PHOTO #32

- **Photo #32** shows a crack in the 3rd floor trimmer beam. This crack is horizontal and spans for a large span of the beam, making this beam unsafe.
- **Photo #33** shows the dry mortar condition which exists where the 4th floor joists pocket into the wall. This condition has been seen throughout the building and not just this floor.

A crack in the 3rd floor trimmer beam. This crack is horizontal and spans for a large span of the beam, making this beam unsafe.

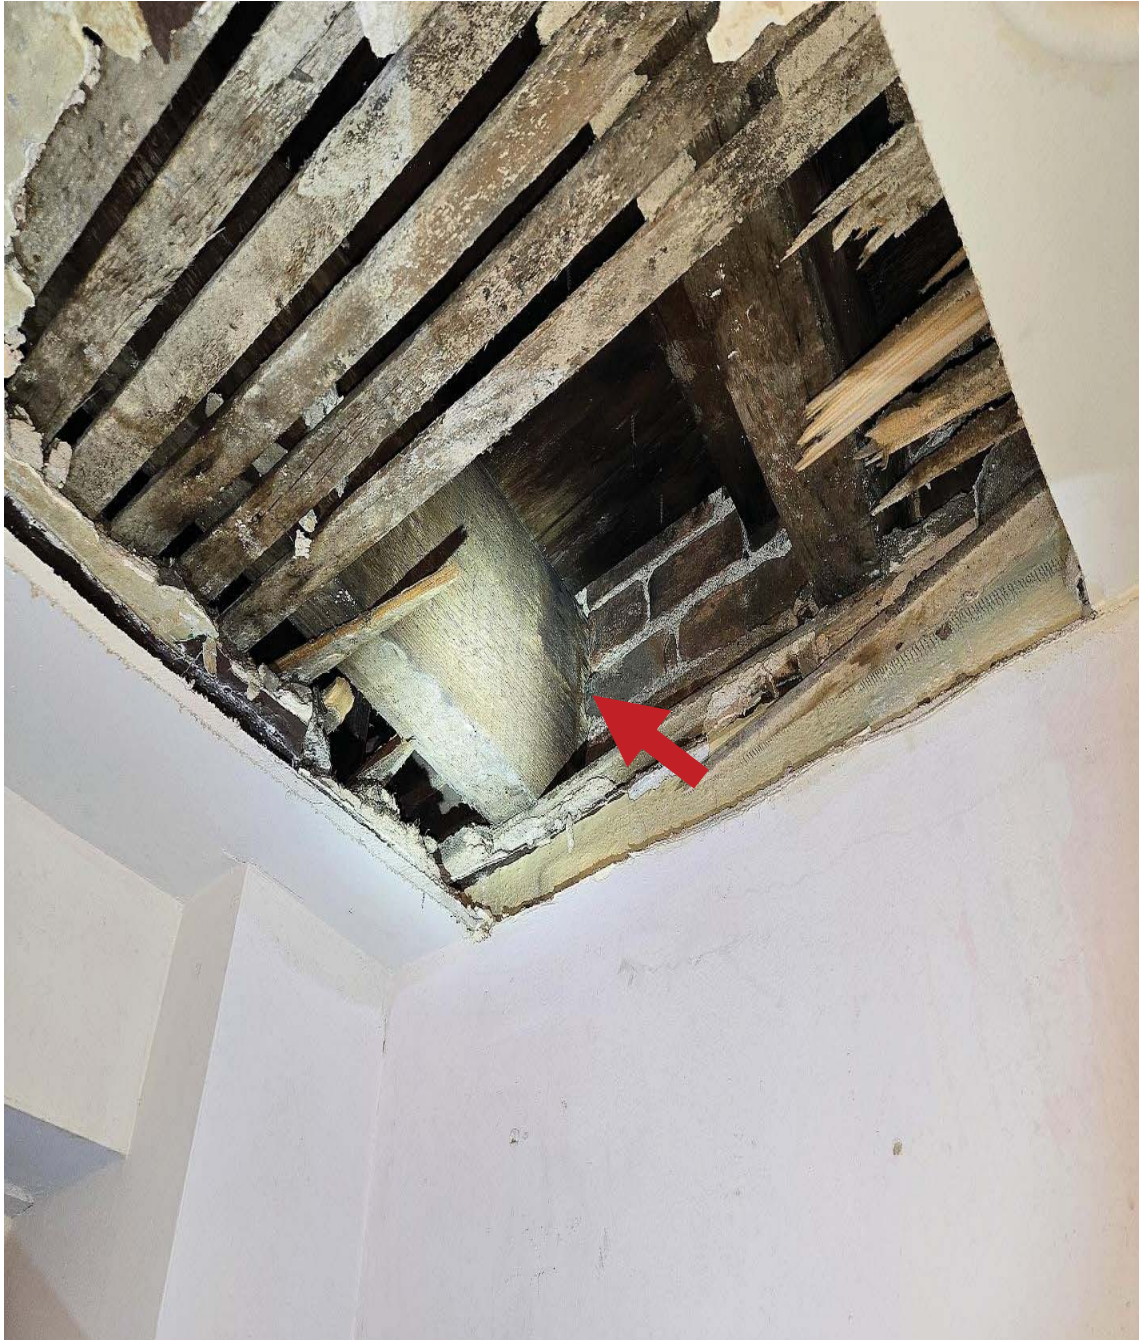
<p>EAST 9TH STREET</p> <p>EXISTING FOURTH FLOOR</p>	<p>PHOTO #33</p> <p>The dry mortar condition which exists where the 4th floor joists pocket into the wall. This condition has been seen throughout the building and not just this floor.</p>
--	---

- **Masonry Walls:** At the bearing masonry walls, removal and replacement of the deteriorated brick as well as deep repointing. Masonry stitching at the interior corners of the building, as required.

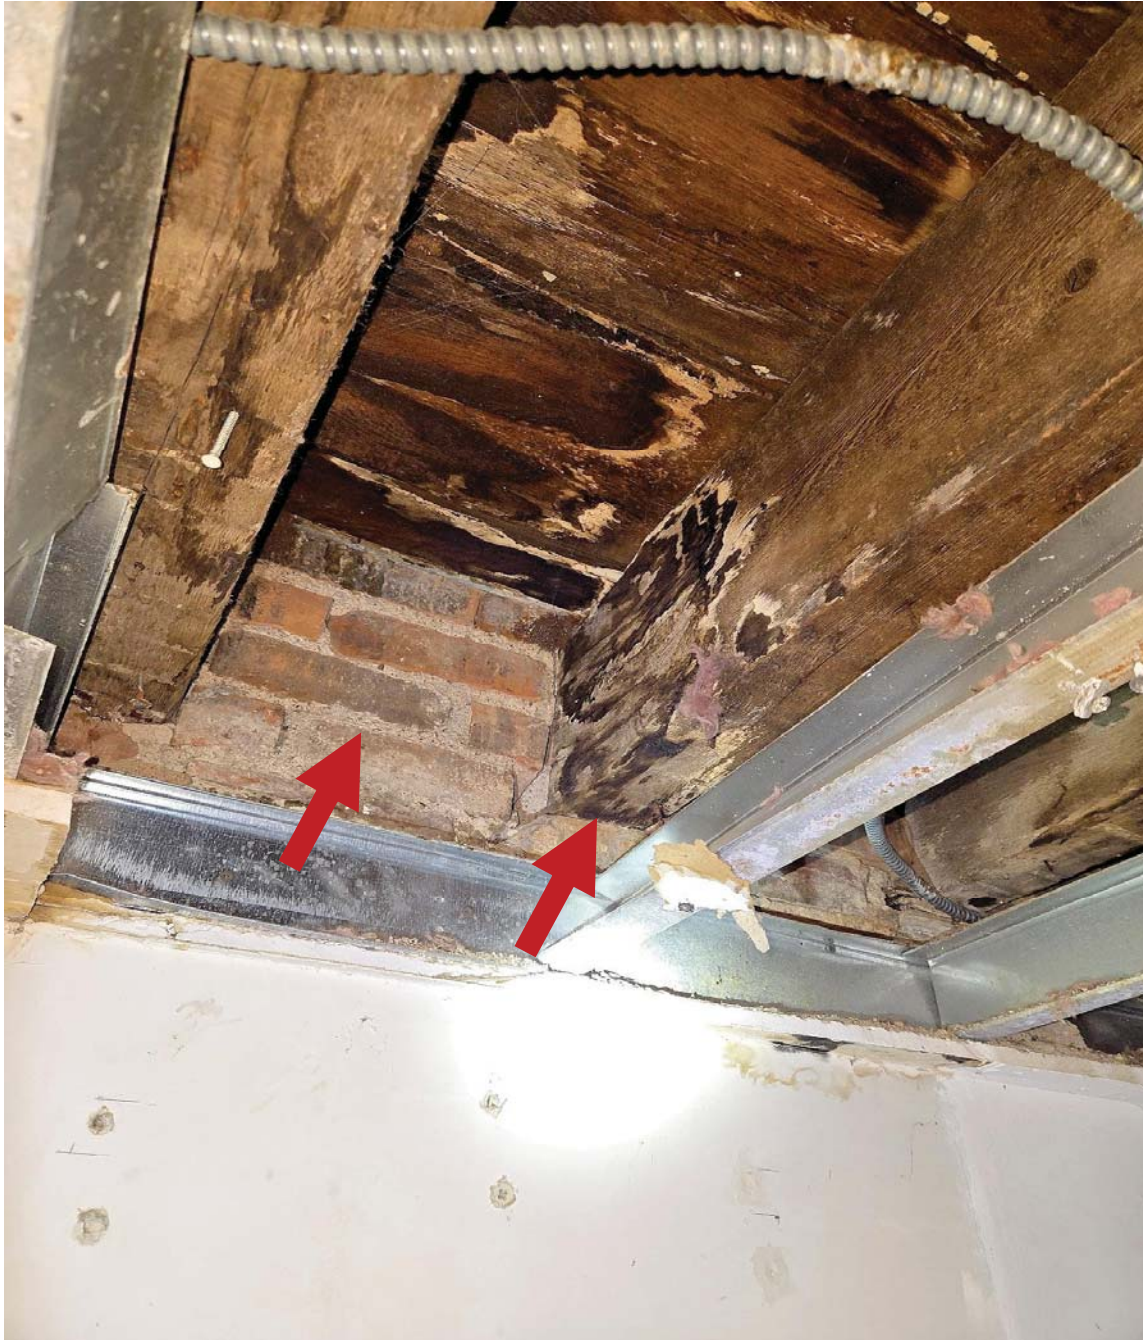
PHOTO #34

- **Photo #34 & #35** show the 3rd floor joist and chimney trimmer beam (in the floor of unit 2C) and show the water damage where the joist and trimmer pocket into the wall. The joist is bearing into the masonry wall for about one inch only. Standard bearing requirements for a floor joist would be about 4 inches. The mortar in the brick wall are also dry and structurally unstable.

The 3rd floor joist and chimney trimmer beam (in the floor of unit 2C) show the water damage where the joist and trimmer pocket into the wall. The joist is bearing into the masonry wall for about one inch only. Standard bearing requirements for a floor joist would be about 4 inches. The mortar in the brick wall are also dry and structurally unstable.

- **Floor Joists at Beam Pockets:** At the deteriorated and unsupported floor joists at the beam pockets, the remediation work would be to sister the floor joists and pocket the sister member into the wall and/or replace the floor joists with a new wood joist or LVL member which would bear at least four inches into the wall.

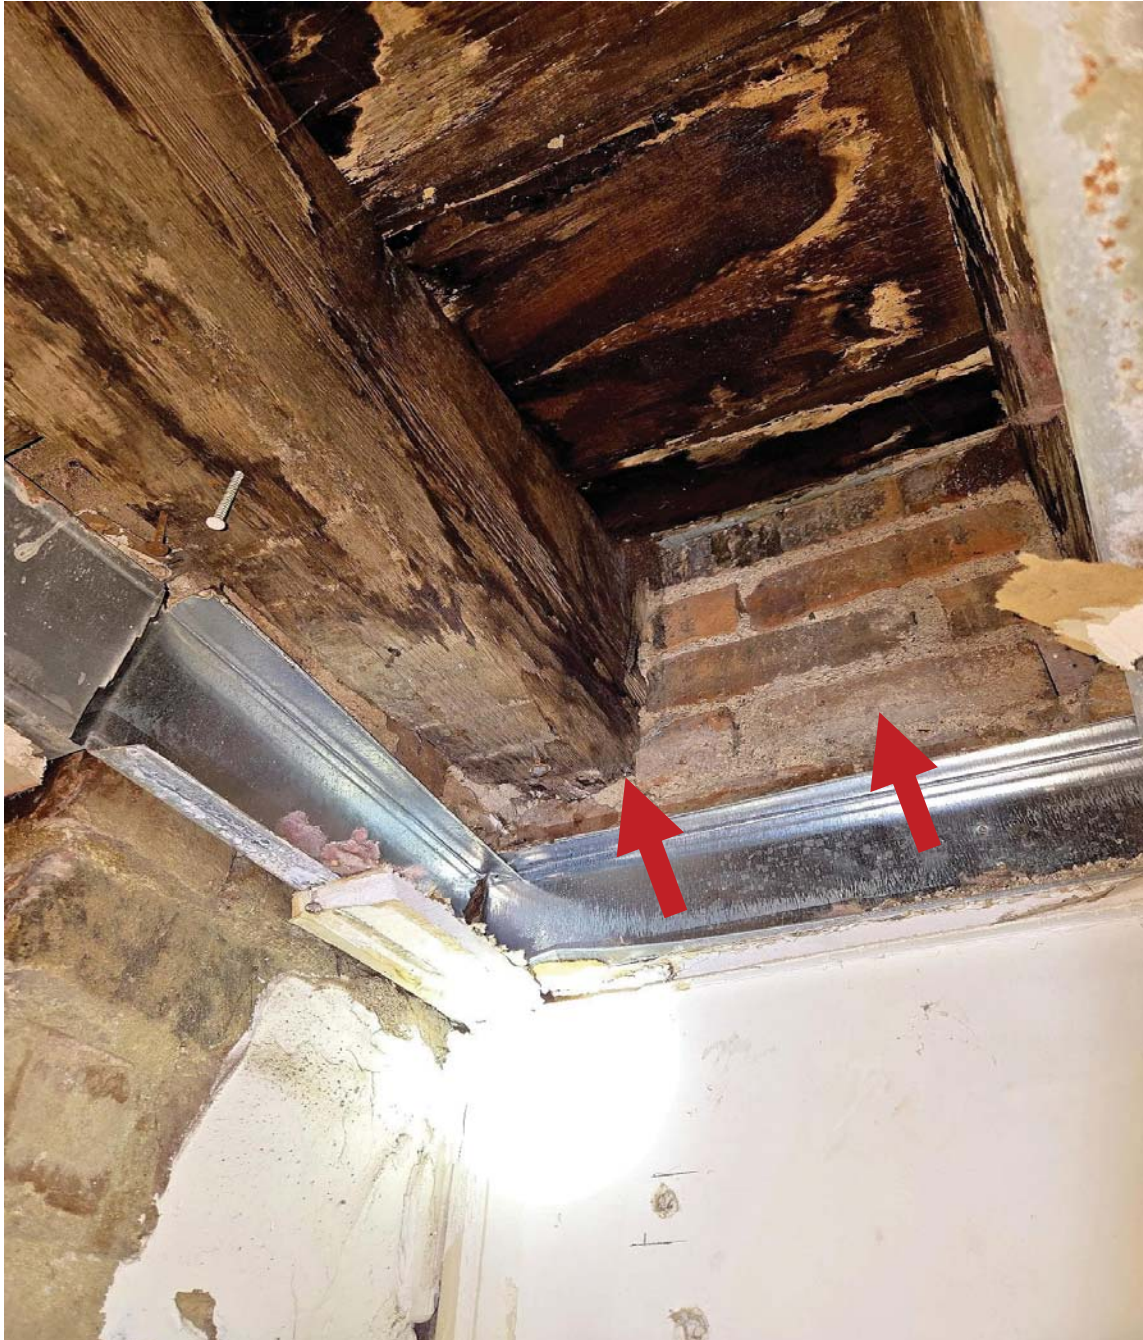
PHOTO #35

The 3rd floor joist and chimney trimmer beam (in the floor of unit 2C) show the water damage where the joist and trimmer pocket into the wall. The joist is bearing into the masonry wall for about one inch only. Standard bearing requirements for a floor joist would be about 4 inches. The mortar in the brick wall are also dry and structurally unstable.

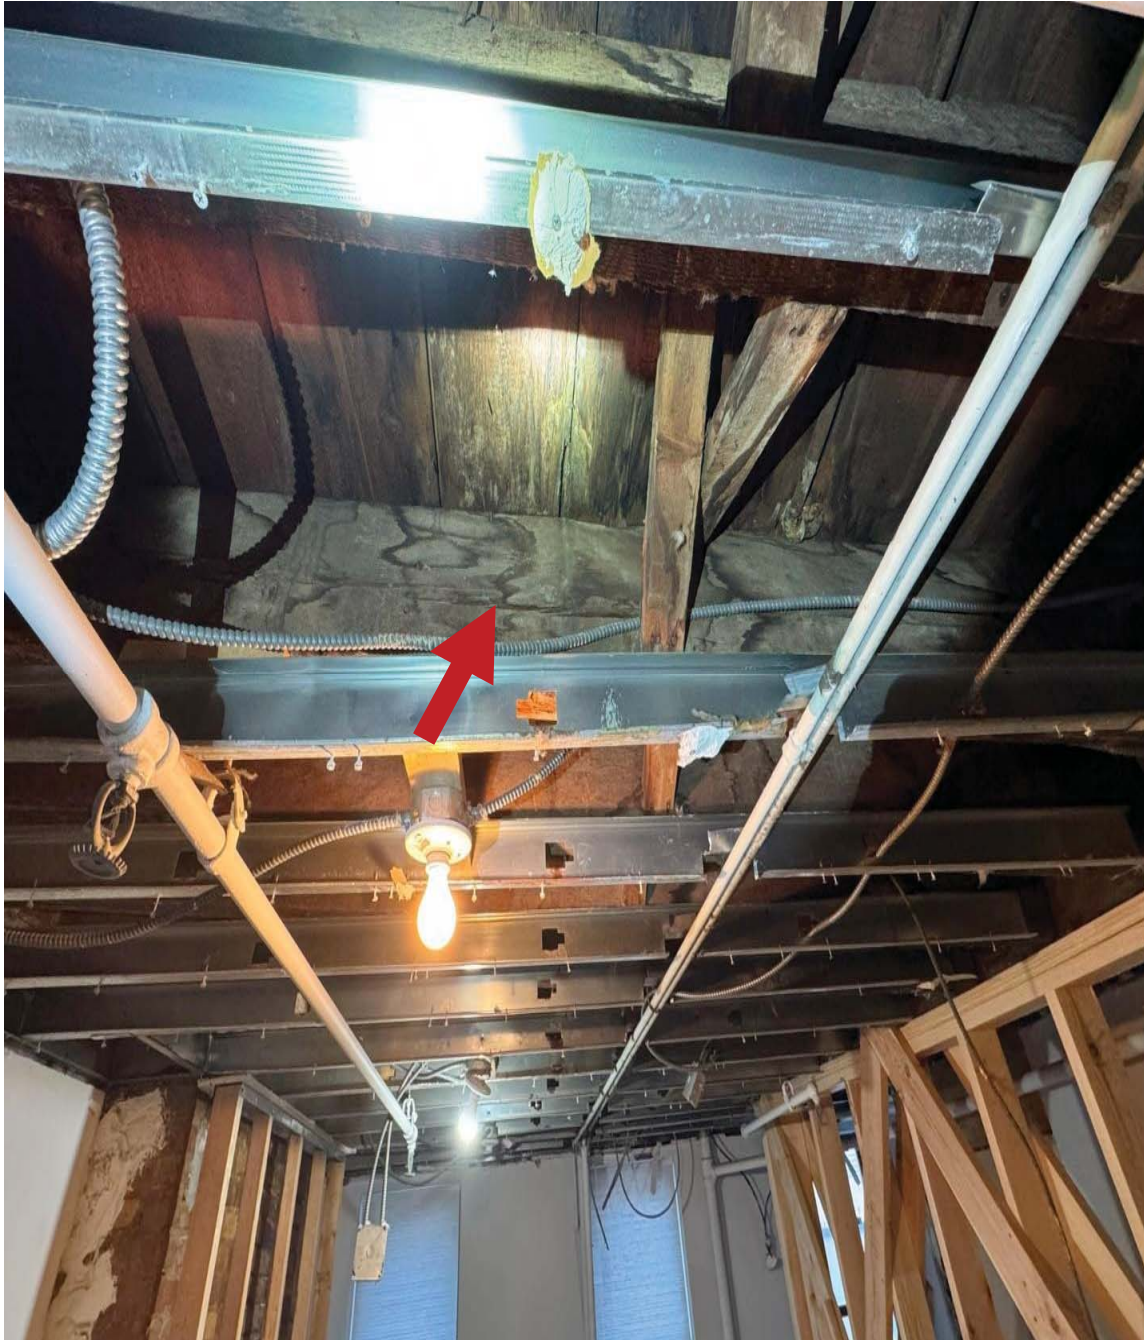
PHOTO #36

- **Photo #36, #37 & #38** show the 3rd floor joist with a large horizontal check/crack which extends for the majority of its span. This crack is an indication that the floor member is beyond its point of failure and is not structurally sound to support the floor loading.

The 3rd floor joist with a large horizontal check/crack which extends for the majority of its span. This crack is an indication that the floor member is beyond its point of failure and is not structurally sound to support the floor loading.

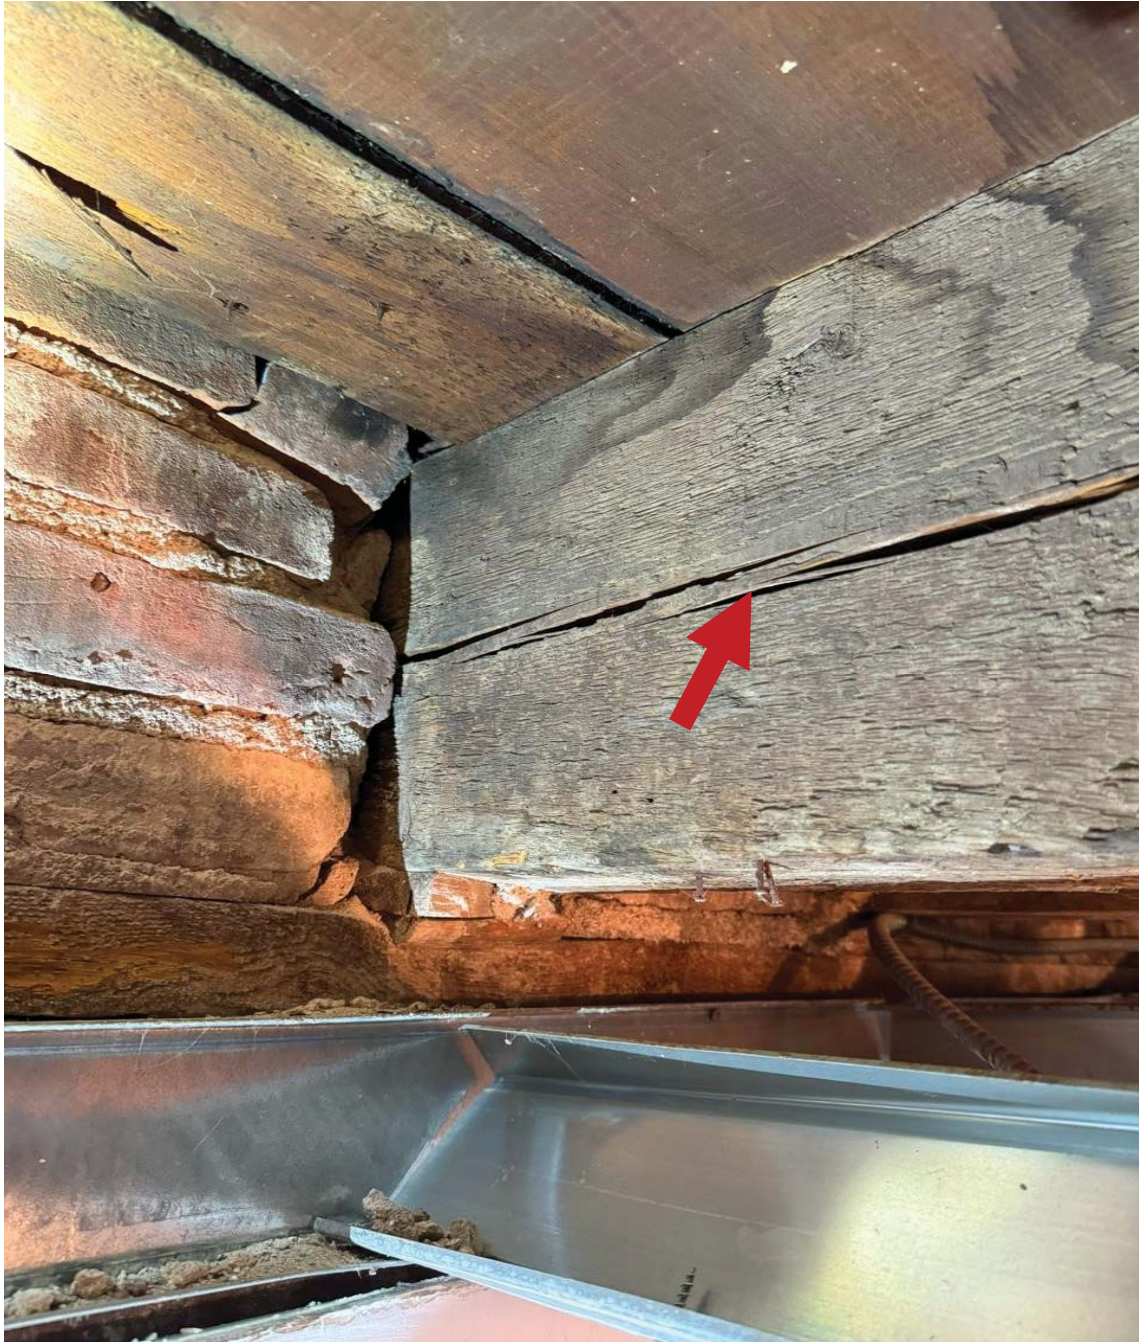
PHOTO #37

The 3rd floor joist with a large horizontal check/crack which extends for the majority of its span. This crack is an indication that the floor member is beyond its point of failure and is not structurally sound to support the floor loading.

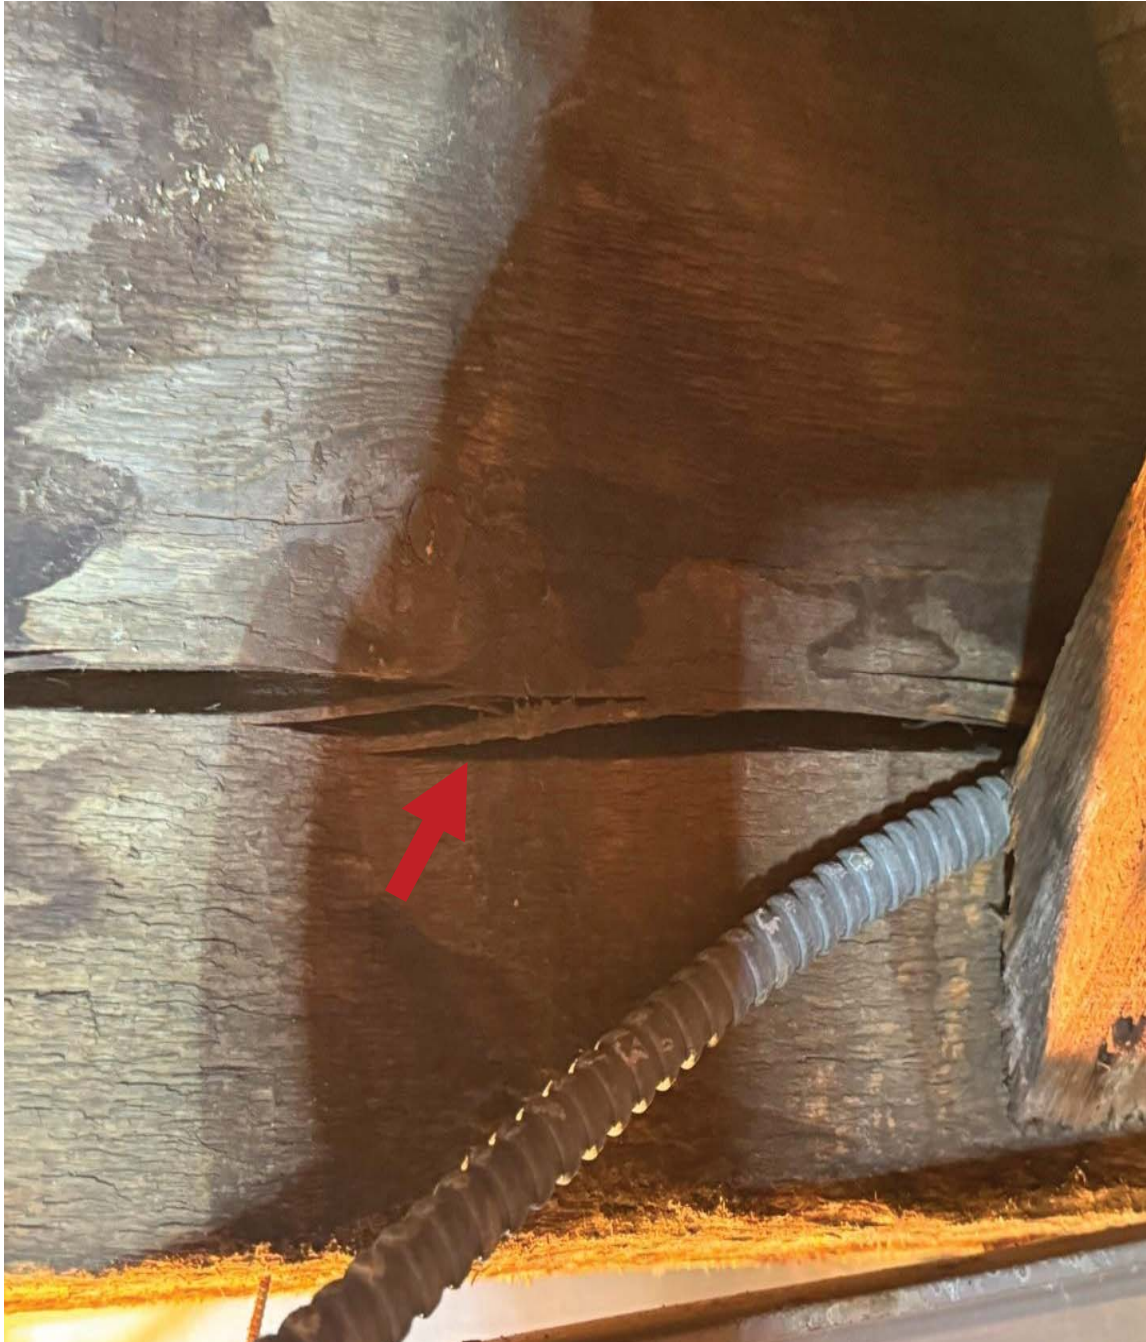
PHOTO #38

The 3rd floor joist with a large horizontal check/crack which extends for the majority of its span. This crack is an indication that the floor member is beyond its point of failure and is not structurally sound to support the floor loading.

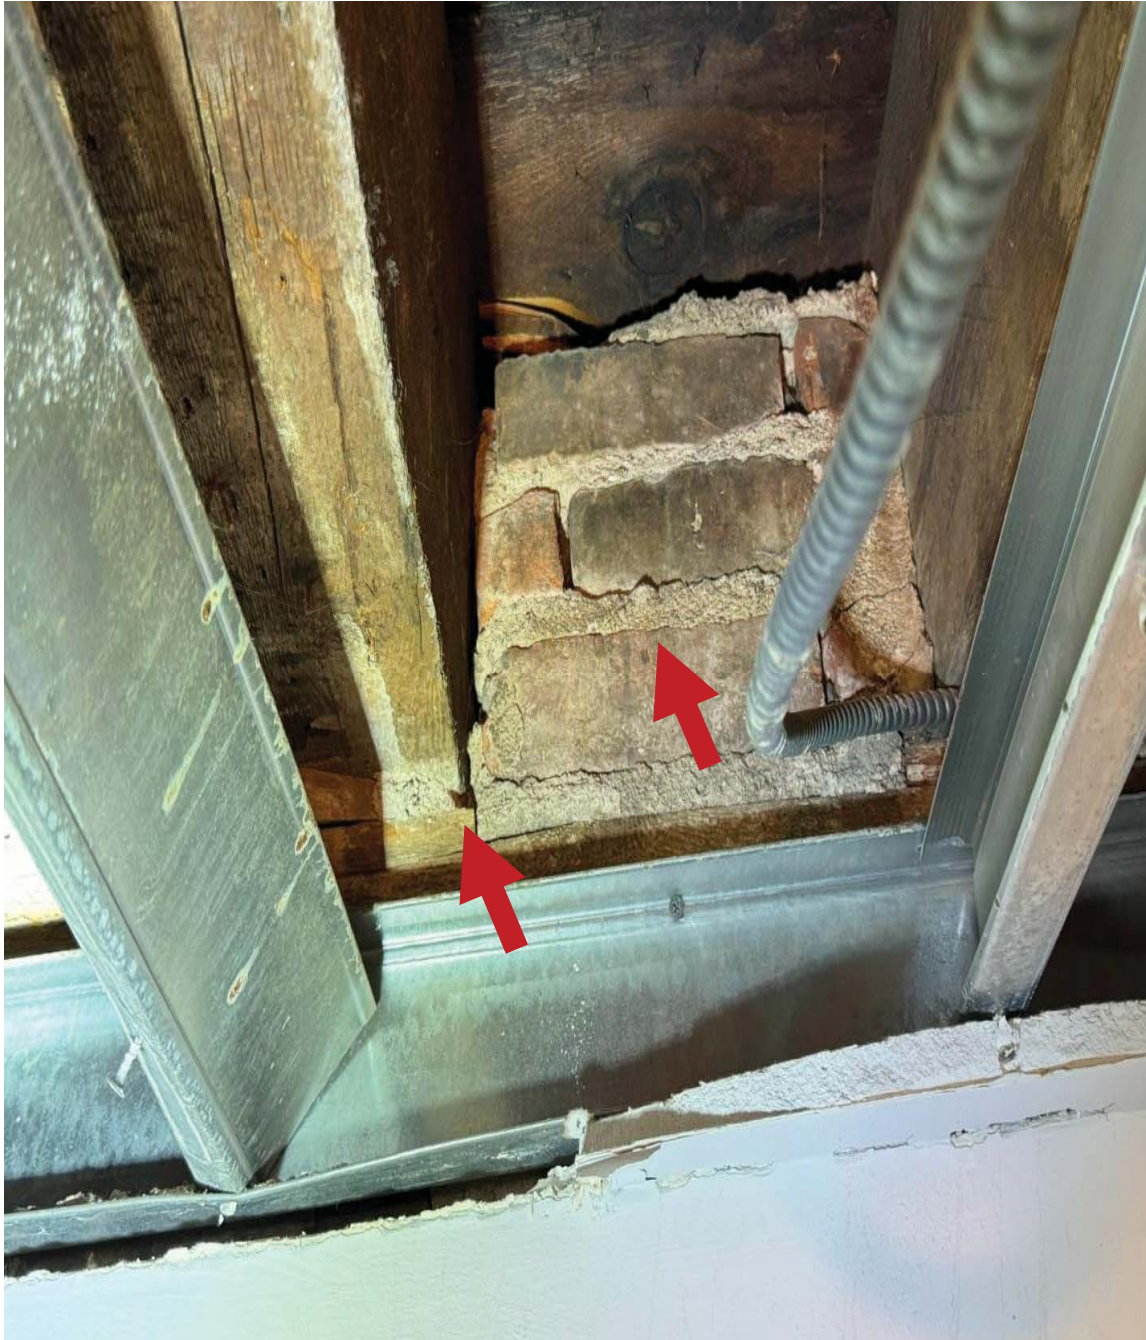
PHOTO #39

- **Photo #39** shows the condition of the beam pockets where the 3rd floor frames into the masonry walls under unit 2D. The beam pockets have voids and such a condition does not provide proper bracing of the exterior wall. The mortar in the brick wall, between the floor joists, has also dried up and crumbles to the touch.

Photo #39 shows the condition of the beam pockets where the 3rd floor frames into the masonry walls under unit 2D. The beam pockets have voids and such a condition does not provide proper bracing of the exterior wall. The mortar in the brick wall, between the floor joists, has also dried up and crumbles to the touch.
