November 25, 2025

Jenny Akchin
TakeRoot Justice
123 William Street
Suite 401
New York, New York 10038

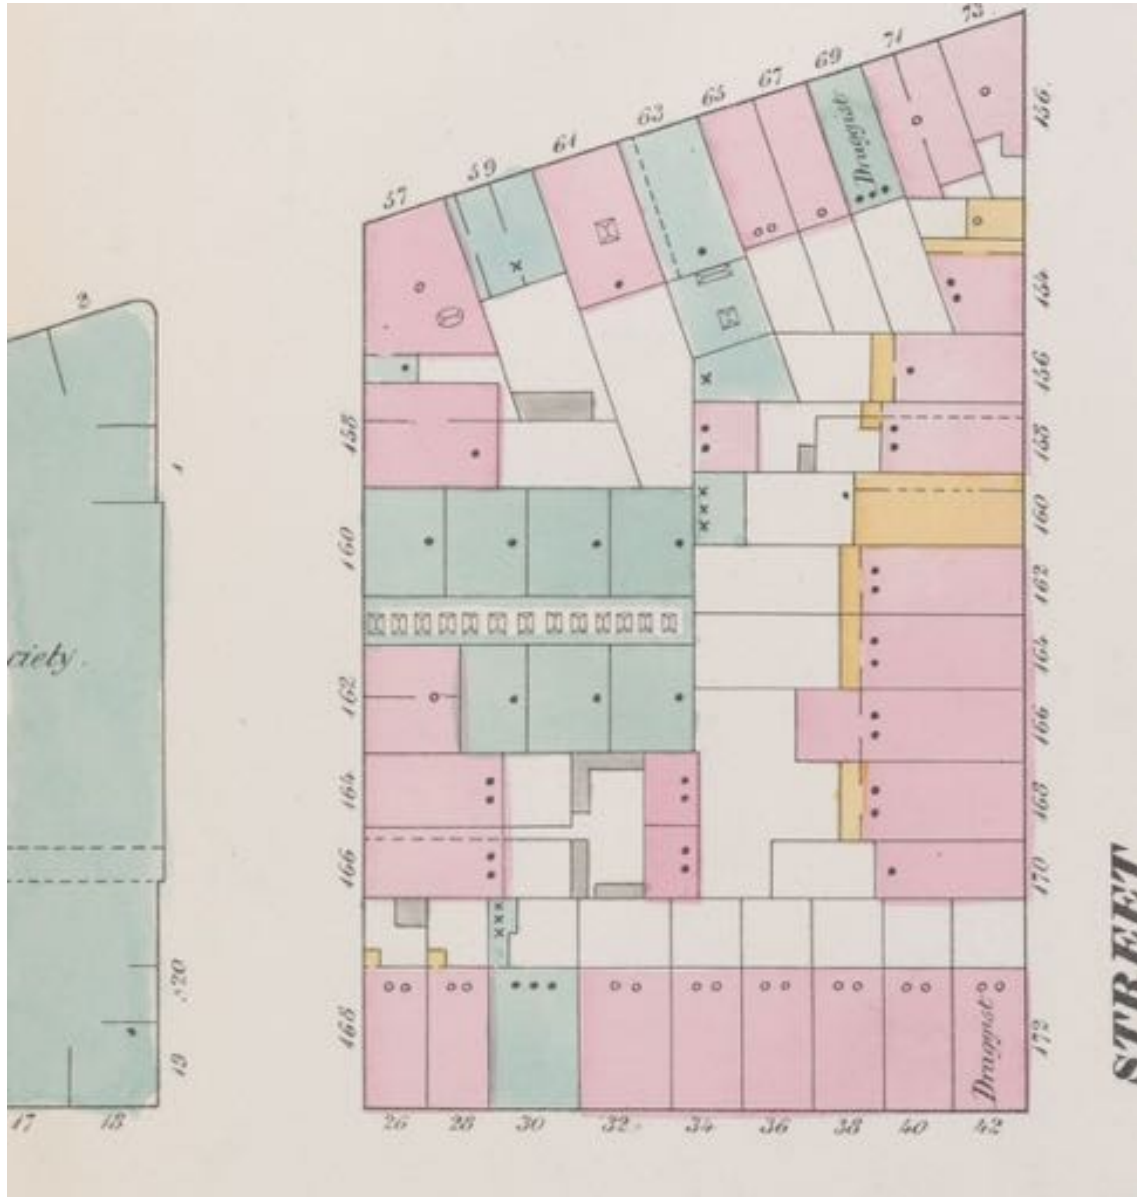
Figure 2: Excerpt of "Maps of the City of New York" by William Perris, volume 3, plate 41, 1859. The site is indicated as 162 East 9th Street (before the 1861 street address renumbering) and the green shading indicates high-fire-hazard occupancy. Third Avenue is at the bottom and north to the right. Note the skylights and roof shown between 160 and 162 East 9th Street.

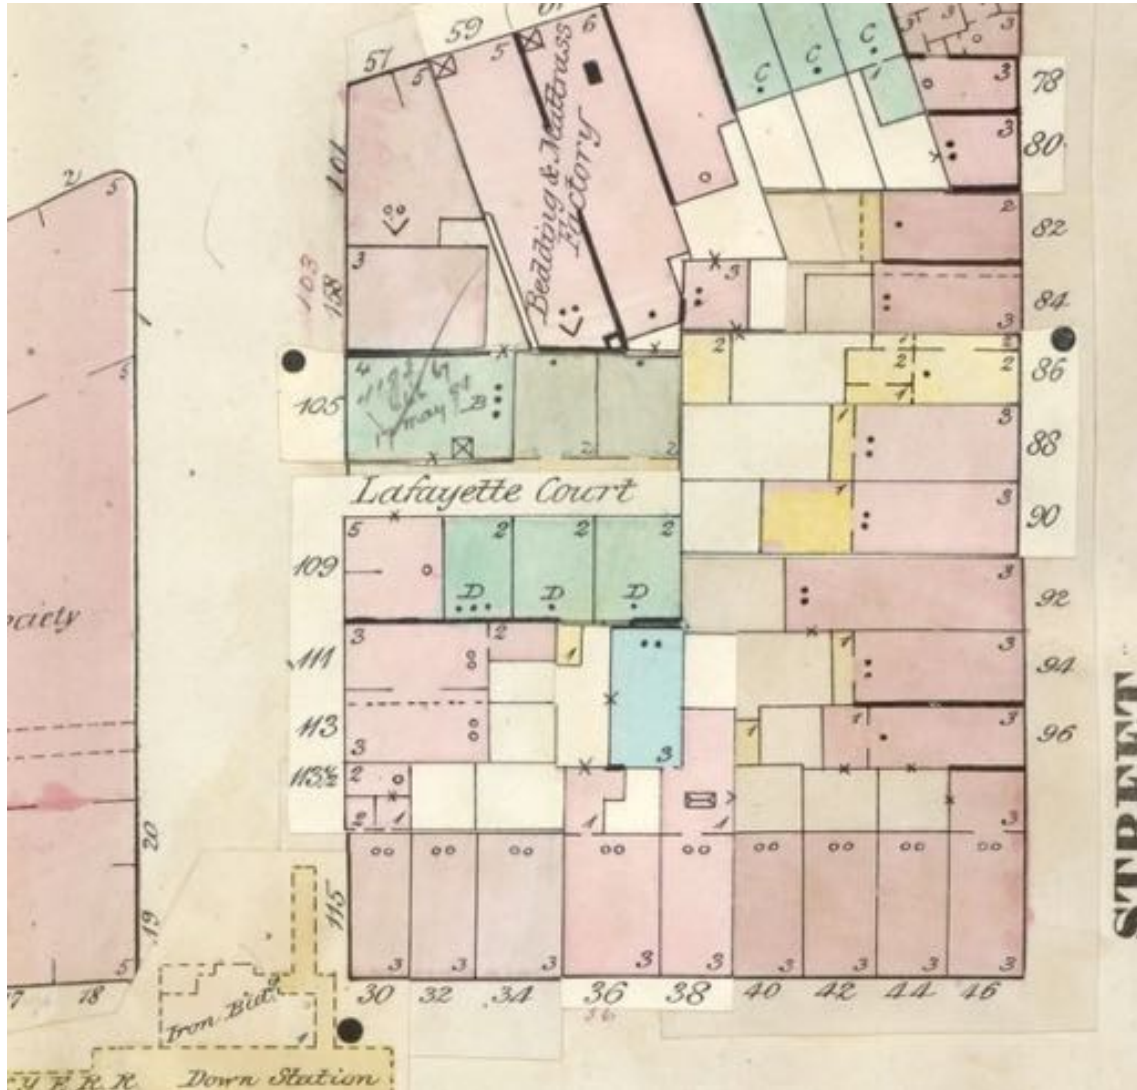
Figure 3: Excerpt of "Maps of the City of New York" by Perris & Browne, volume 2, plate 41, 1868. The green shading indicates high-fire-hazard occupancy. Third Avenue is at the bottom and north to the right. Note that the connector building between 105 and 109 East 9th Street has been replaced by the open Lafayette Court.

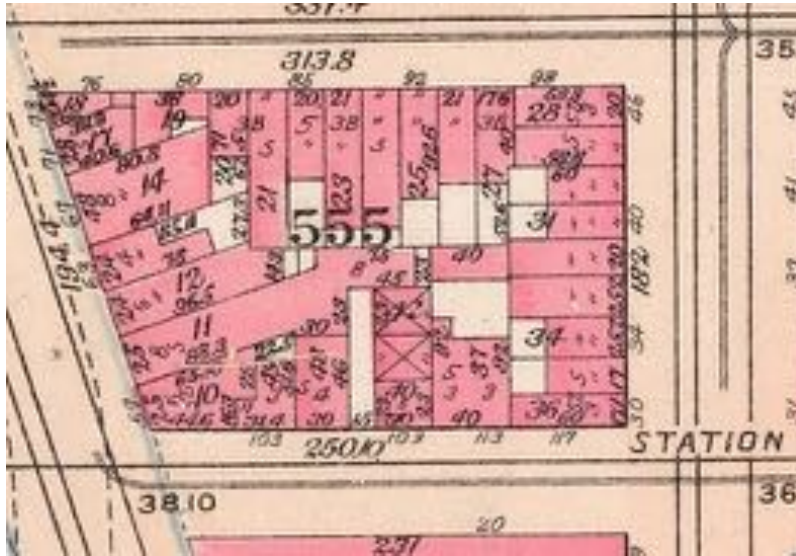
Figure 4: Excerpt of "Atlas of the City of New York" by G. W. Bromley & Co., plate 11, 1911. Third Avenue is at the right and north to the top. The vacant land is at the center of the lower end of the block, with 109 East 9th Street to the right.

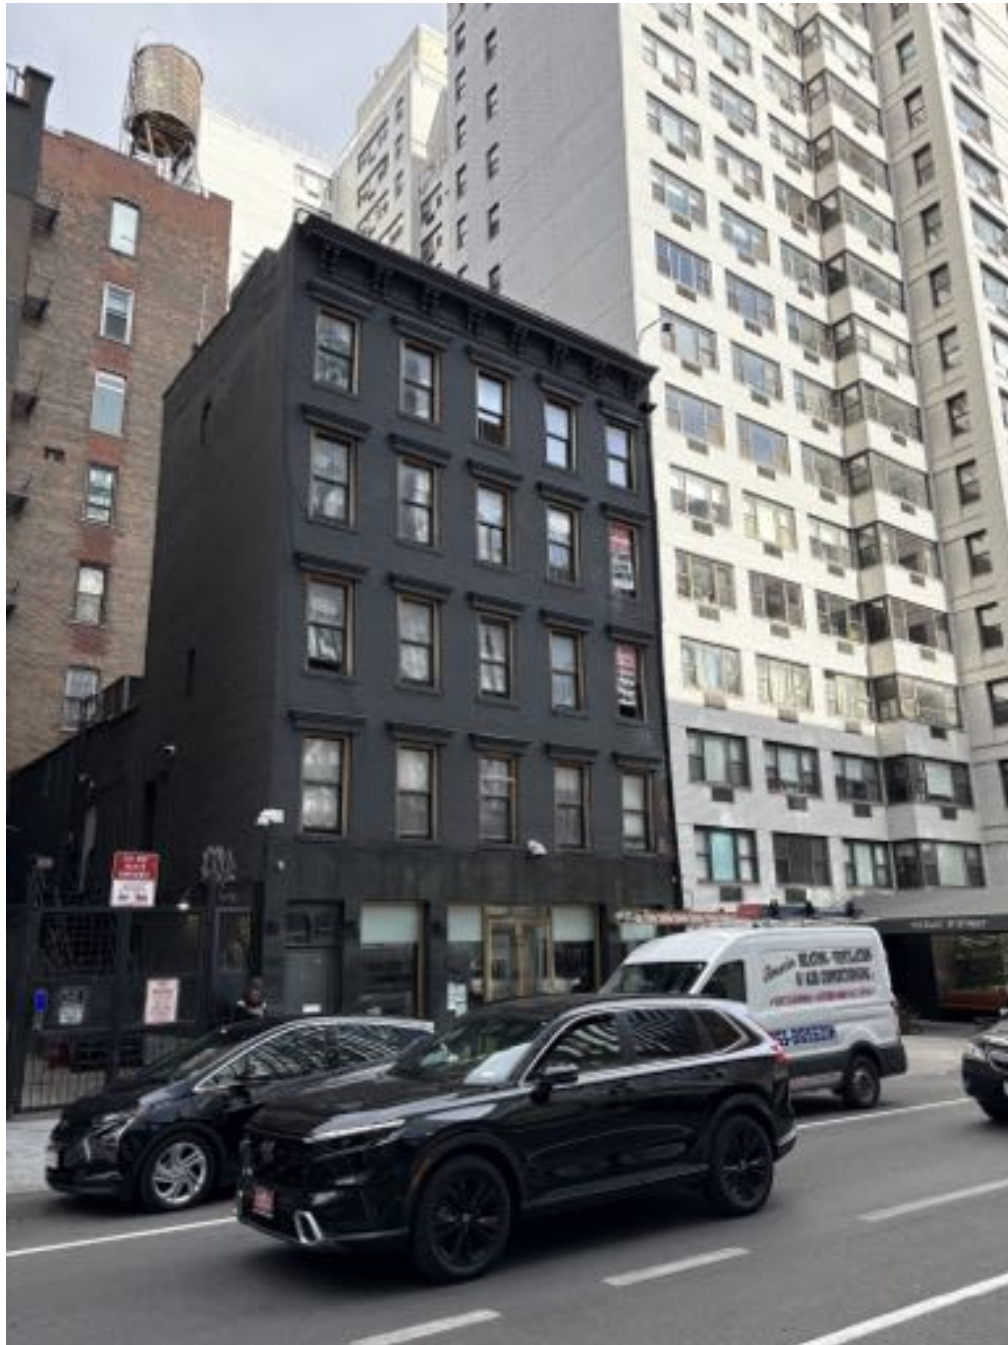
Figure 8: Front and west facades as observed on November 7, 2025. The exterior configuration is structurally identical to that seen in figures 5 and 6.

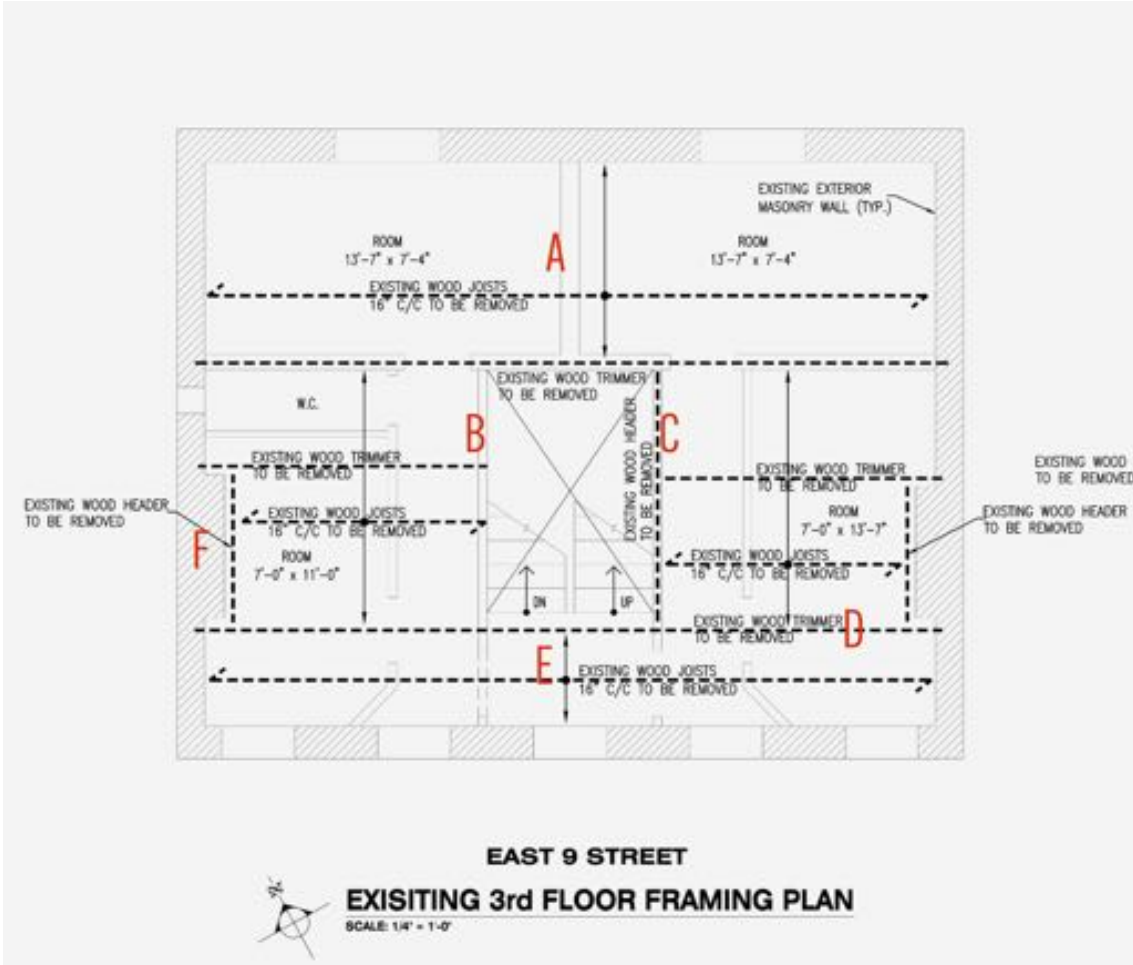
Figure 9: Typical residential floor plan, north to the top, excerpted from the set of structural drawings by Steel Core Engineering approved by the DoB on March 18, 2025 as filing M01181265-11. The red letters are annotations for this report: A indicates the rear bearing partition, B and C are the western and eastern stair bearing partitions, D is the front fireplace trimmer that supports the front strip of north-south joists (indicated as E), and F is the western front chimney.

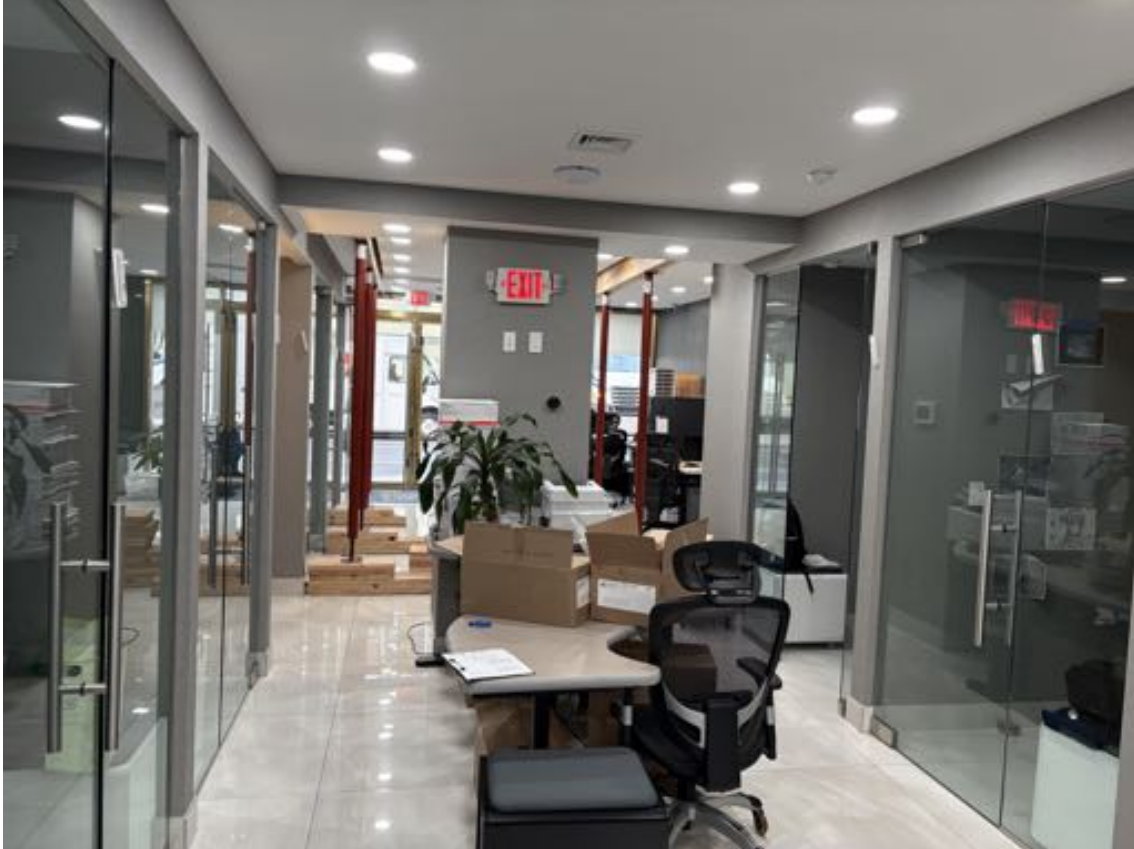
Figure 10: The first-floor retail space, as observed on November 7, looking towards the front facade. The gray wall with the EXIT sign is roughly at the back of the stair above, and is a likely location for a column to cut the span of a beam above (between the front and rear walls of the residential front portion of the building) in half. The red screw-jacks and wood plank in front of that are the first-floor portion of the shoring installed in response to the DoB violation regarding the damaged header.

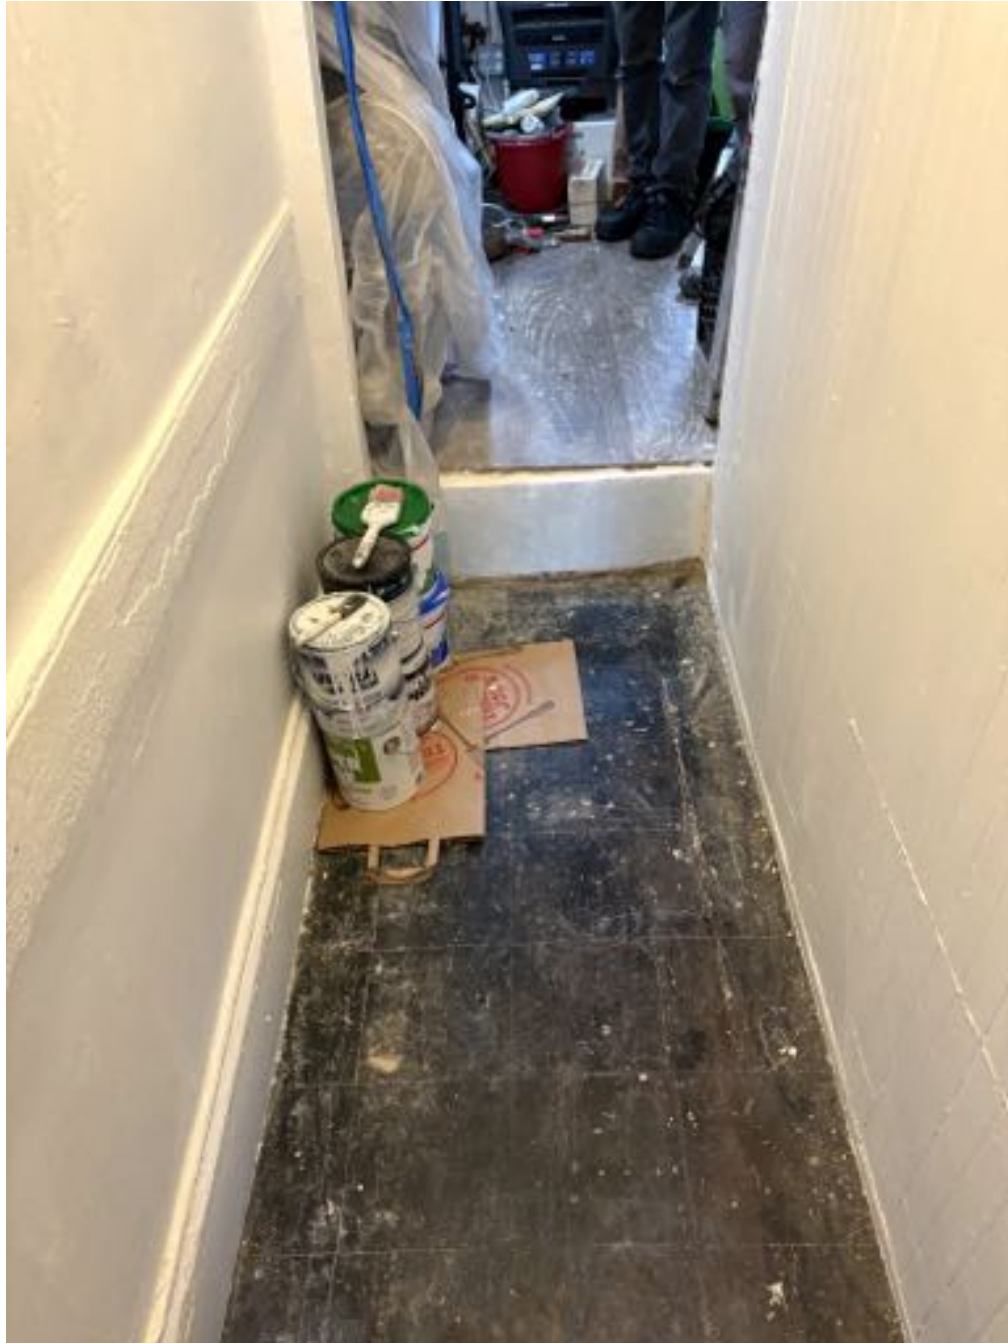
Figure 11: The entrance hall of unit 3D as observed on November 7, 2025. Note the slope of the hallway floor compared to the built-up leveled platform for the room beyond.

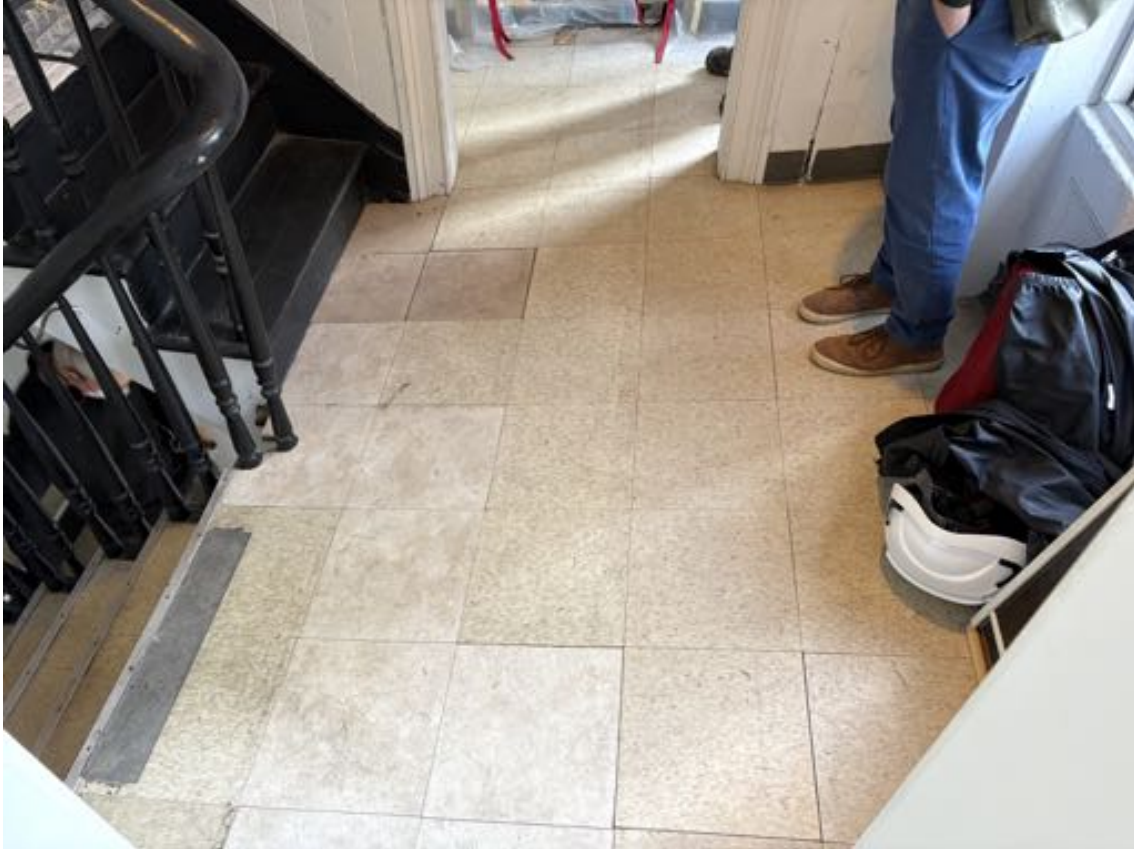
Figure 12: The 5th floor front as observed on November 7, 2025, showing the slope back to the stair. Note that the baseboard molding follows the slope and fits at the door, indicating that it was cut to match the slope, which is not recent.

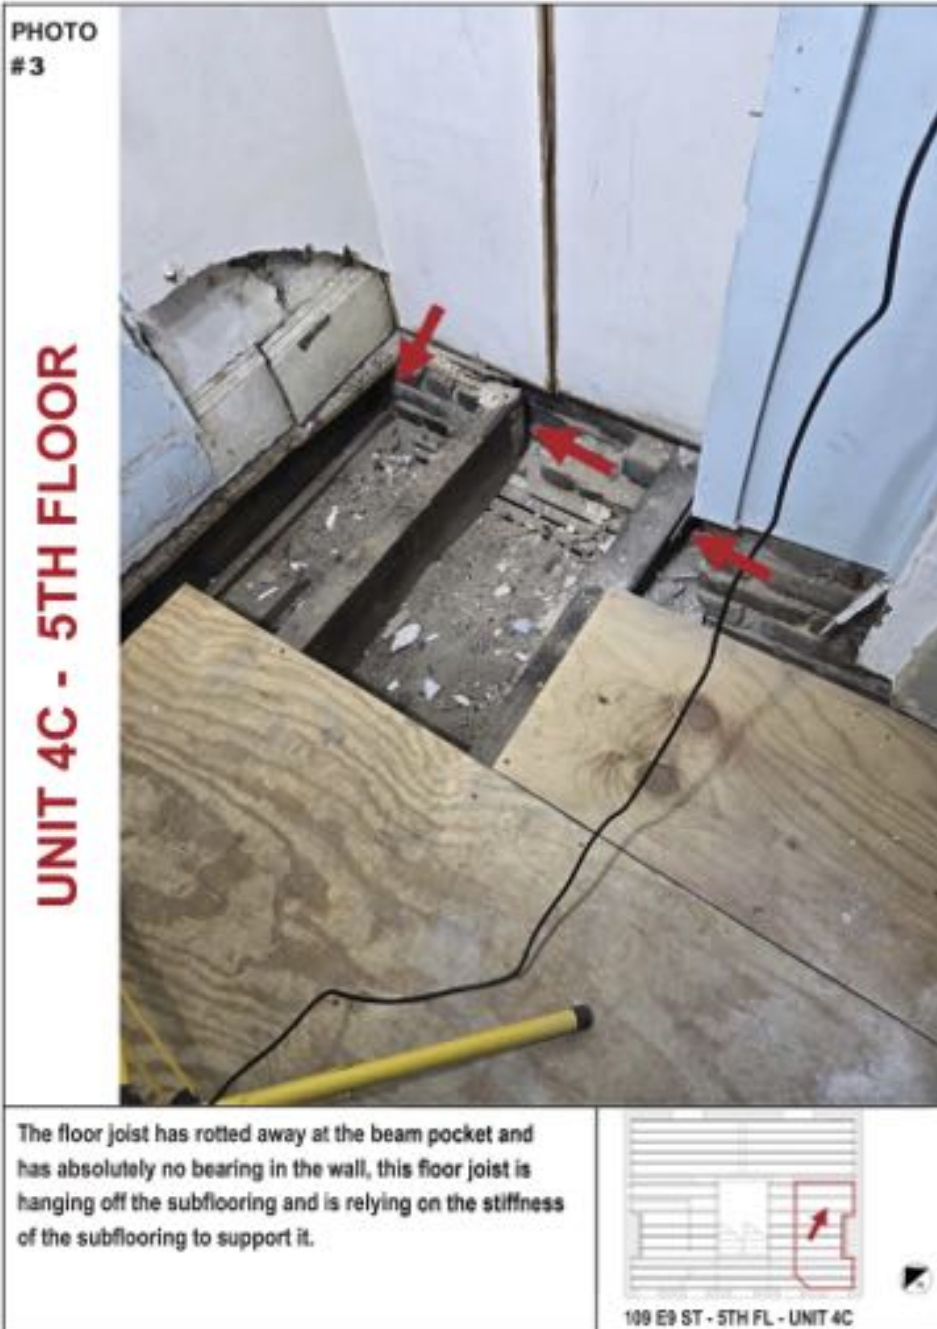
Figure 13: Photo 3 from the November 14, 2025 report by Steel Core Engineering. The red arrows are Steel Core annotation. The joist ends are damaged, but the joists extend into the brick wall and therefore have bearing and the rightmost joist has a wall tie (visible immediately to the left of the rightmost red arrow). The mortar is deteriorated but the wall is in position.

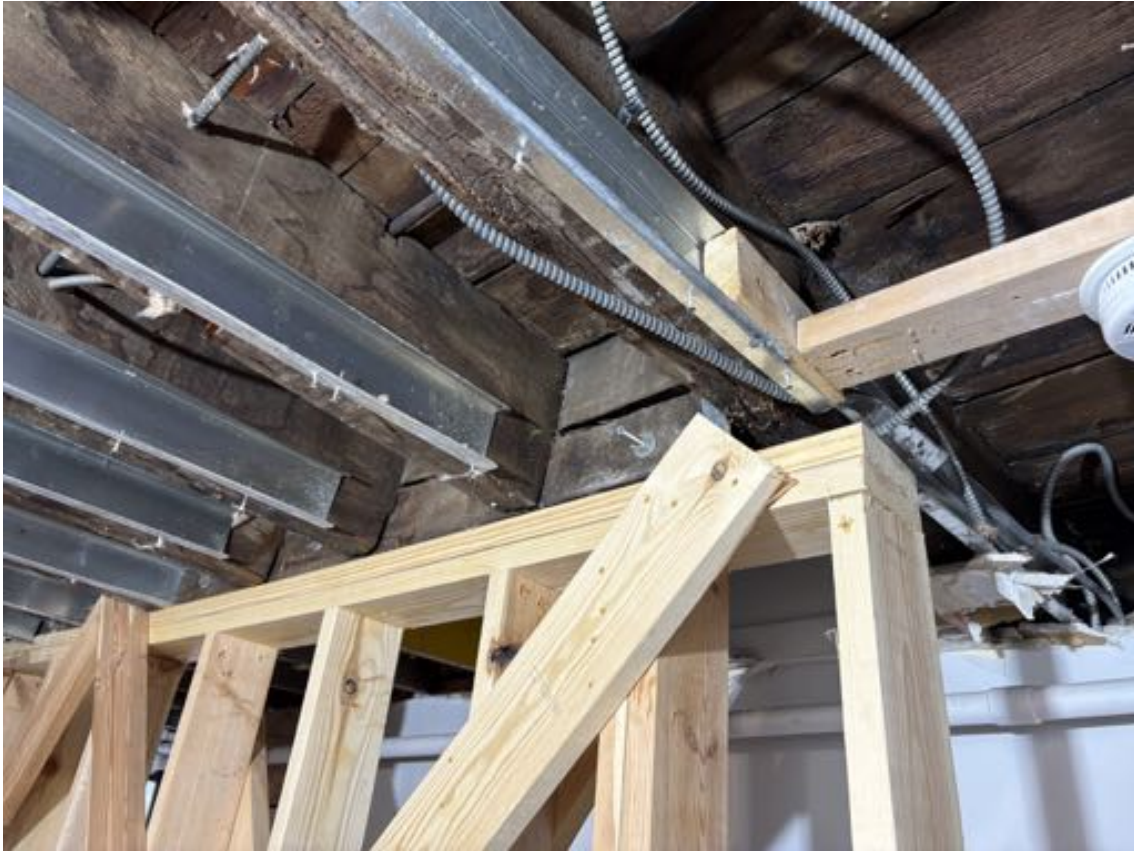
Figure 14: The header below the eastern stair bearing partition, as observed on November 7, 2025 in unit 1A. The light-colored wood is the shoring recently installed, and the crack in the header is visible at roughly the mid-height of the header and supported joists. The steel framing appears to be leveling for a ceiling that was not installed.

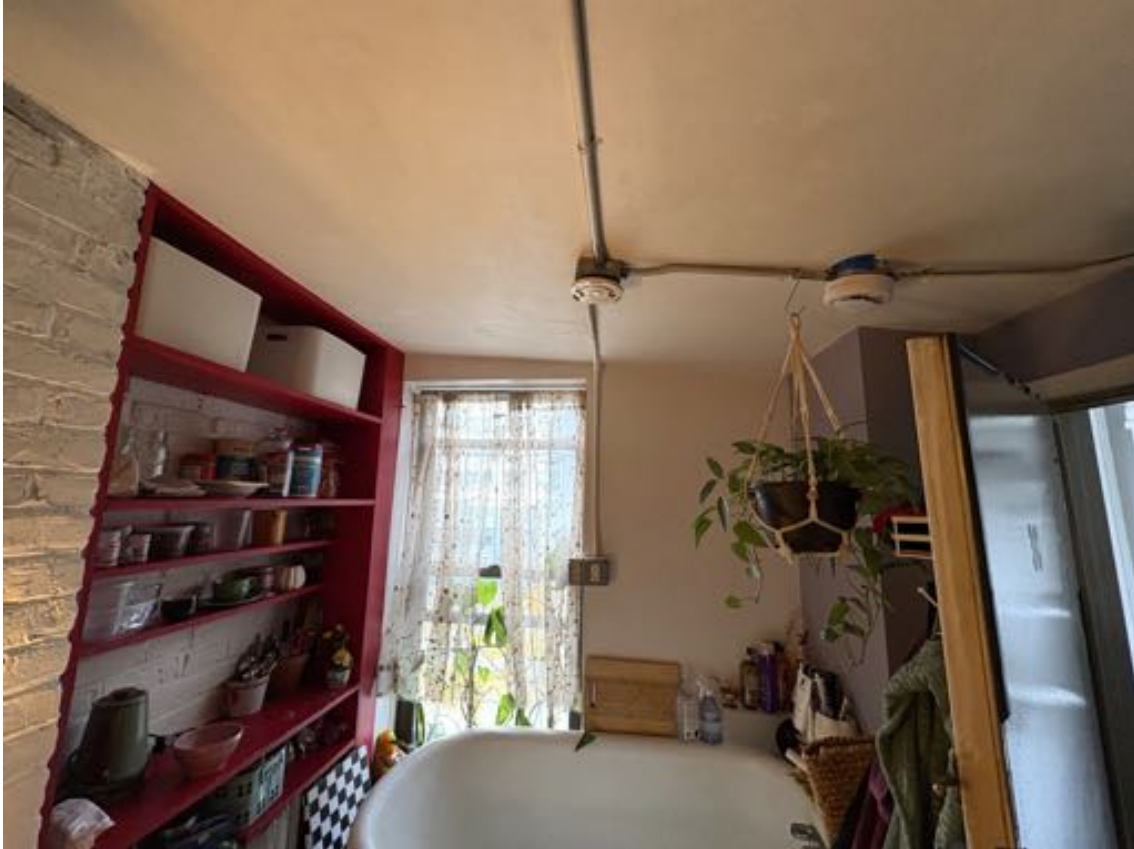
Figure 15: Interior of unit 3C as observed on November 7, 2025. Note the slope of the ceiling, following the slope of the floor above. The lack of plaster damage where the ceiling meets the wall indicates that this is not recent movement.

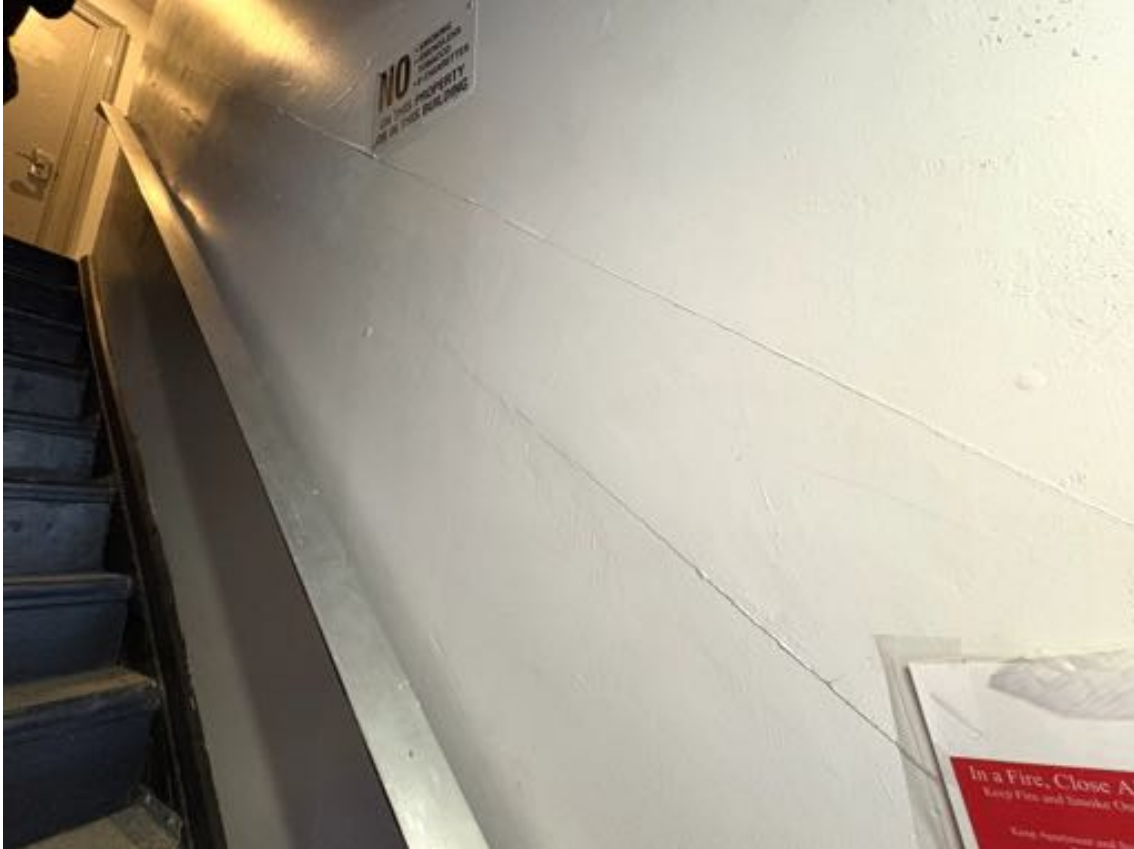
Figure 16: The stair from the street entry up to the second floor, as observed on November 7, 2025. The two cracks paralleling the stair slope appear to be non-structural damage in the partition finish, likely where wainscoting ends or used to end.
