STEEL CORE ENGINEERING

109 East 9th St. New York, NY 10003

Re: Additional Probing of Upper Floors structure

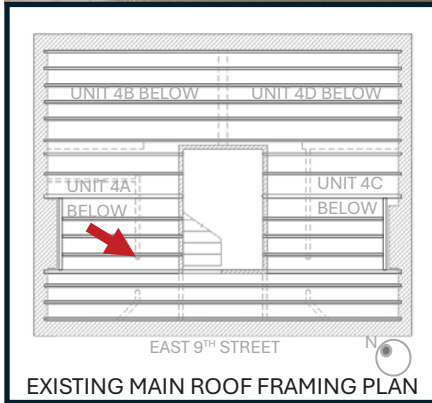
PHOTO #1

- **Photo #1 & #2** show roof rafters and chimney trimmer beam having extensive water deterioration. All of the roof rafters in unit 4A have water stains and have decay due to water exposure.

Roof rafter and chimney trimmer beams show extreme water deterioration

- **Water-Damaged Framing:** Throughout the building where the roof rafters and floor framing have substantial water damage and deterioration at the beam pockets and along their spans, the framing should be either sistered with new reinforcement, which is plumb, dry and stiff enough to span the length of the existing beam at minimum. However, the proper solution would be to replace the deteriorated framing with a new dry framing structure which will not be in contact with existing wet and deteriorated joists.

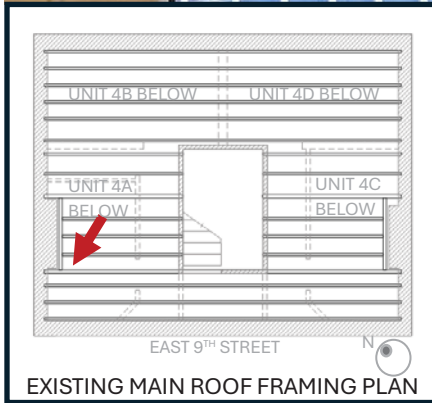
PHOTO #2

Roof rafter and chimney trimmer beams show extreme water deterioration

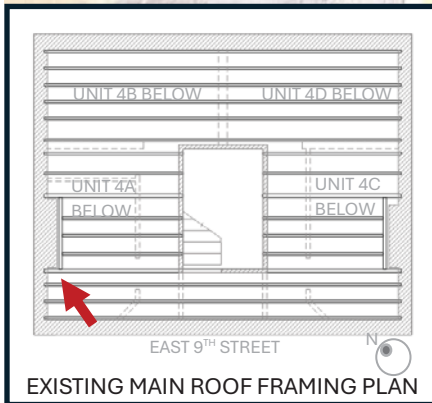
PHOTO #3

- **Photo #3** shows how the chimney trimmer beam is deteriorated at the beam pocket due to water exposure and this is an unsafe condition as the beam is weakened where it has to resist the maximum shear and bearing stresses.

Chimney trimmer beam is deteriorated at the beam pocket due to water exposure and this is an unsafe condition as the beam is weakened where it has to resist the maximum shear and bearing stresses

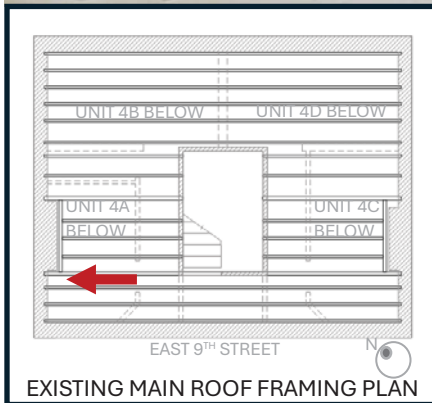
PHOTO #4

- **Photo #4** shows the brick and mortar condition where the roof framing ties into the wall. The brick has extensive water marks throughout and the mortar between the bricks is just sand. There is no adhesive properties in the mortar as it is dry and crumbles when touched. Such a mortar condition does not provide the wall with any tensile strength from out of plane bending and impacts the way the wall transfers the load down the building.

The brick has extensive water marks throughout and the mortar between the bricks is just sand. There is no adhesive properties in the mortar as it is dry and crumbles when touched. Such a mortar condition does not provide the wall with any tensile strength from out of plane bending and impacts the way the wall transfers the load down the building

- **Masonry Walls:** At the bearing masonry walls, removal and replacement of the deteriorated brick as well as deep repointing. Masonry stitching at the interior corners of the building, as required.

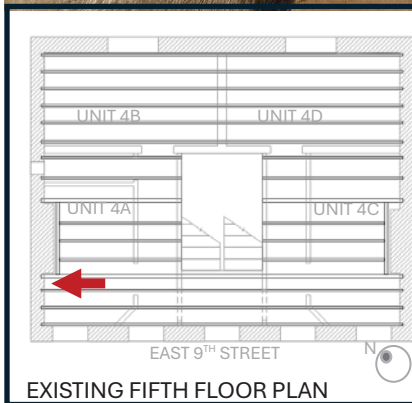
PHOTO #5

- **Photo #5** also shows dried mortar conditions at the 5th floor and extensive water deterioration in the floor joists where the 5th floor joists pocket into the wall and where the shear and bearing stresses are the highest in the floor joists.

Dried mortar conditions at the 5th floor and extensive water deterioration in the floor joists where the 5th floor joists pocket into the wall and where the shear and bearing stresses are the highest in the floor joists.

- **Floor Joists at Beam Pockets:** At the deteriorated and unsupported floor joists at the beam pockets, the remediation work would be to sister the floor joists and pocket the sister member into the wall and/or replace the floor joists with a new wood joist or LVL member which would bear at least four inches into the wall.

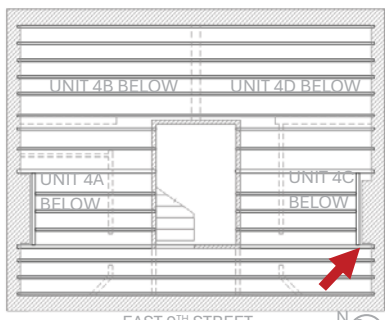
PHOTO #6

- **Photo #6** show that in unit 4C, the roof rafters were exposed and the chimney header along with the trimmer beams have water stains throughout and excessive decay at the beam pockets.

The roof rafters where exposed and the chimney header and trimmer beams have water stains throughout and excessive decay at the beam pockets

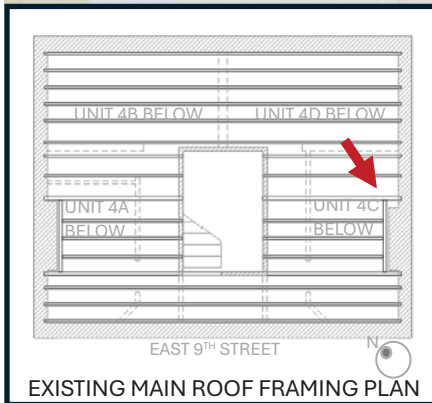
PHOTO #7

Multiple mortise holes made into the trimmer beam which take away bending moment capacity in the trimmer where it has the largest bending moment due to the point load acting on it from the chimney header beam.

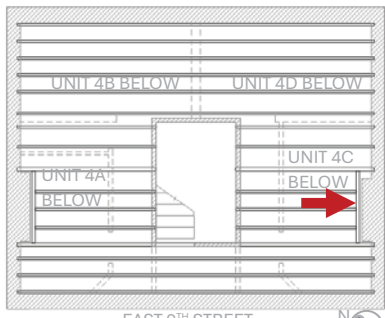
PHOTO #8

- **Photo #8** shows a large horizontal crack running across the length of the chimney header beam which supports multiple roof joists. Such a crack drastically decreases the sectional properties of the header where it must resist the maximum bending moment. Such a beam will fail if fully loaded for the roof load that it was designed for.

A large horizontal crack running across the length of the chimney header beam which supports multiple roof joists. Such a crack drastically decreases the sectional properties of the header where it has to resist the maximum bending moment. Such a beam will fail if fully imposed upon by roof loads for which it was designed to carry.

- **Cracked Structural Members:** At the existing headers, trimmers and floor joists throughout the building that have large cracks, and are at imminent risk of failure, such members must be replaced.

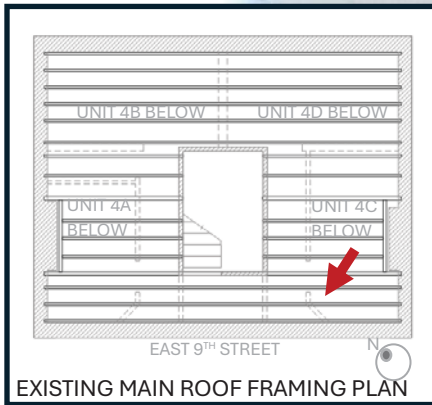
PHOTO #9

- **Photo #9 & #10** show a roof rafter which is oriented to 90 degrees with water damage. Such a rafter is supporting the roof load along its weak axis and does not have the capacity to support the roof loading imposed onto it.

Roof rafter which is oriented to 90 degrees with water damage. Such a rafter is supporting the roof load along its weak axis and does not have the capacity to support the roof loading imposed onto it.

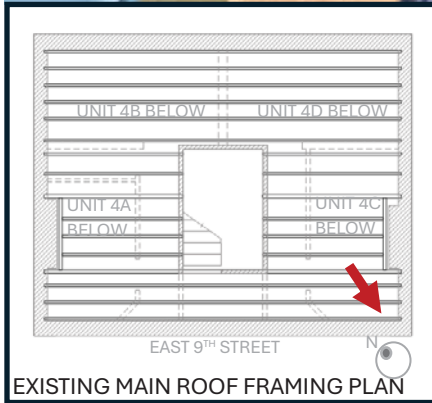
PHOTO #10

Roof rafter which is oriented to 90 degrees with water damage. Such a rafter is supporting the roof load along its weak axis and does not have the capacity to support the roof loading imposed onto it.

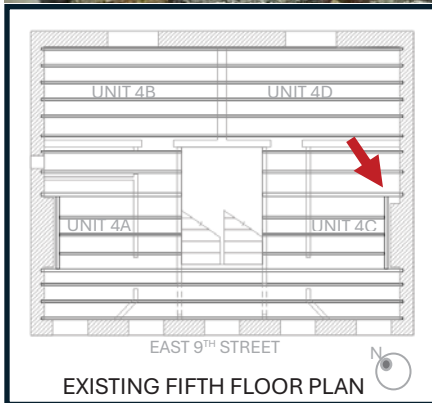
PHOTO #11

- **Photo #11 & #12** show the condition of the masonry wall where the 5th floor framing ties into it. The masonry wall in this location has experienced so much deterioration that the mortar has been completely washed out, leaving large gaps between the bricks. The bricks can be moved by hand and are not bonded to each other and work independently, not like a wall. Such a masonry condition is incredibly dangerous, and this wall has no structural integrity and is in risk of collapse due to there being no bonding between the bricks and large gaps that allow for movement.

Condition of the masonry wall where the 5th floor framing ties into it. Mortar of the masonry wall is deteriorated to the extent that bricks are no longer bonded together and do not function like an incumbent system. There is no structural integrity to this wall

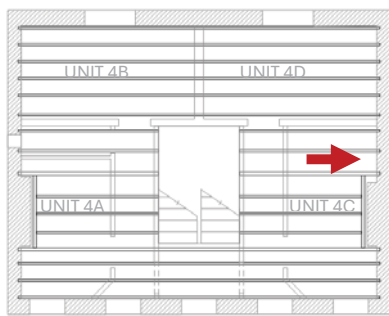
PHOTO #12

Condition of the masonry wall where the 5th floor framing ties into it. Mortar of the masonry wall is deteriorated to the extent that bricks are no longer bonded together and do not function like an incumbent system. There is no structural integrity to this wall

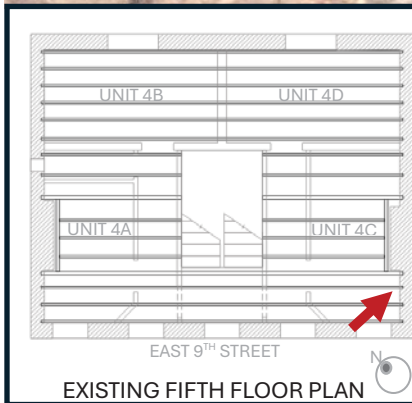
PHOTO #13

- **Photo #13** shows how the floor joist had rotten away at the beam pocket and has absolutely no bearing in the wall, this floor joist is hanging off the subflooring and is relying on the stiffness of the subflooring to support it.

The floor joist has rotted away at the beam pocket and has absolutely no bearing in the wall, this floor joist is hanging off the subflooring and is relying on the stiffness of the subflooring to support it.

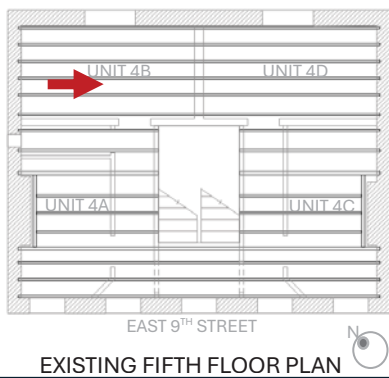
PHOTO #14

- **Photo #14 & #15** show that in unit 3B, all of the ceiling joists were exposed, and we can see warping in the ceiling joists and excessive water damage throughout the joist span.

In unit 3B, all of the ceiling joists were exposed, and we can see warping in the ceiling joists and excessive water damage throughout the joist span

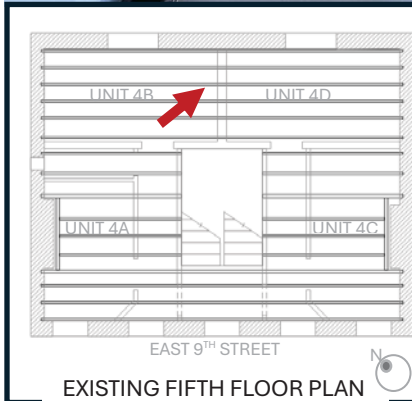
PHOTO #15

In unit 3B, all of the ceiling joists were exposed, and we can see warping in the ceiling joists and excessive water damage throughout the joist span

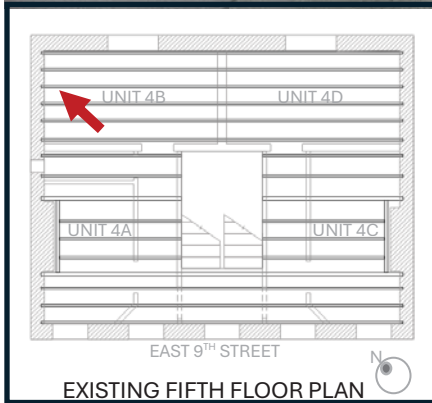
PHOTO #16

- **Photo #16 & #17** show the extensive water damage in the floor joists, especially at the beam pockets where water contact is present due to porous and poor masonry wall conditions which allow rainwater infiltration.

Extensive water damage in the floor joists, especially at the beam pockets where water contact is present due to porous and poor masonry wall conditions which allow rainwater infiltration

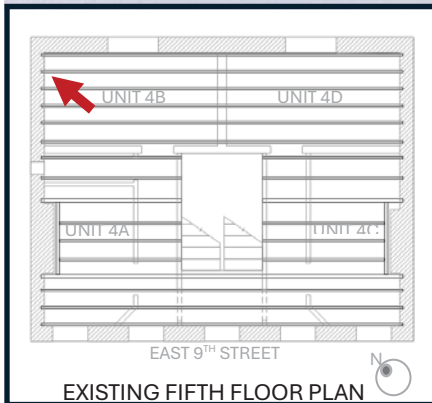
PHOTO #17

Extensive water damage in the floor joists, especially at the beam pockets where water contact is present due to porous and poor masonry wall conditions which allow rainwater infiltration.

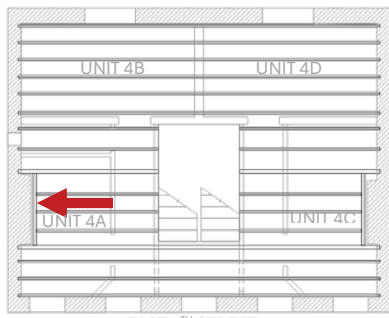
PHOTO #18

Cracking of the chimney header beam which supports multiple floor joists.

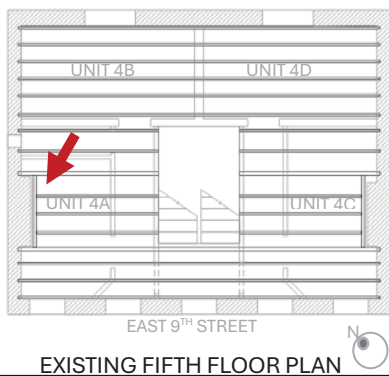
PHOTO #19

Horizontal cracks for the visible span of the floor beam. Such large cracks compromise the beams' structural integrity and deem it unsafe. Such beams rely on the adjacent beams to support the floor weight as they themselves do not have the structural integrity to do so, such a condition is hazardous and unsafe.

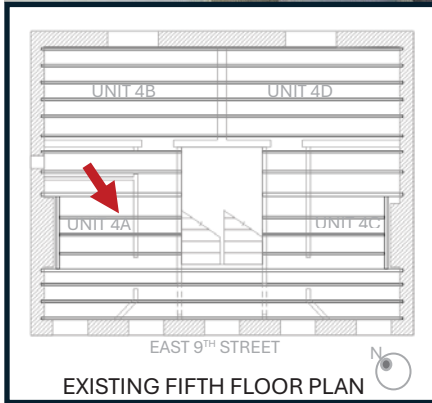
PHOTO #20

Horizontal cracks for the visible span of the floor beam. Such large cracks compromise the beams' structural integrity and deem it unsafe. Such beams rely on the adjacent beams to support the floor weight as they themselves do not have the structural integrity to do so, such a condition is hazardous and unsafe.

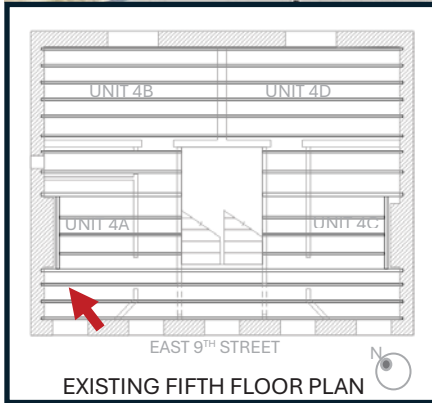
PHOTO #21

The conditions of the 5th floor joists at the masonry wall and the water damage that these joists have at the beam pockets which weakens their integrity at the beam pockets. The mortar condition is also compromised and can be easily scraped with a nail or chisel.

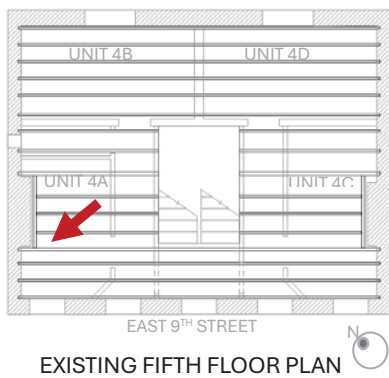
PHOTO #22

The conditions of the 5th floor joists at the masonry wall and the water damage that these joists have at the beam pockets which weakens their integrity at the beam pockets. The mortar condition is also compromised and can be easily scraped with a nail or chisel.

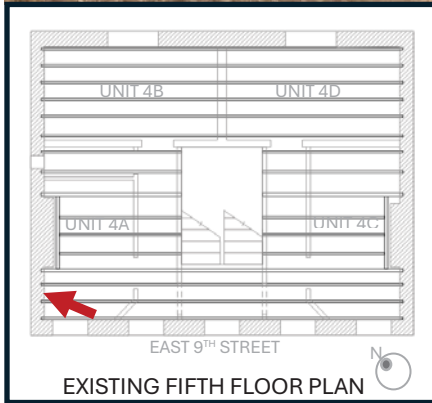
PHOTO #23

The conditions of the 5th floor joists at the masonry wall and the water damage that these joists have at the beam pockets which weakens their integrity at the beam pockets. The mortar condition is also compromised and can be easily scraped with a nail or chisel.

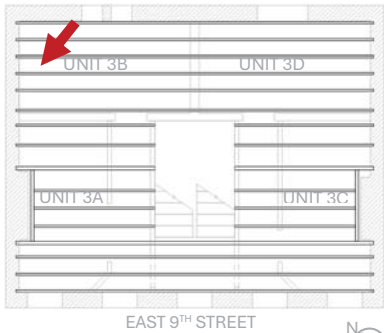
- **Photo #24, #25 & #26** provide multiple views of the 4th floor joist conditions and their deterioration. In unit 2B, all of the exposed 4th floor joists (ceiling joists) have water stains and deterioration from water damage. The 4th floor joists are sloping down towards the center of the building at a minimum of 2 degrees and lack bridging in some bays. deterioration.

<p>EXISTING FOURTH FLOOR PLAN</p>	<p>PHOTO #24</p> <p>In unit 2B, all of the exposed 4th floor joists (ceiling joists) have water stains and deterioration from water damage. The 4th floor joists are sloping down towards the center of the building at a minimum of 2 degrees and lack bridging in some bays. Photos #24, #25 and #26 provide multiple views of the 4th floor joist conditions and their deterioration.</p>
---	---

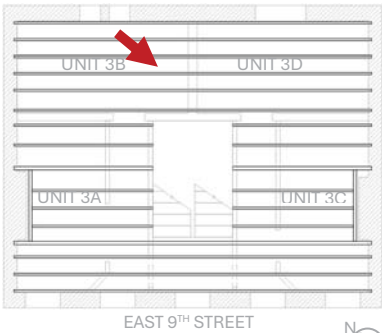
<p>EXISTING FOURTH FLOOR PLAN</p>	<p>PHOTO #25</p> <p>In unit 2B, all of the exposed 4th floor joists (ceiling joists) have water stains and deterioration from water damage. The 4th floor joists are sloping down towards the center of the building at a minimum of 2 degrees and lack bridging in some bays. Photos #24, #25 and #26 provide multiple views of the 4th floor joist conditions and their deterioration.</p>
---	---

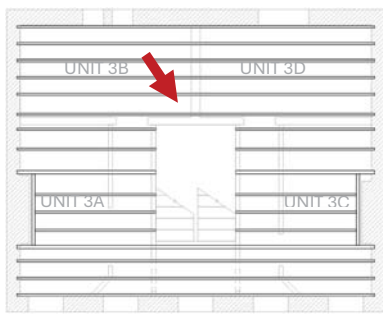
PHOTO #26

In unit 2B, all of the exposed 4th floor joists (ceiling joists) have water stains and deterioration from water damage. The 4th floor joists are sloping down towards the center of the building at a minimum of 2 degrees and lack bridging in some bays. Photos #24, 25 and #26 provide multiple views of the 4th floor joist conditions and their deterioration.

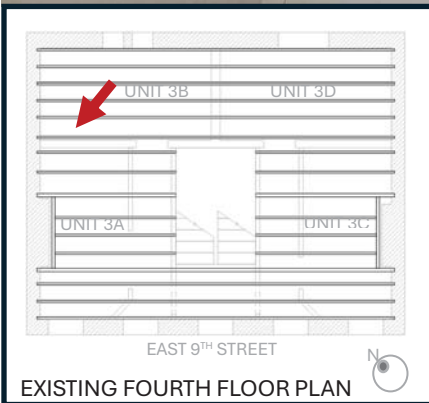
PHOTO #27

Water damage of the 4th floor joists at the beam pockets and the dried-up mortar joints in the bearing masonry wall.

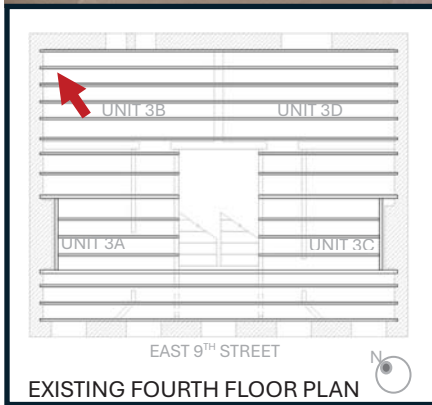
PHOTO #28

Water damage of the 4th floor joists at the beam pockets and the dried-up mortar joints in the bearing masonry wall.

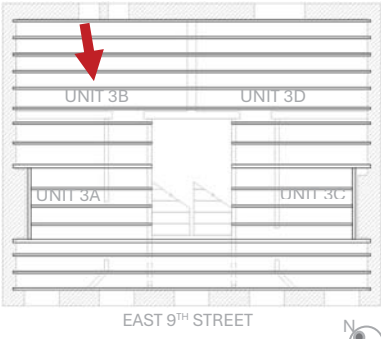
<p>EXISTING FOURTH FLOOR PLAN</p>	<p>PHOTO #29</p> <p>Lack of bridging in a bay between two floor joists.</p>
---	--

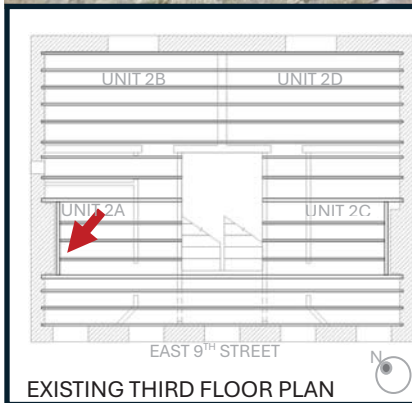
PHOTO #30

- In unit 2A, some of the 3rd floor joists were exposed and large cracks, water damage and joist sloping were observed.
- **Photo #30 & #31** show the chimney header beam having a very large horizontal check/crack which represents beam failure. This beam supports multiple floor joists and the joists are sloping towards the middle of the building which also pull on this cracked chimney header in its weak axis. Such a framing condition is not safe and hazardous.

Chimney header beam having a very large horizontal check/crack which represents beam failure. This beam supports multiple floor joists and the joists are sloping towards the middle of the building which also pull on this cracked chimney header in its weak axis. Such a framing condition is not safe and hazardous.

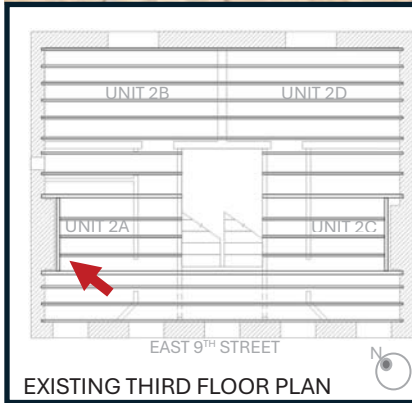
PHOTO #31

Chimney header beam having a very large horizontal check/crack which represents beam failure. This beam supports multiple floor joists and the joists are sloping towards the middle of the building which also pull on this cracked chimney header in its weak axis. Such a framing condition is not safe and hazardous.

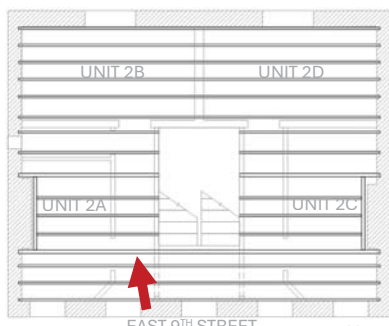
PHOTO #32

A crack in the 3rd floor trimmer beam. This crack is horizontal and spans for a large span of the beam, making this beam unsafe.

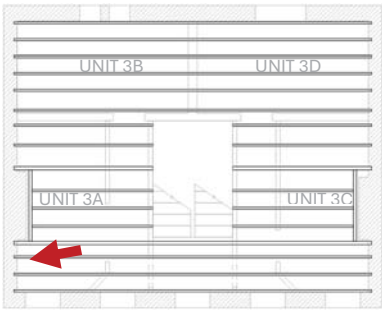
<p>EAST 9TH STREET</p> <p>EXISTING FOURTH FLOOR</p>	<p>PHOTO #33</p> <p>The dry mortar condition which exists where the 4th floor joists pocket into the wall. This condition has been seen throughout the building and not just this floor.</p>
--	---

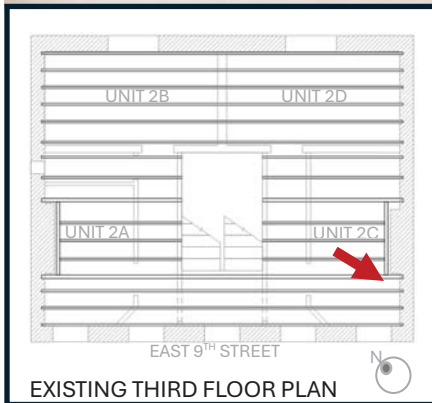
PHOTO #34

- **Photo #34 & #35** show the 3rd floor joist and chimney trimmer beam (in the floor of unit 2C) and show the water damage where the joist and trimmer pocket into the wall. The joist is bearing into the masonry wall for about one inch only. Standard bearing requirements for a floor joist would be about 4 inches. The mortar in the brick wall are also dry and structurally unstable.

The 3rd floor joist and chimney trimmer beam (in the floor of unit 2C) show the water damage where the joist and trimmer pocket into the wall. The joist is bearing into the masonry wall for about one inch only. Standard bearing requirements for a floor joist would be about 4 inches. The mortar in the brick wall are also dry and structurally unstable.

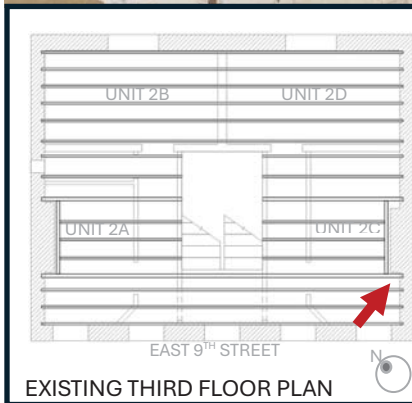
PHOTO #35

The 3rd floor joist and chimney trimmer beam (in the floor of unit 2C) show the water damage where the joist and trimmer pocket into the wall. The joist is bearing into the masonry wall for about one inch only. Standard bearing requirements for a floor joist would be about 4 inches. The mortar in the brick wall are also dry and structurally unstable.

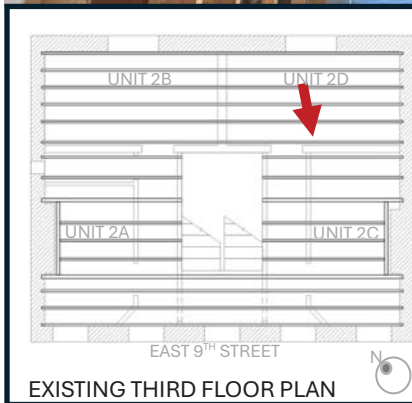
PHOTO #36

- **Photo #36, #37 & #38** show the 3rd floor joist with a large horizontal check/crack which extends for the majority of its span. This crack is an indication that the floor member is beyond its point of failure and is not structurally sound to support the floor loading.

The 3rd floor joist with a large horizontal check/crack which extends for the majority of its span. This crack is an indication that the floor member is beyond its point of failure and is not structurally sound to support the floor loading.

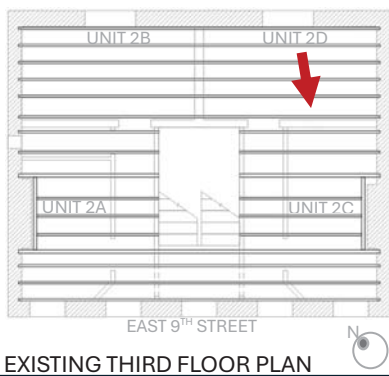
PHOTO #37

The 3rd floor joist with a large horizontal check/crack which extends for the majority of its span. This crack is an indication that the floor member is beyond its point of failure and is not structurally sound to support the floor loading.

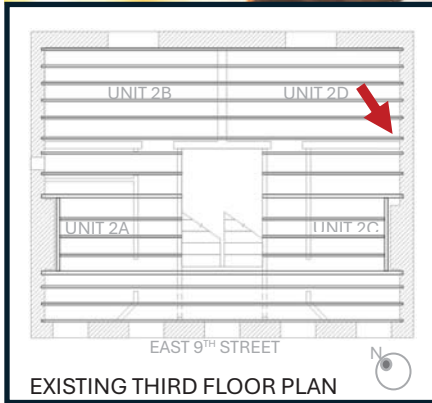
PHOTO #38

The 3rd floor joist with a large horizontal check/crack which extends for the majority of its span. This crack is an indication that the floor member is beyond its point of failure and is not structurally sound to support the floor loading.
